Annual Inspection Report for Coal Combustion
Residuals Surface Impoundments

City Water, Light & Power
Ash Impoundments
Springfield, Sangamon County, Illinois

January 2025

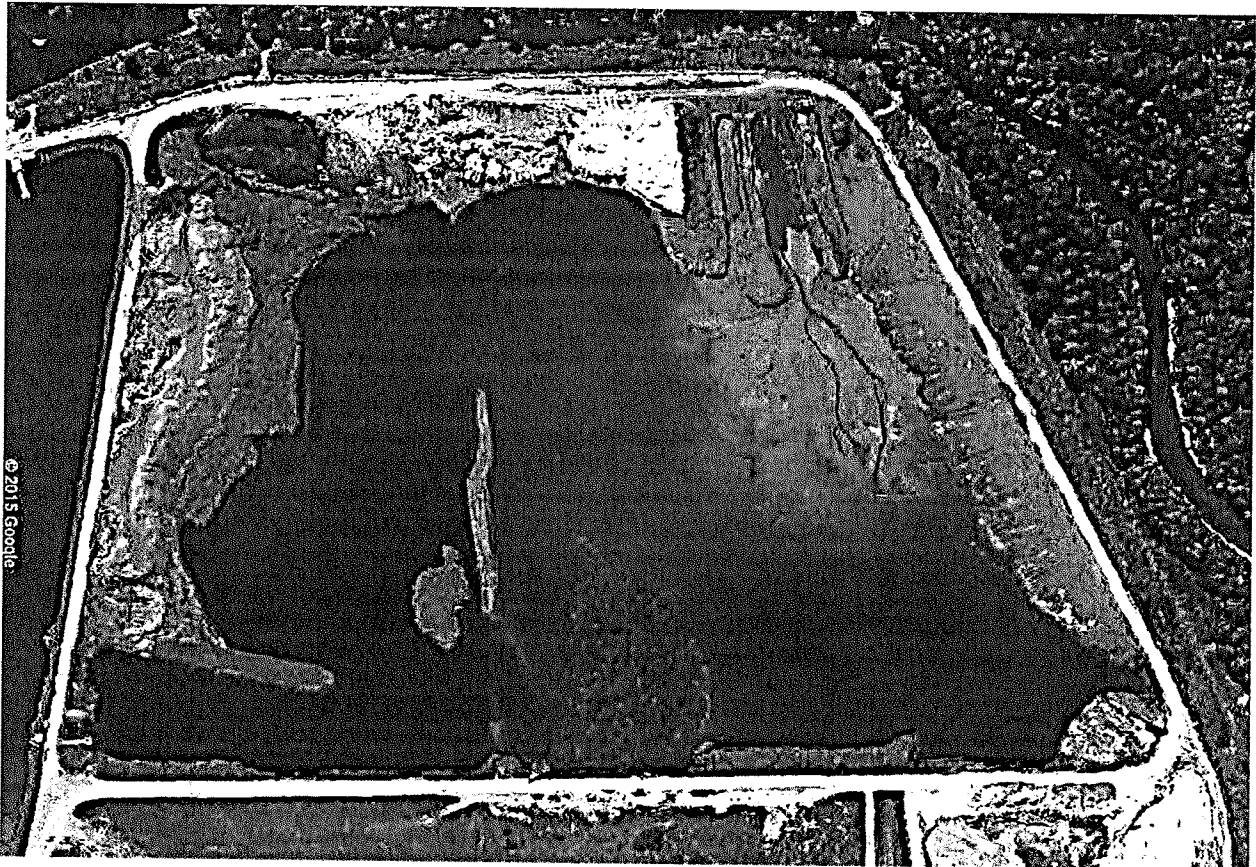
Berms – Dallman Ash Pond

In reports from the previous years, it was noted that signs of erosion had been periodically observed on the north and west outer berms of the Dallman Ash Pond in the forms of ruts and gullies that typically range from 6 – 24 inches deep. The erosion appeared to be caused by storm water flow collecting at points along the top of the berm before flowing down the outer slope in concentrated streams. Erosion of similar severity was discussed in the 2011 Site Assessment Final Report, which recommended that the erosion be repaired on an as-needed basis. In the fall of 2017, the tops of the berms of the Dallman Ash Ponds were regarded with a cross slope of approximately 1/4" per foot inward towards the ponds. This has allowed the rain water to be contained in the ponds and to not cause erosion on the slopes.

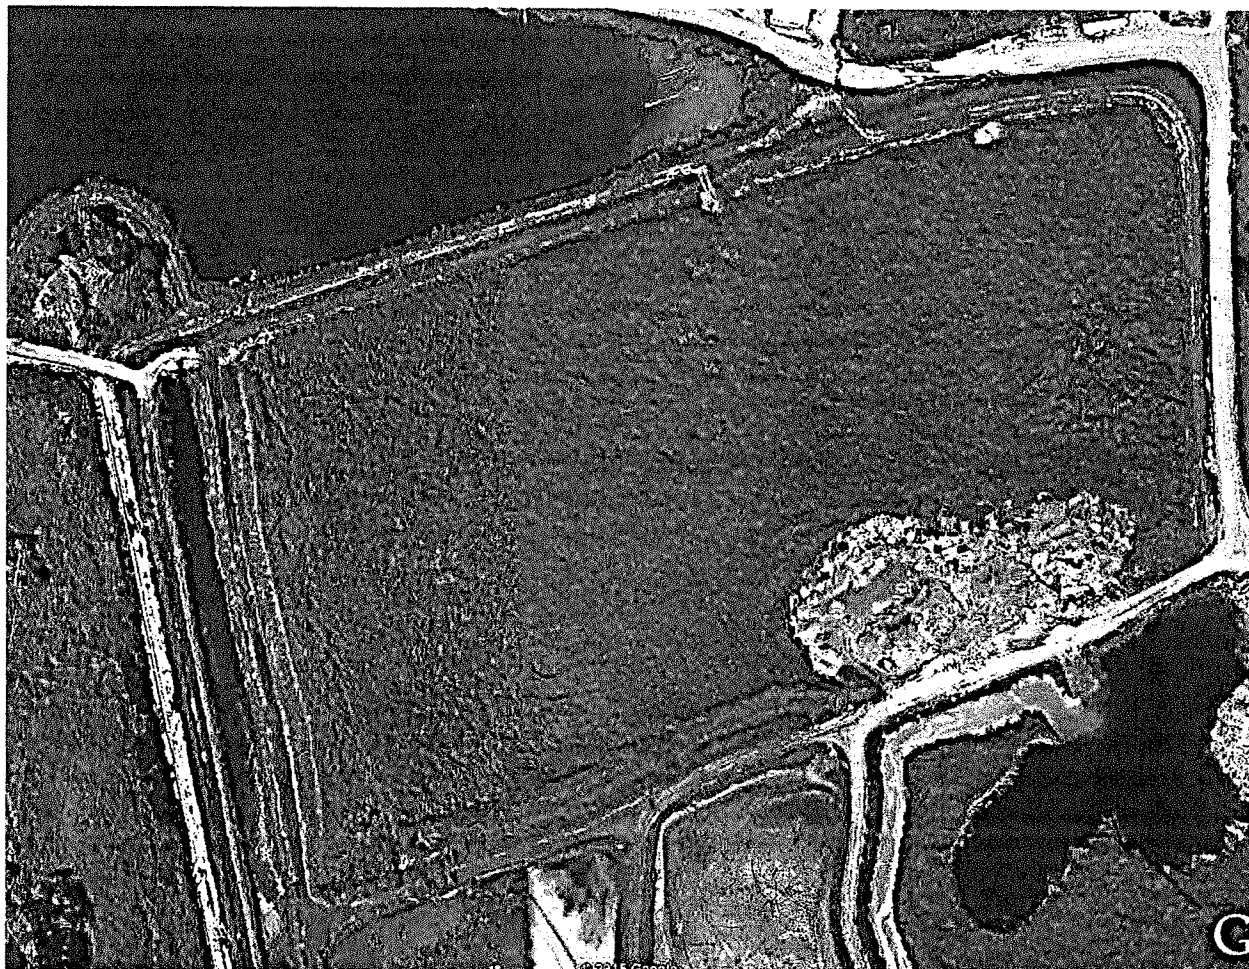
Berms – Lakeside Ash Pond

As previously reported, indications of seepage have been observed on outer berms of the Lakeside Ash Pond and lime ponds, between the top of the original pond berms and the vertical expansion berms. These range from staining or dampness to areas with noticeable drainage. Signs of seepage have been observed along the west berm, as well as isolated portions on the east and west portions of the north berm of the Lakeside Ash Pond. This seepage is discussed in the 2011 Site Assessment Final Report. During the fall of 2017, two 8" diameter perforated dual wall HDPE drain pipes were installed underneath the toe of the slope of the vertical extension. The water from these drain tiles outlets into the Clarification Pond. In July and August of 2019, lime removal was executed in the channel on the west side of the Lakeside Ash Pond. Shortly after, the seepage was again visible at the vertical expansion joint. After a few weeks, the berm self-sealed. Only once during 2020 was seepage observed at the vertical expansion joint. In 2021, seepage was visible for a few weeks when the west lime pond was put into service. In the Summer of 2022 and again in the Winter of 2023, the north berm of the Lakeside Ash Pond was cleared of all brush and woody plants; multiple animal dens were filled and compacted. A couple of those were required to be refilled and recompacted. Two animal dens were also filled and compacted along this berm in January 2024. In 2024, similar minor events involving animal dens and seepage occurred. The dens were destroyed and filled and the seepage was directed to the Clarification Pond. The seepage only occurred after heavy spring rains.
