City Water, Light and Power  
Coal Combustion Residuals Units  
40 CFR 257 and 35 IAC 845  
Weekly Inspection Form

Date 10-24-23 Time 4:30

Inspector(s) / Position: Staley

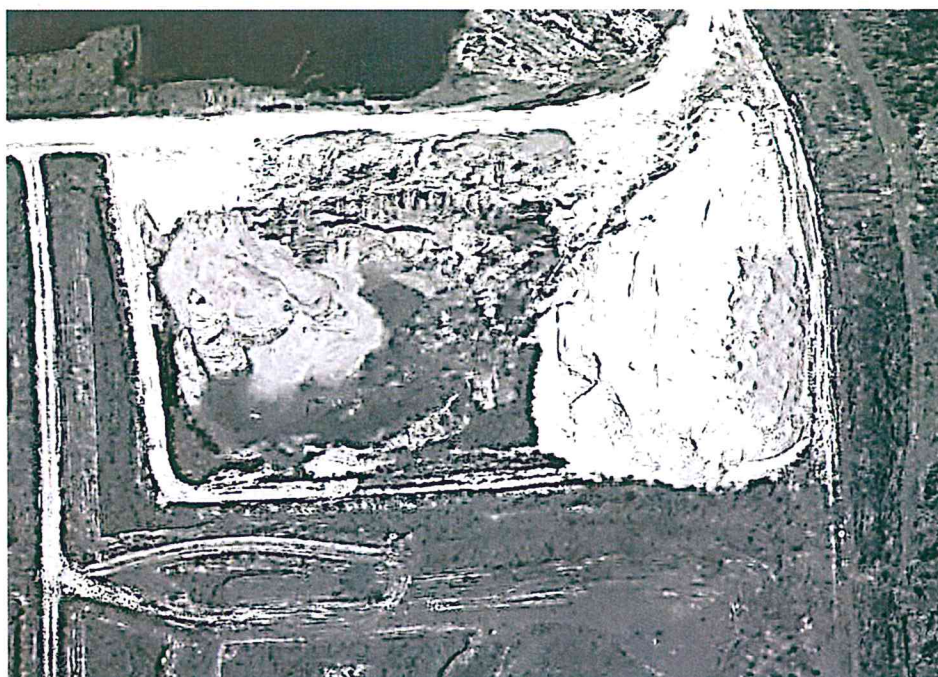
**Berms – Landfill Unit 2:**

☒ No observed problems

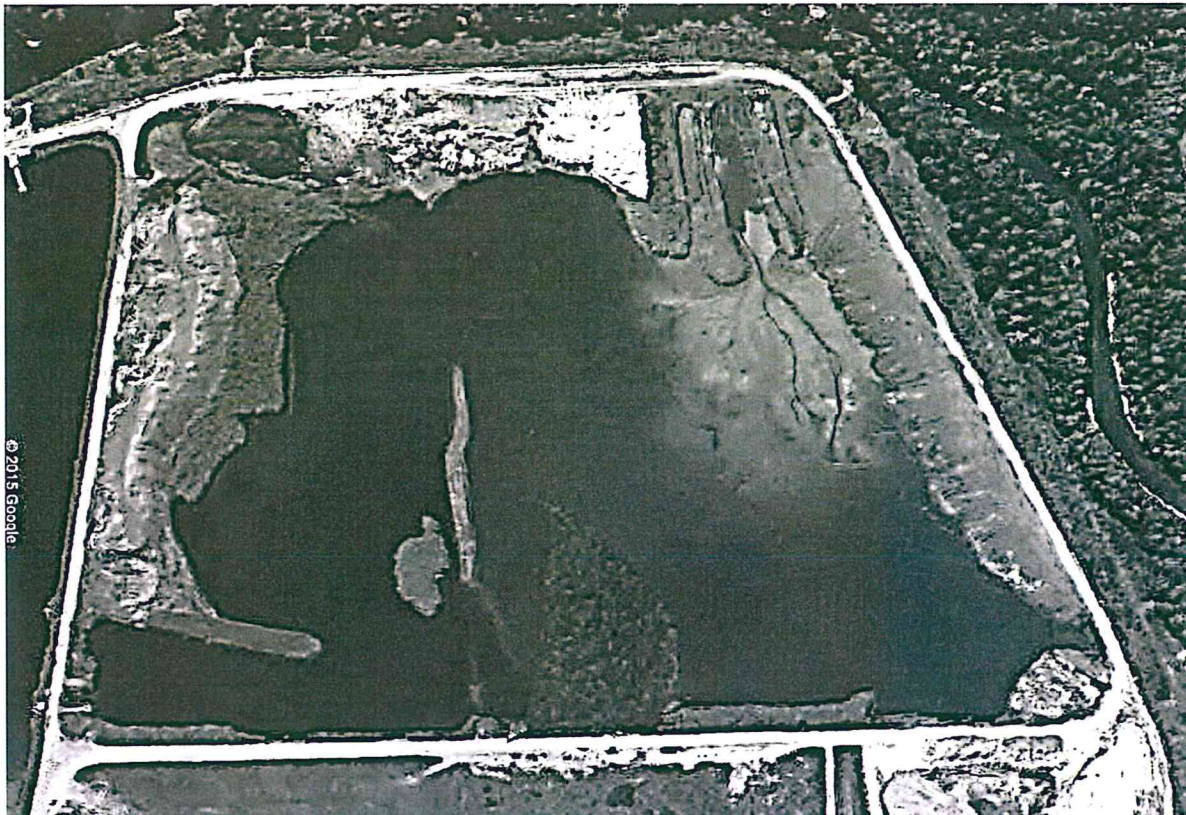
**Berms – Dallman Ash Pond**

☒ No observed problems

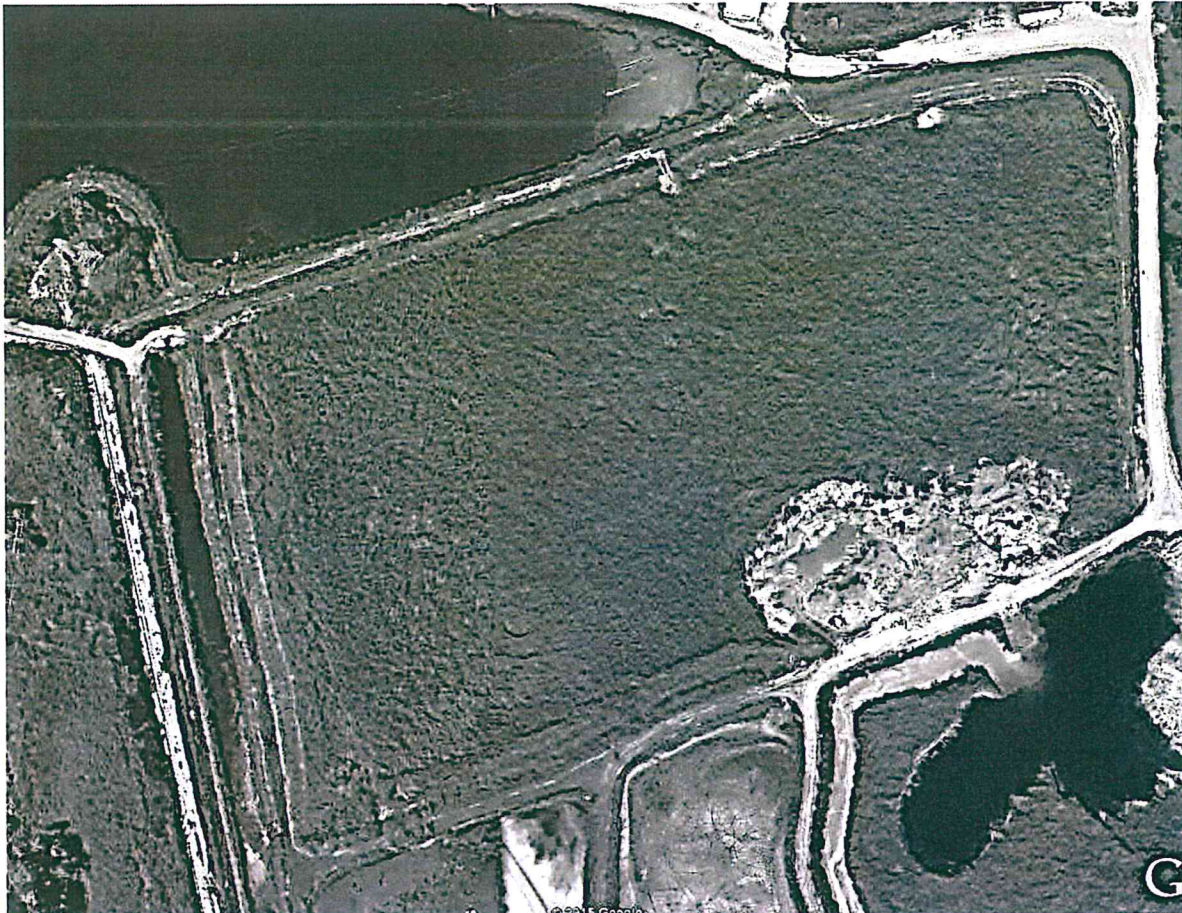
**Berms – Lakeside Ash Pond**

- ☐ Sudden drop in impoundment level  
☐ Actual or potential structural weakness  
☐ Improper operation of overtopping control  
☐ Visible release  
☒ No observed problems

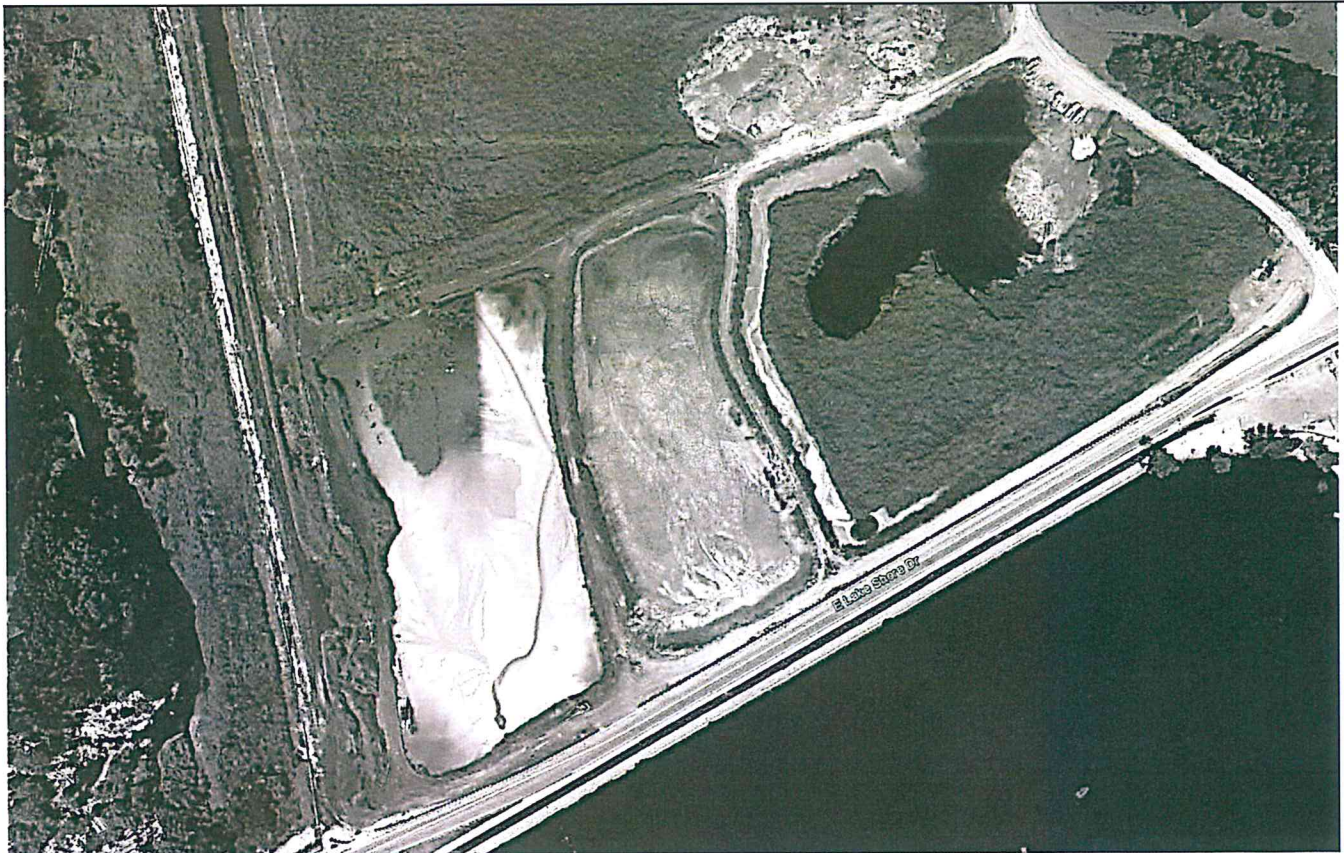
**Berms – Lime Softening Ponds**

☒ No observed problems
