Date: 4-16-25 Time: 7:45 AM Inspector(s) / Position: Jim KETCHUM				
Site Conditions:				
Sky: Sunny Ground Moisture: DRY Temperature: 41°F Precipitation: NONE				
Berms – Landfill Unit 2:				
Conditions Limiting Visibility:				
□ Snow Cover □ Other				
∀ Vegetation  □ None				
Observations:				
□ Erosion / Gullies □ Sudden drop in impoundment level				
□ Cracking / Sloughing □ Actual or potential structural weakness				
□ Seeps / Damp Areas □ Improper operation of overtopping control				
□ Signs of Creep □ Visible release				
□ Failed/eroded vegetation >100sq ft. No observed problems				
Describe findings. Identify locations on attached map. Attach additional pages if necessary.

### Berms - Dallman Ash Pond

### Berms - Lakeside Ash Pond

### Berms - Lime Softening Ponds

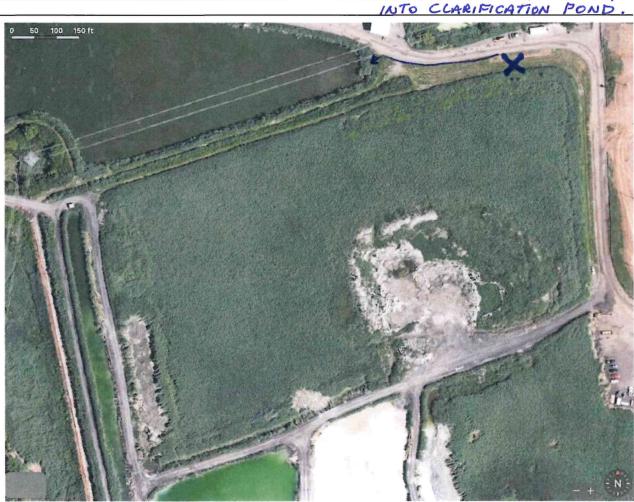
241001407101110114		
Condit	tions Limiting Visibility:		
	Snow Cover		Other
	Vegetation	X	None
Obser	vations:		
	Erosion / Gullies		Sudden drop in impoundment level
	Cracking / Sloughing		Actual or potential structural weakness
×	Seeps / Damp Areas		Improper operation of overtopping control
	Signs of Creep		Visible release
	Failed/eroded vegetation >100sq ft.		No observed problems
Descri	be findings. Identify locations on attached map. Attach	n add	ditional pages if necessary.
			SEEPAGE FROM NE LSAP
•			INTO DITCH AND DRAINING
