Date: 4/30/25 Time: //:30 Inspector(s) /	Position: Schy Willmore
Site Conditions:	light vain
Sky: Guvcust Ground Moisture: Wet Tempe	rature: 58 Precipitation: at start
Berms – Landfill Unit 2:	
Conditions Limiting Visibility:	
□ Snow Cover	□ Other
□ Vegetation	None
Observations:	
□ Erosion / Gullies	□ Sudden drop in impoundment level
□ Cracking / Sloughing	☐ Actual or potential structural weakness
□ Seeps / Damp Areas	☐ Improper operation of overtopping control
□ Signs of Creep	□ Visible release
☐ Failed/eroded vegetation >100sq ft.	No observed problems
	2
Describe findings. Identify locations on attached map. Attac	h additional pages if necessary.

#### Berms - Dallman Ash Pond

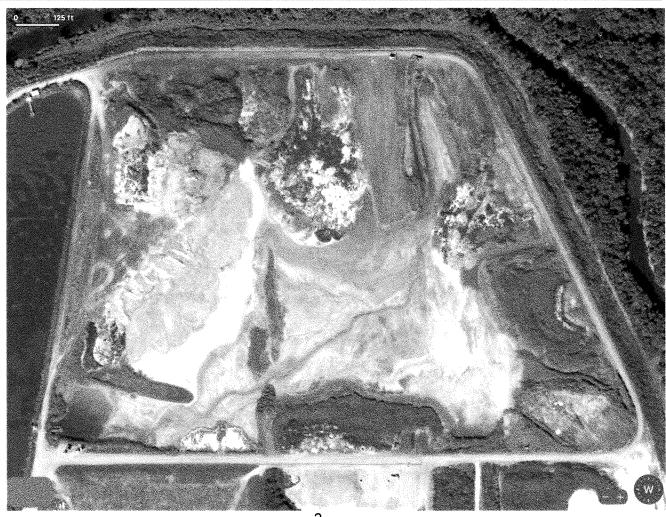
Condit	tions Limiting Visibility:		
	Snow Cover		Other
	Vegetation	70	None
Obser	vations:	•	
	Erosion / Gullies		Sudden drop in impoundment level
	Cracking / Sloughing		Actual or potential structural weakness
	Seeps / Damp Areas		Improper operation of overtopping control
	Signs of Creep		Visible release
	Failed/eroded vegetation >100sq ft.	X	No observed problems
Descri	be findings. Identify locations on attached map. Attach	ado	ditional pages if necessary.
**************************************			
***************************************

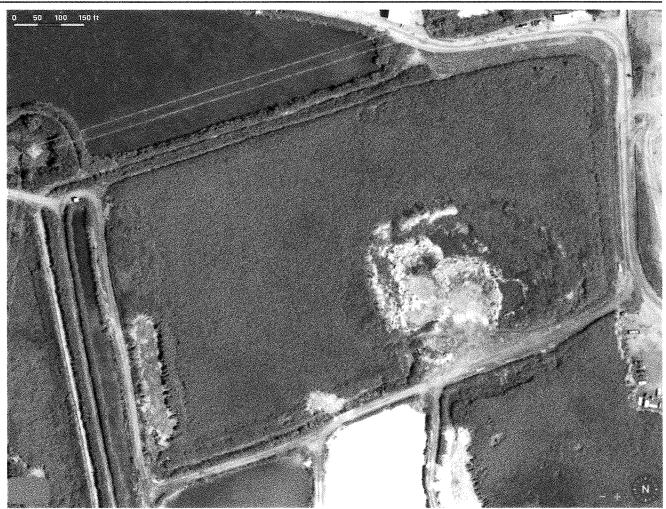
Berms - Lakeside As	sh	Po	nd
---------------------	----	----	----

3011110		
Condit	ions Limiting Visibility:	
	Snow Cover	□ Other
	Vegetation	None
Obser	vations:	
	Erosion / Gullies	☐ Sudden drop in impoundment level
	Cracking / Sloughing	□ Actual or potential structural weakness
	Seeps / Damp Areas	☐ Improper operation of overtopping control
	Signs of Creep	□ Visible release
	Failed/eroded vegetation >100sq ft.	No observed problems
Descri	be findings. Identify locations on attached map. Attac NO Seeps observed, thou could have made obse

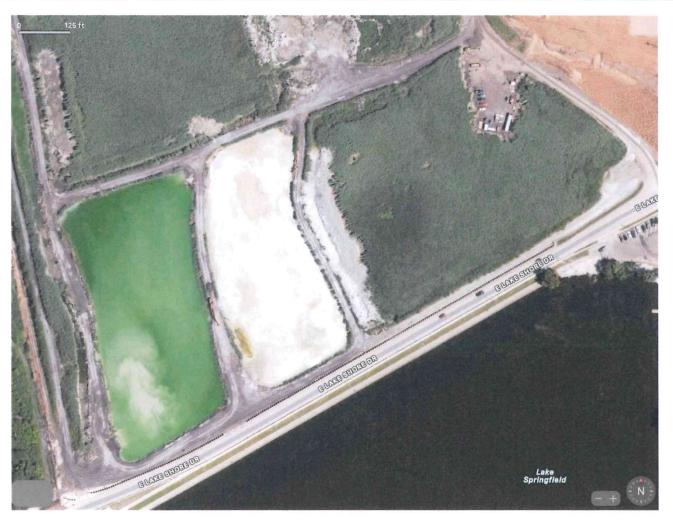
#### **Berms – Lime Softening Ponds**

Condi	tions Limiting Visibility: Snow Cover Vegetation	□ Other None
Obser	vations: Erosion / Gullies Cracking / Sloughing Seeps / Damp Areas Signs of Creep Failed/eroded vegetation >100sq ft.	<ul> <li>□ Sudden drop in impoundment level</li> <li>□ Actual or potential structural weakness</li> <li>□ Improper operation of overtopping control</li> <li>□ Visible release</li> <li>□ No observed problems</li> </ul>
Descri	be findings. Identify locations on attached map. Atta	ach additional pages if necessary.
