Date: $3-7-25$ Time: $8:30 \text{ Am}$ Inspector(s)	Position: JIM RETCHUM	
Site Conditions: MostLy Sky: CLOUDY Ground Moisture: Light Damp Temp	erature: 59°F Precipitation: NONE	
Berms – Landfill Unit 2: Conditions Limiting Visibility: □ Snow Cover	□ Other	
Vegetation	□ None	
Observations: □ Erosion / Gullies □ Cracking / Sloughing □ Seeps / Damp Areas □ Signs of Creep □ Failed/eroded vegetation >100sq ft. Describe findings. Identify locations on attached map. Attached	□ Sudden drop in impoundment level □ Actual or potential structural weakness □ Improper operation of overtopping control □ Visible release ➤ No observed problems ch additional pages if necessary.

Berms - Dallman Ash Pond

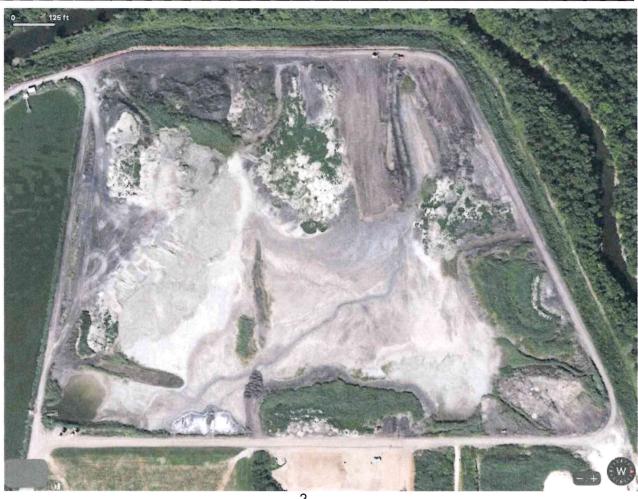
Dumian Aon I Ona		
Condit	ions Limiting Visibility:		
	Snow Cover		Other
×	Vegetation NW CRNR		None
Obser	vations:		
	Erosion / Gullies		Sudden drop in impoundment level
	Cracking / Sloughing		Actual or potential structural weakness
	Seeps / Damp Areas		Improper operation of overtopping control
	Signs of Creep		Visible release
	Failed/eroded vegetation >100sq ft.	X	No observed problems
Describe findings. Identify locations on attached map. Attach additional pages if necessary.			
-

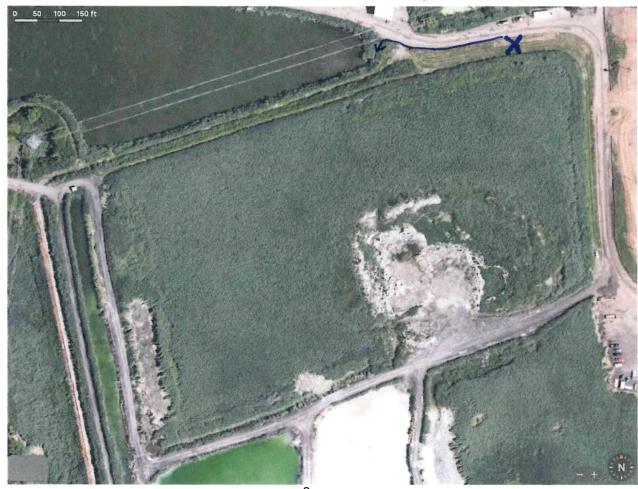
Berms -	Lakeside	Ash Pond
---------	----------	----------

Lancoldo Morri Oria		
Condit	ions Limiting Visibility:		
	Snow Cover		Other
	Vegetation	X,	None
Obser	vations:		
	Erosion / Gullies		Sudden drop in impoundment level
	Cracking / Sloughing		Actual or potential structural weakness
×	Seeps / Damp Areas		Improper operation of overtopping control
	Signs of Creep		Visible release
	Failed/eroded vegetation >100sq ft.		No observed problems
Describe findings. Identify locations on attached map. Attach additional pages if necessary.			
			TRACE SEEPAGE FROM
			NE LSAP INTO DITCH
		-	AND DRAINING INTO
			CLARIFICATION POND.

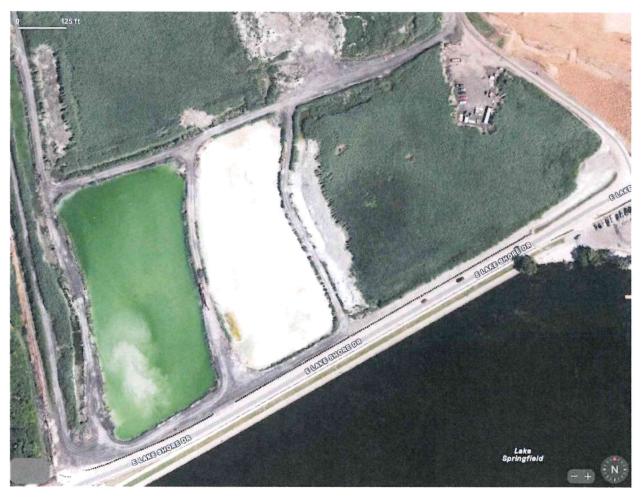
Berms – Lime Softening Ponds

Conditions Limiting Visibility: □ Snow Cover □ Vegetation	□ Other None		
Observations: □ Erosion / Gullies □ Cracking / Sloughing □ Seeps / Damp Areas □ Signs of Creep □ Failed/eroded vegetation >100sq ft.	 □ Sudden drop in impoundment level □ Actual or potential structural weakness □ Improper operation of overtopping control □ Visible release ☒ No observed problems 		
Describe findings. Identify locations on attached map. Attach additional pages if necessary.
