City Water, Light and Power  
Coal Combustion Residuals Units  
40 CFR 257 and 35 IAC 845  
Weekly Inspection Form

Date: 5-14-25 Time: 2:00 Inspector(s) / Position: Staley

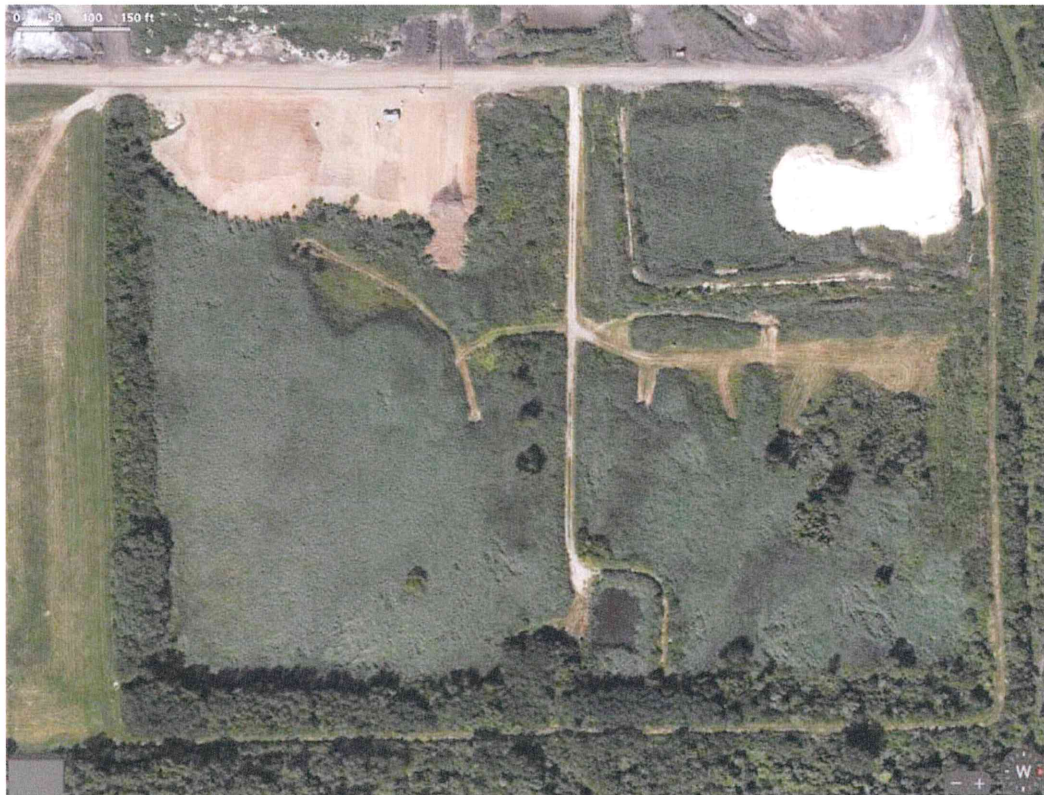
**Berms – Landfill Unit 2:**

- ☐ Sudden drop in impoundment level
- ☐ Actual or potential structural weakness
- ☐ Improper operation of overtopping control
- ☐ Visible release
- ☒ No observed problems

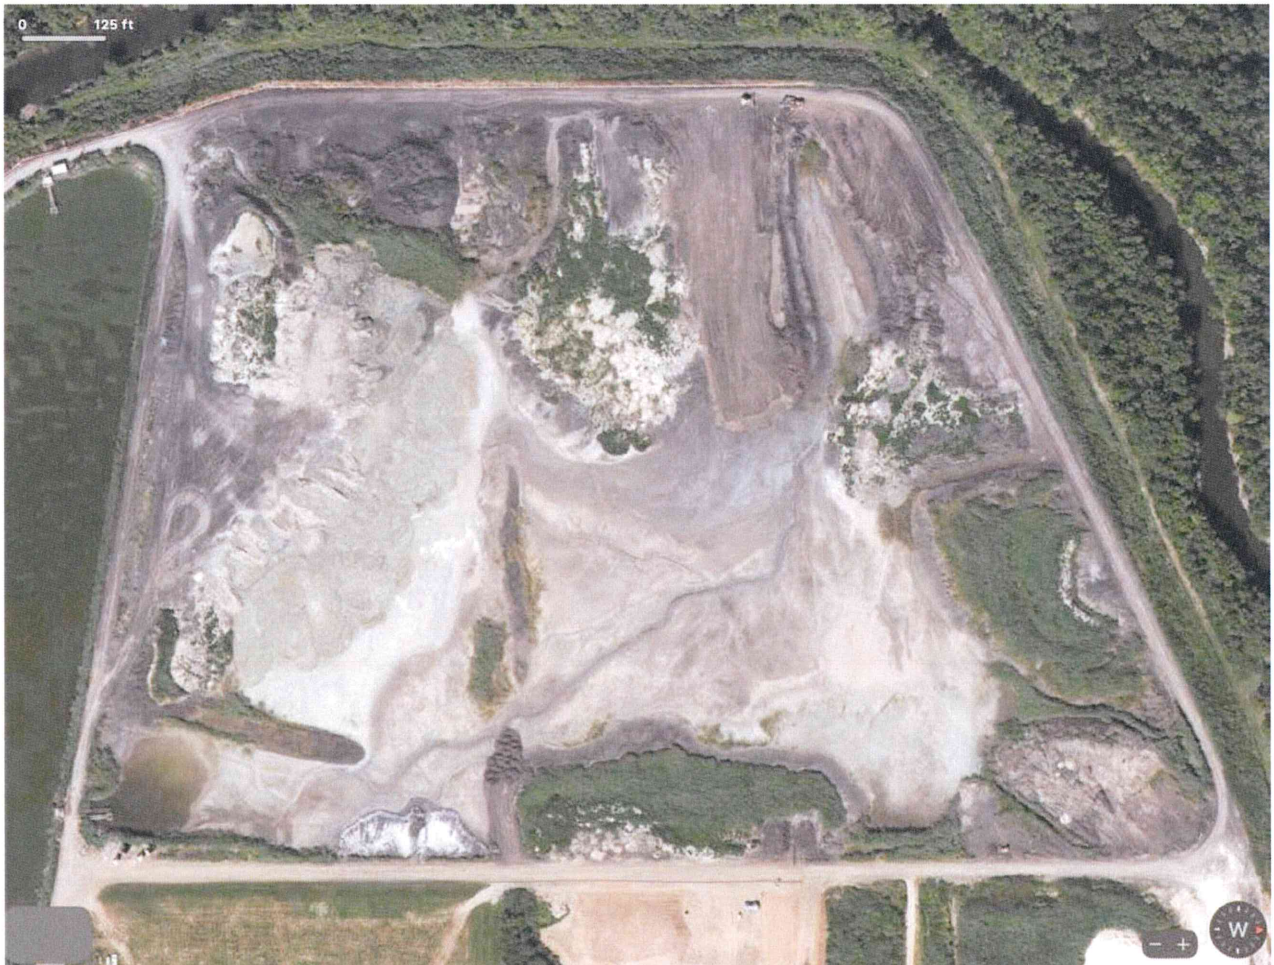
**Berms – Dallman Ash Pond**

| <input type="checkbox"/> Failed/eroded vegetation >100sq ft. | <input checked="" type="checkbox"/> No observed problems |

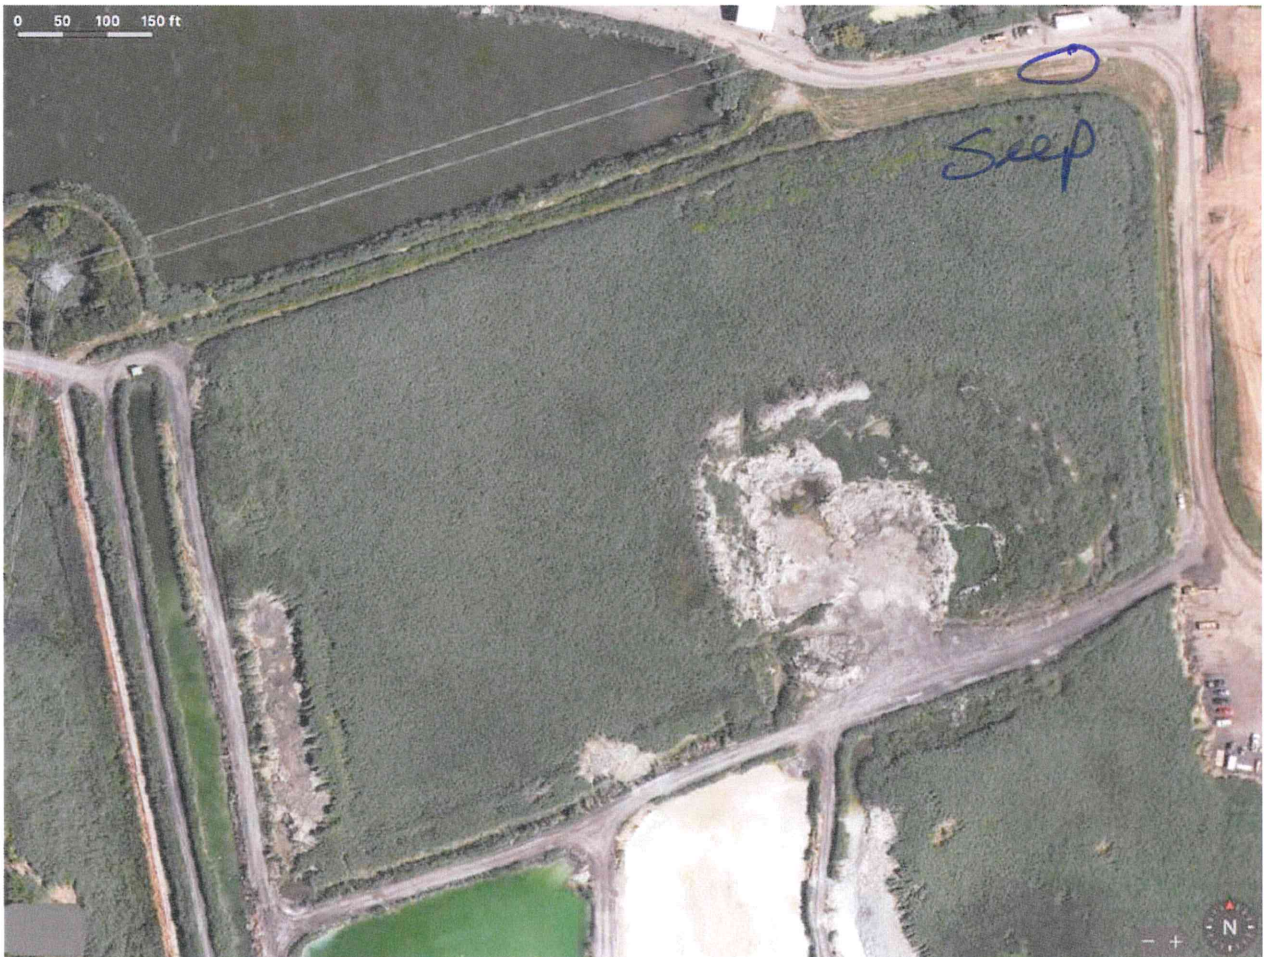
**Berms – Lakeside Ash Pond**

- ☐ Erosion / Gullies
- ☐ Cracking / Sloughing
- ☒ Seeps / Damp Areas
- ☐ Signs of Creep
- ☐ Failed/eroded vegetation >100sq ft.

*One seep at toe of NE corner. Flow reporting  
to Clarification Pond.*

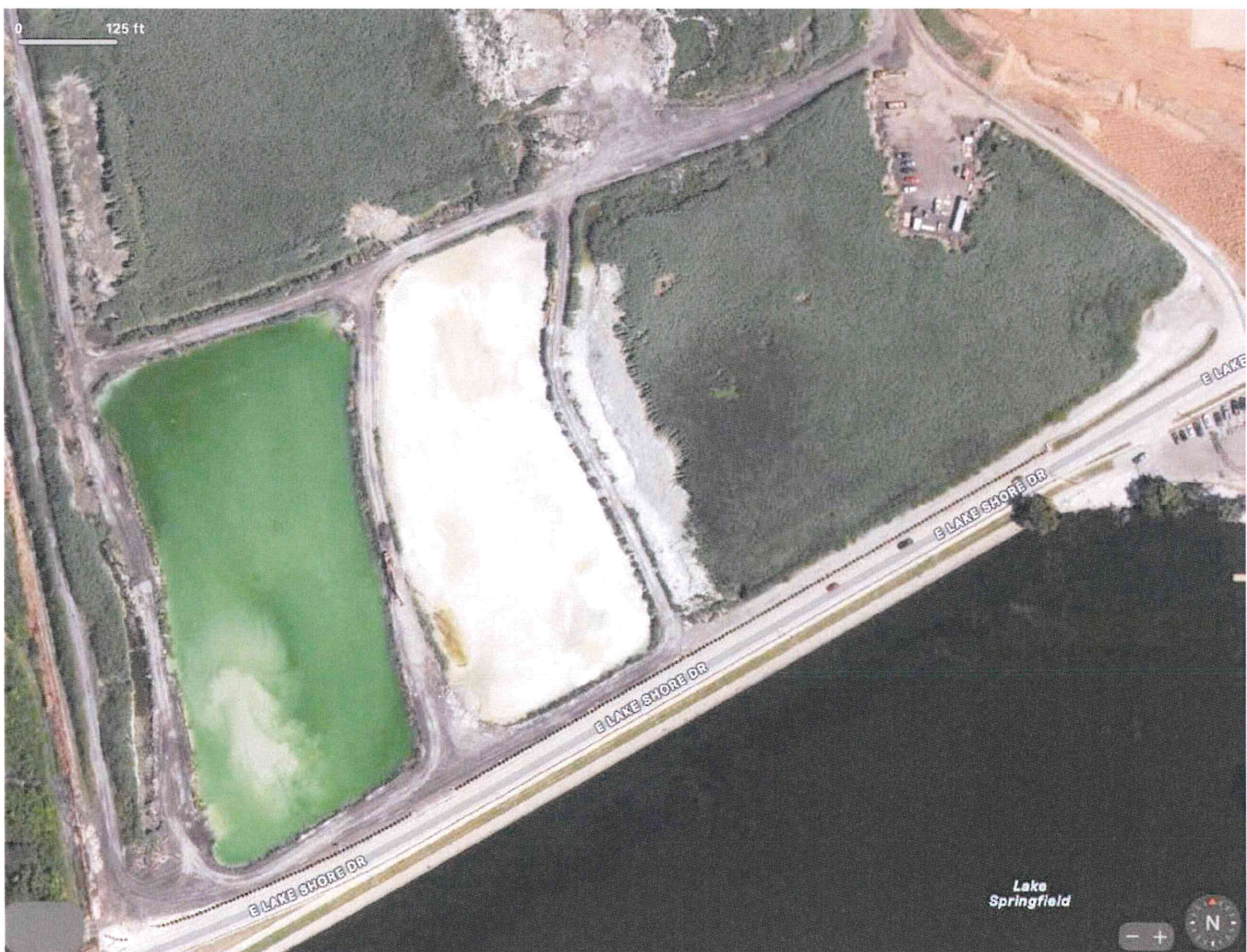
**Berms – Lime Softening Ponds**

- ☐ Sudden drop in impoundment level
- ☐ Actual or potential structural weakness
- ☐ Improper operation of overtopping control
- ☐ Visible release
- ☒ No observed problems
