Date:	5/21/25 Time: 12:30 Inspe	ector(s) / Position: Schy Willmore		
	Site Conditions:			
Sky:	Cloudy Ground Moisture: Wet	_Temperature: 60 Precipitation: 10012		
Berms	Berms – Landfill Unit 2:			
Condit	tions Limiting Visibility:			
	Snow Cover	□ Other		
	Vegetation	None		
Obser	vations:	/		
	Erosion / Gullies	☐ Sudden drop in impoundment level		
	Cracking / Sloughing	☐ Actual or potential structural weakness		
	Seeps / Damp Areas	☐ Improper operation of overtopping control		
	Signs of Creep	☐ Visible release		
	Failed/eroded vegetation >100sq ft.	No observed problems		
Describe findings. Identify locations on attached map. Attach additional pages if necessary.

#### Berms – Dallman Ash Pond

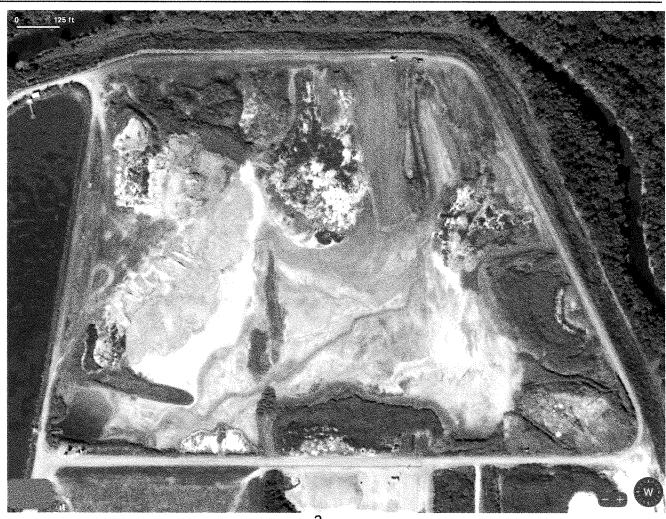
Delilli	5 - Dailinan Ash Fond		
Condit	tions Limiting Visibility:		
	Snow Cover		Other
	Vegetation	×	None
Obser	vations:	/	
	Erosion / Gullies		Sudden drop in impoundment level
	Cracking / Sloughing		Actual or potential structural weakness
	Seeps / Damp Areas		Improper operation of overtopping control
	Signs of Creep		Visible release
	Failed/eroded vegetation >100sq ft.	Æ	No observed problems
Descri	be findings. Identify locations on attached	map. Attach add	ditional pages if necessary.
		***************************************

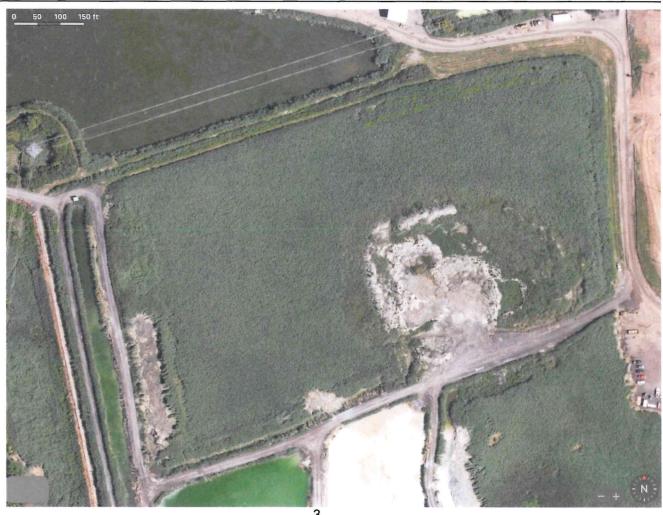
Berms –	Lakeside	Ash Pond
---------	----------	----------

2611113	- Lakeside Asii Fulid		
Condit	ions Limiting Visibility:		
	Snow Cover		Other
	Vegetation	$\gg$	None
Obser	vations:	/	
	Erosion / Gullies		Sudden drop in impoundment level
	Cracking / Sloughing		Actual or potential structural weakness
	Seeps / Damp Areas		Improper operation of overtopping control
	Signs of Creep		Visible release
	Failed/eroded vegetation >100sq ft.	M	No observed problems
Describe findings. Identify locations on attached map. Attach additional pages if necessary.			
	<del>-</del>

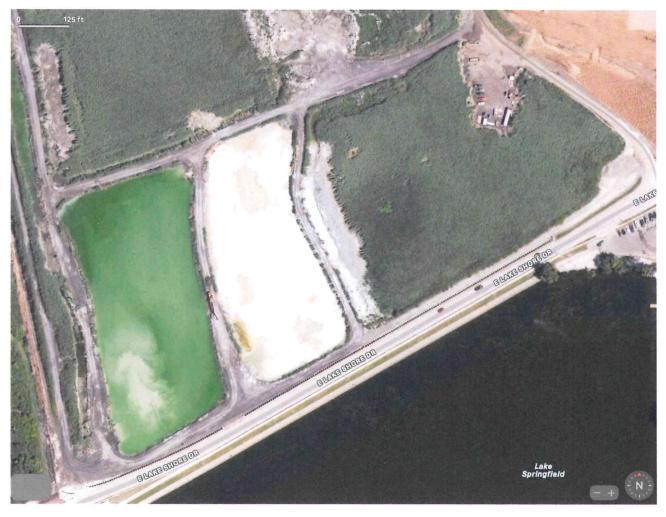
#### Berms - Lime Softening Ponds

Condit	ions Limiting Visibility: Snow Cover Vegetation		Other	
Observed Control of the Control of t	vations: Erosion / Gullies Cracking / Sloughing Seeps / Damp Areas Signs of Creep Failed/eroded vegetation >100sq ft.		Sudden drop in impoundment level Actual or potential structural weakness Improper operation of overtopping control Visible release No observed problems	
Describe findings. Identify locations on attached map. Attach additional pages if necessary.
