Date: 5-28-25 Time: 12:30 PM Inspector(s) / Position: Jim KETCHUM Site Conditions: Sky: <u>CLOUDY</u> Ground Moisture: <u>WET</u> Temperature: <u>64°F</u> Precipitation: <u>ZAM-9AM</u> Berms - Landfill Unit 2: Conditions Limiting Visibility: □ Other □ Snow Cover □ None Observations: □ Sudden drop in impoundment level □ Erosion / Gullies □ Actual or potential structural weakness □ Cracking / Sloughing ☐ Improper operation of overtopping control □ Seeps / Damp Areas □ Visible release □ Signs of Creep X No observed problems ☐ Failed/eroded vegetation >100sq ft. Describe findings. Identify locations on attached map. Attach additional pages if necessary.

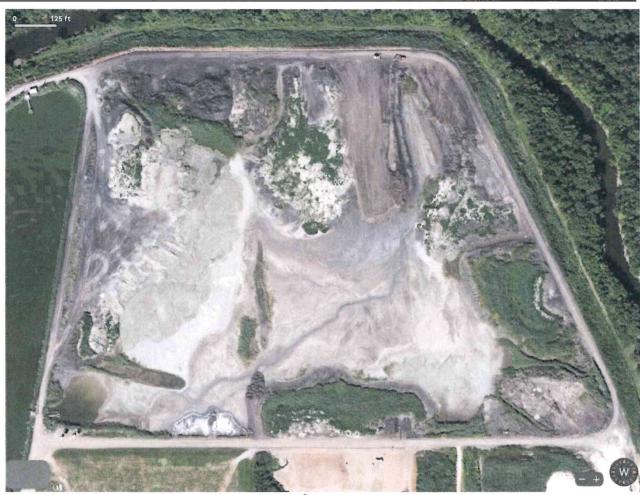
### Berms - Dallman Ash Pond

tions Limiting Visibility:				
Snow Cover		Other		
Vegetation NW CRUR		None		
vations:				
Erosion / Gullies		Sudden drop in impoundment level		
Cracking / Sloughing		Actual or potential structural weakness		
Seeps / Damp Areas		Improper operation of overtopping control		
Signs of Creep		Visible release		
Failed/eroded vegetation >100sq ft.	X	No observed problems		
Describe findings. Identify locations on attached map. Attach additional pages if necessary.				
	Snow Cover Vegetation NW CRNR  vations: Erosion / Gullies Cracking / Sloughing Seeps / Damp Areas Signs of Creep Failed/eroded vegetation >100sq ft.	Snow Cover  Vegetation NW CRNR  vations:  Erosion / Gullies  Cracking / Sloughing  Seeps / Damp Areas  Signs of Creep  Failed/eroded vegetation >100sq ft.

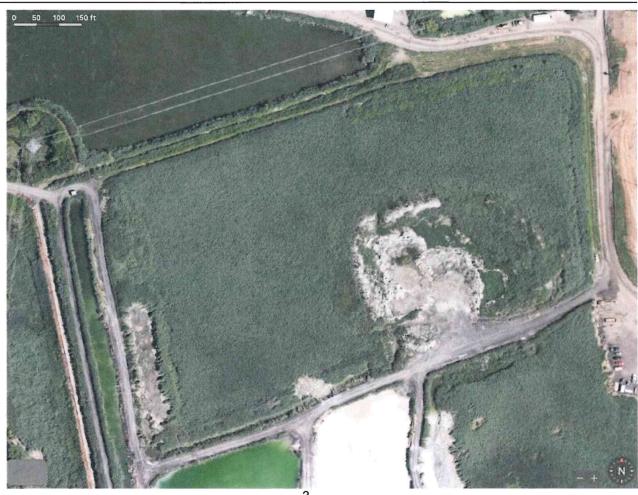
### Berms – Lakeside Ash Pond

Delilli5	- Lakeside Asii Polid				
Condit	ions Limiting Visibility:				
	Snow Cover		Other		
	Vegetation	X	None		
Obser	vations:				
	Erosion / Gullies		Sudden drop in impoundment level		
	Cracking / Sloughing		Actual or potential structural weakness		
	Seeps / Damp Areas		Improper operation of overtopping control		
	Signs of Creep		Visible release		
	Failed/eroded vegetation >100sq ft.	X	No observed problems		
Describe findings. Identify locations on attached map. Attach additional pages if necessary.					
i <del>.</del>					
-

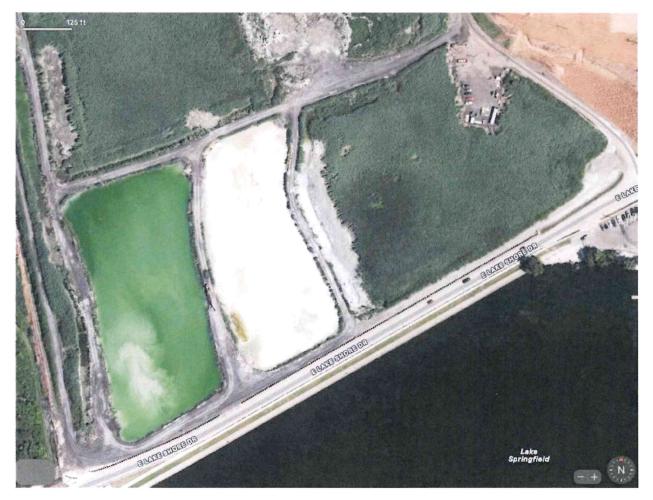
### Berms – Lime Softening Ponds

ions Limiting Visibility: Snow Cover Vegetation		Other None			
	vations: Erosion / Gullies Cracking / Sloughing Seeps / Damp Areas Signs of Creep Failed/eroded vegetation >100sq ft.		Sudden drop in impoundment level Actual or potential structural weakness Improper operation of overtopping control Visible release No observed problems			
Describe findings. Identify locations on attached map. Attach additional pages if necessary.
