#### City Water, Light and Power Coal Combustion Residuals Units 40 CFR 257 and 35 IAC 845

Weekly Inspection Form	//
1	Inaparter(a) / Desition:	Stalor

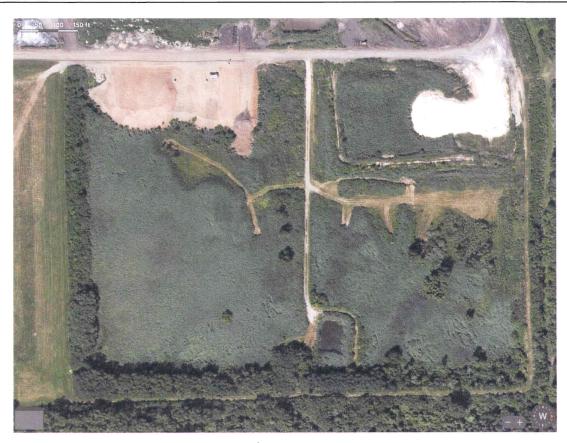
Date: $6-3-35$ Time: 13:00 Inspector	(s) / Position:
Site Conditions:  Sky: ( ) Ground Moisture: Dry Ten	mperature: 75 Precipitation: Mone
Berms – Landfill Unit 2:	
Conditions Limiting Visibility:	
<ul><li>□ Snow Cover</li><li>□ Vegetation</li></ul>	OtherNone
Observations:  □ Erosion / Gullies □ Cracking / Sloughing □ Seeps / Damp Areas □ Signs of Creep □ Failed/eroded vegetation >100sq ft.  Describe findings. Identify locations on attached map. A	□ Sudden drop in impoundment level □ Actual or potential structural weakness □ Improper operation of overtopping control □ Visible release No observed problems

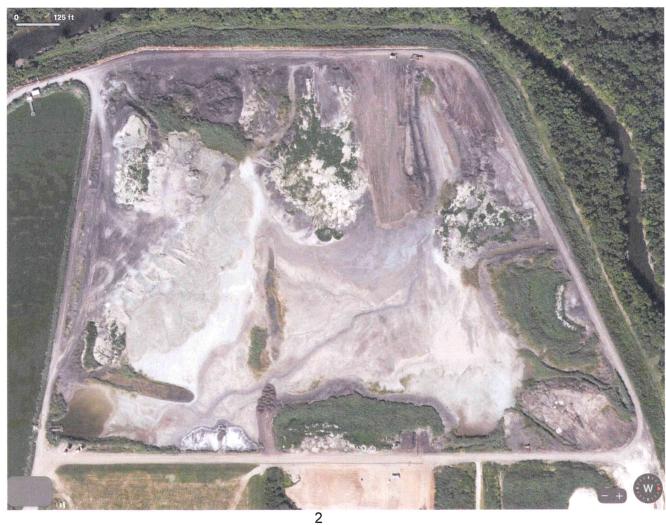
#### Berms - Dallman Ash Pond

Condit	ions Limiting Visibility:		
	Snow Cover		Other
	Vegetation	8	None
Obser	vations:		
	Erosion / Gullies		Sudden drop in impoundment level
	Cracking / Sloughing		Actual or potential structural weakness
	Seeps / Damp Areas		Improper operation of overtopping control
	Signs of Creep		Visible release
	Failed/eroded vegetation >100sq ft.	X	No observed problems
Describe findings. Identify locations on attached map. Attach additional pages if necessary.

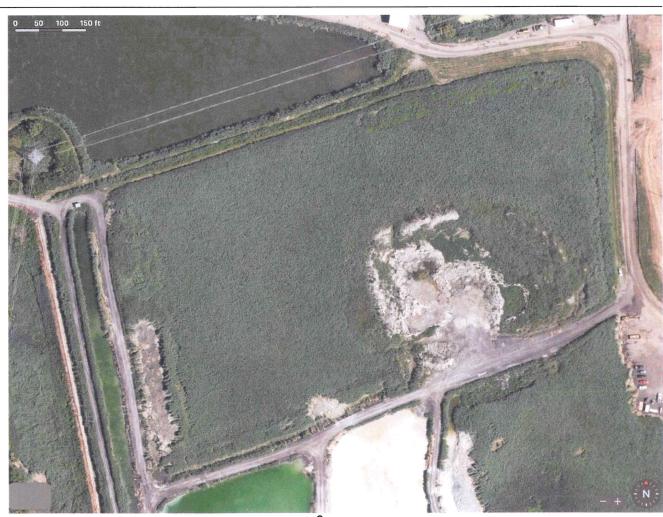
Berms	<ul> <li>Lakeside Ash Pond</li> </ul>		
Condit	tions Limiting Visibility:		
	Snow Cover		Other
	Vegetation	X	None
Obser	vations:		
	Erosion / Gullies		Sudden drop in impoundment level
	Cracking / Sloughing		Actual or potential structural weakness
	Seeps / Damp Areas		Improper operation of overtopping control
	Signs of Creep		√Visible release
	Failed/eroded vegetation >100sq ft.	X	No observed problems
Describe findings. Identify locations on attached map. Attach additional pages if necessary.

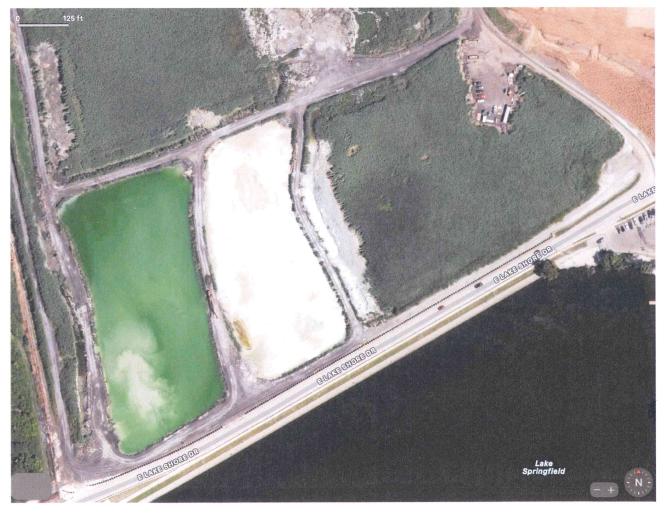
#### **Berms – Lime Softening Ponds**

□ Sno	Limiting Visibility: ow Cover getation		Other	
□ Crac □ See □ Sigr	ns: sion / Gullies cking / Sloughing eps / Damp Areas ns of Creep ed/eroded vegetation >100sq ft.		Sudden drop in impoundment level Actual or potential structural weakness Improper operation of overtopping control Visible release No observed problems	
Describe findings. Identify locations on attached map. Attach additional pages if necessary.
