**City Water, Light and Power  
Coal Combustion Residuals Units  
40 CFR 257 and 35 IAC 845  
Weekly Inspection Form**

Date: 7-9-25 Time: 9:30 AM Inspector(s) / Position: JIM KETCHUM

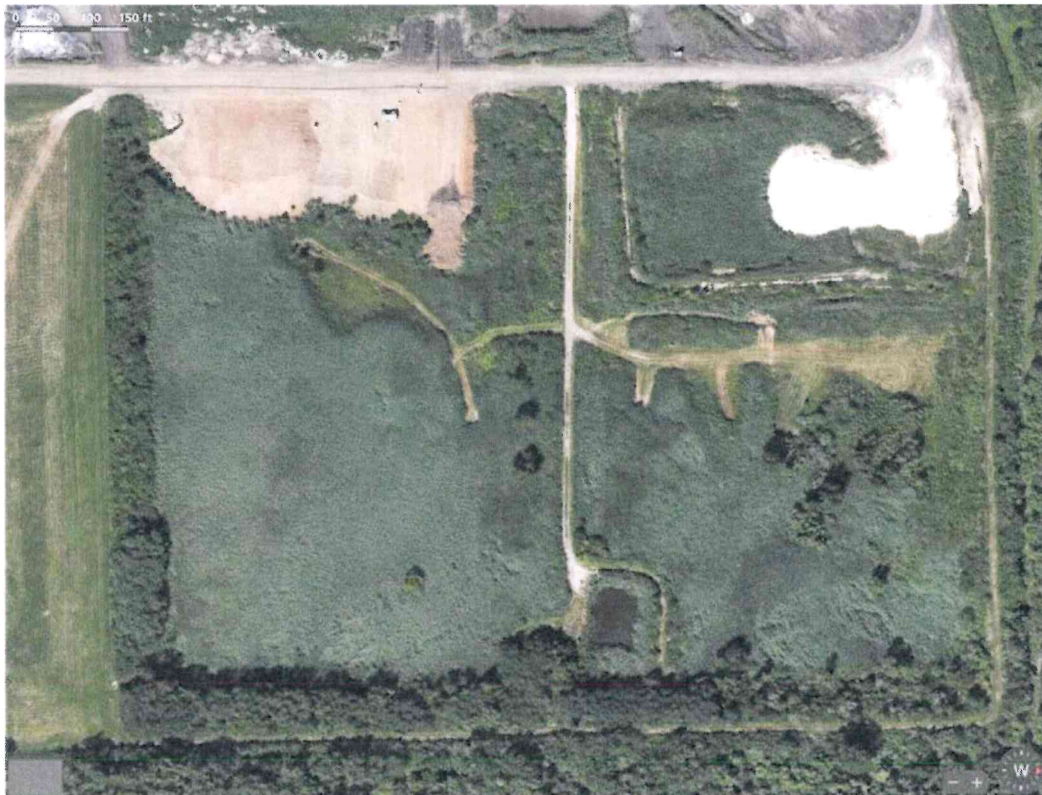
**Berms – Landfill Unit 2:**

- ☐ Sudden drop in impoundment level  
☐ Actual or potential structural weakness  
☐ Improper operation of overtopping control  
☐ Visible release  
☒ No observed problems

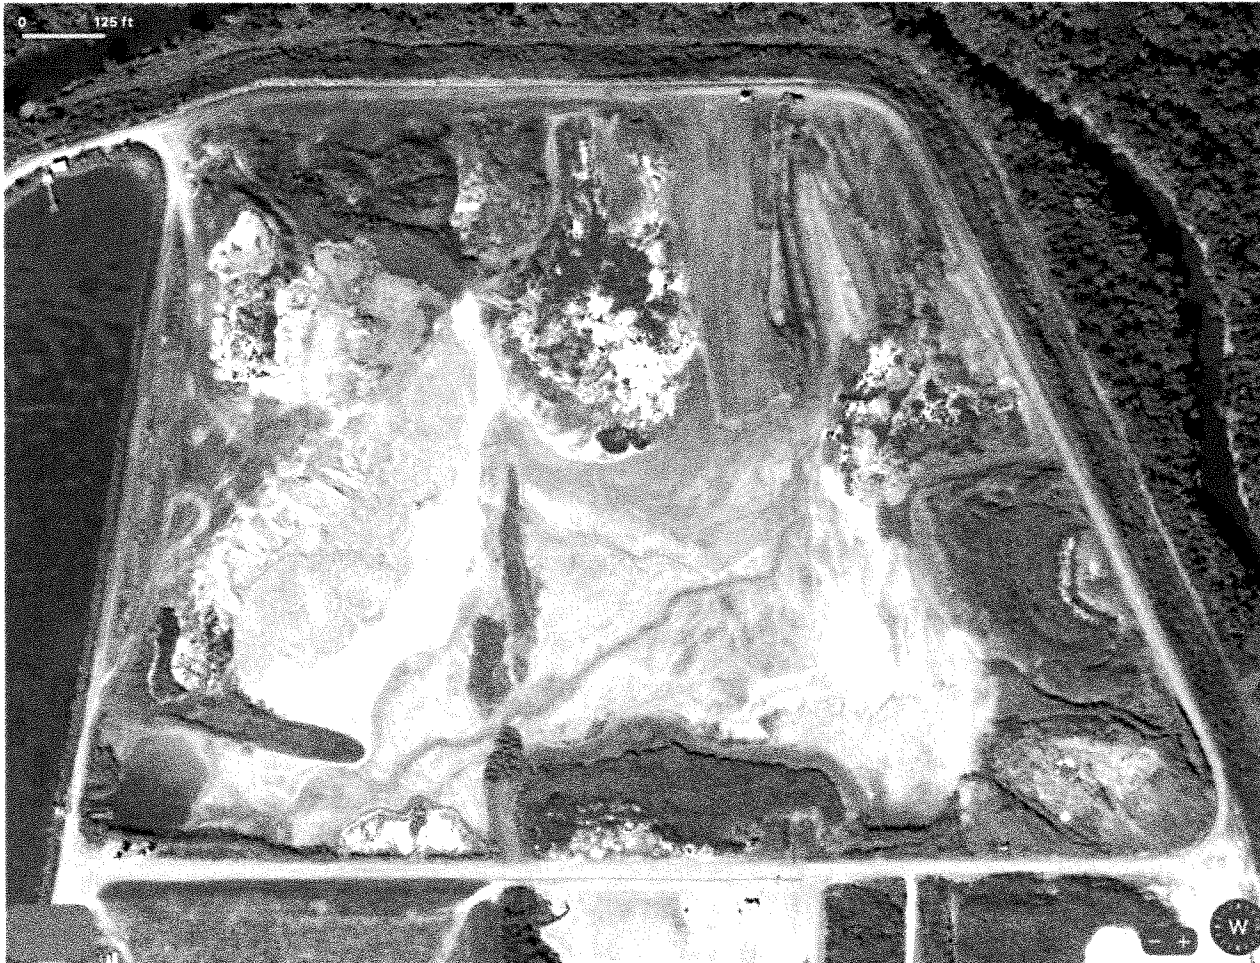
**Berms – Dallman Ash Pond**

- ☐ Sudden drop in impoundment level
- ☐ Actual or potential structural weakness
- ☐ Improper operation of overtopping control
- ☐ Visible release
- ☒ No observed problems

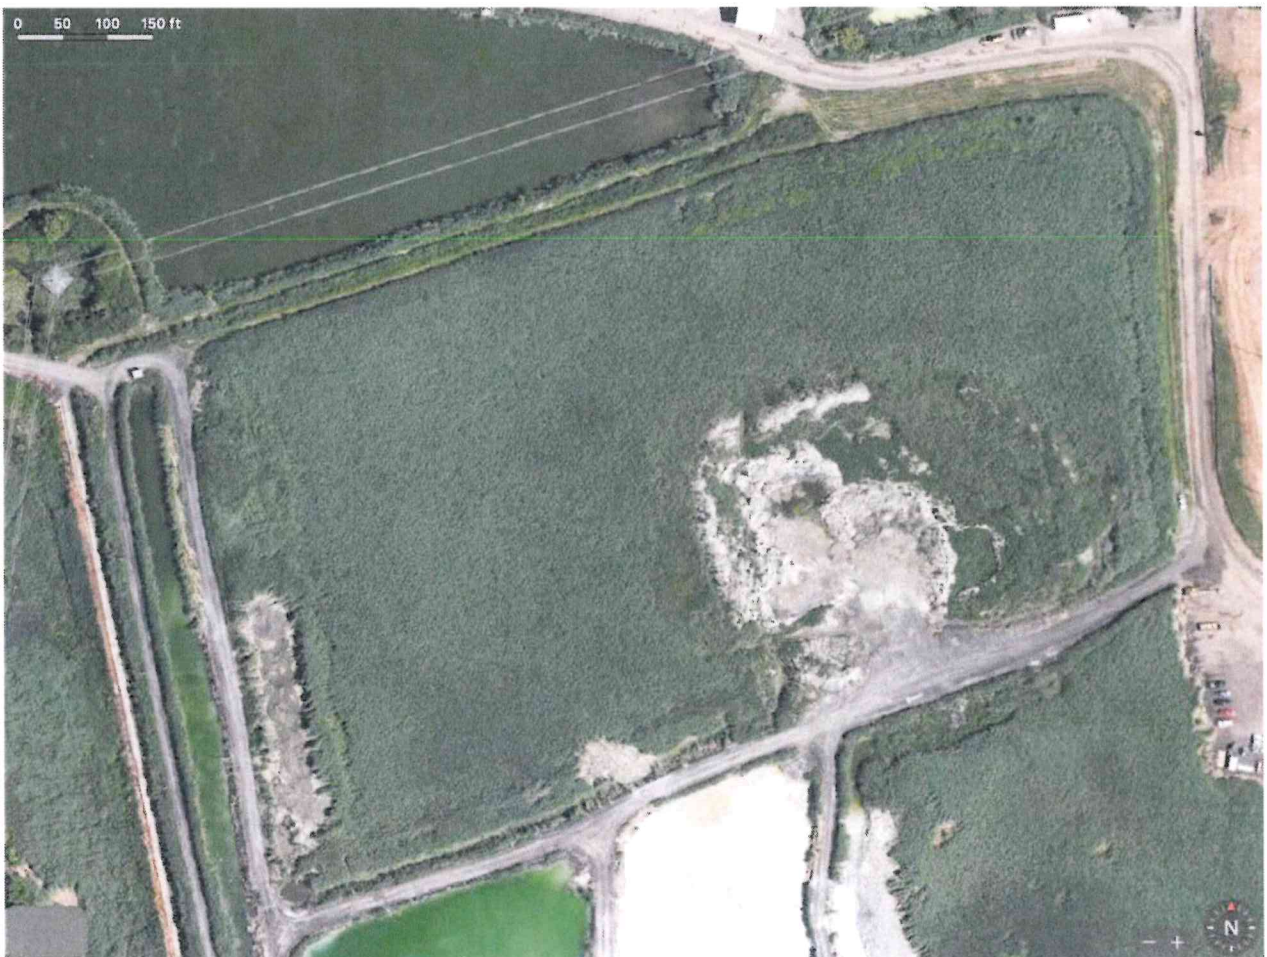
**Berms – Lakeside Ash Pond**

- ☐ Sudden drop in impoundment level  
☐ Actual or potential structural weakness  
☐ Improper operation of overtopping control  
☐ Visible release  
☒ No observed problems

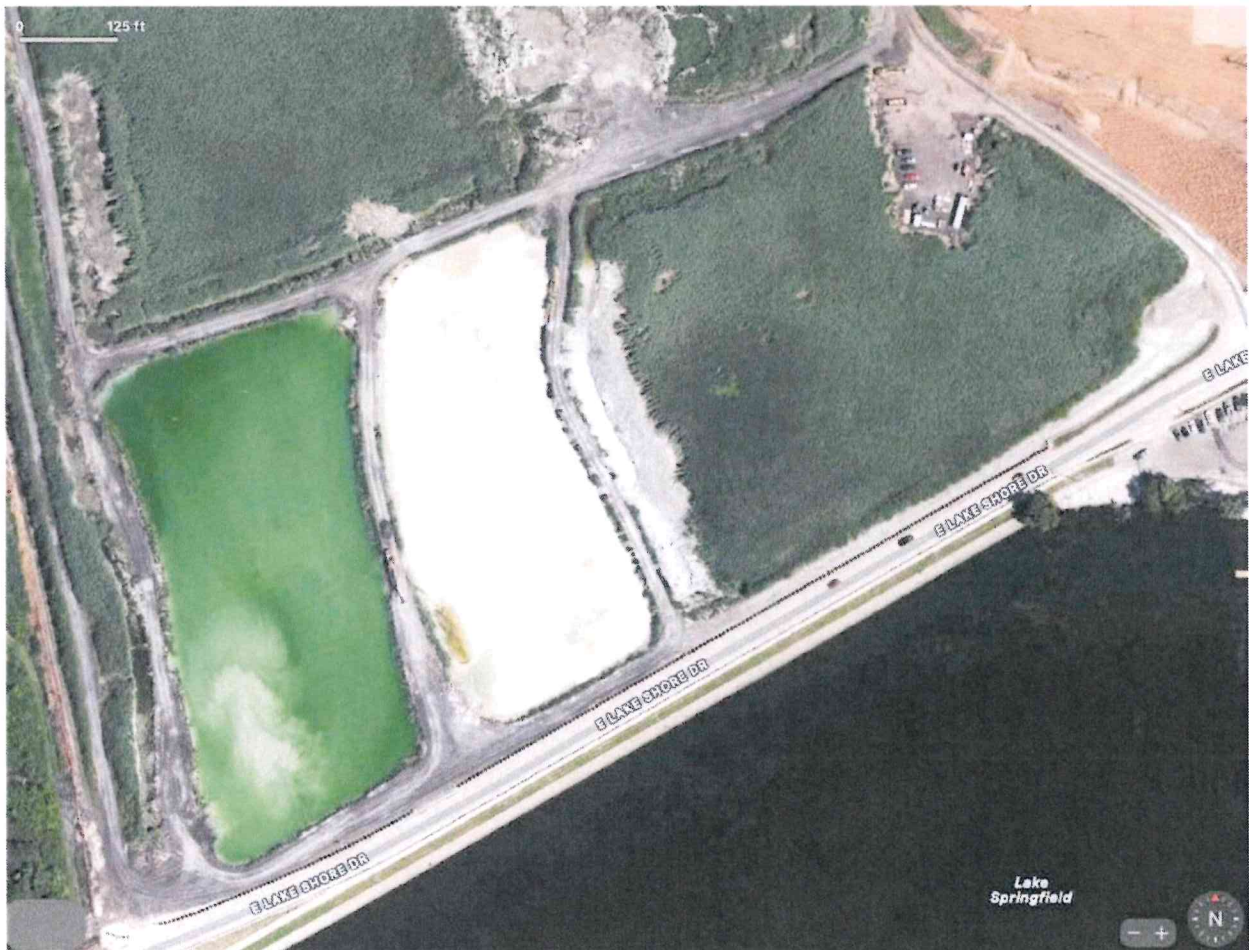
**Berms – Lime Softening Ponds**

- ☐ Sudden drop in impoundment level  
☐ Actual or potential structural weakness  
☐ Improper operation of overtopping control  
☐ Visible release  
☒ No observed problems
