Date: 7/23/25 Time: 7:40 Inspector(s) / I	Position: Schy Willmore
Site Conditions:	jong vijimo z
Sky: Clear Ground Moisture: Wet Temper	rature: 78 Precipitation: None
Berms – Landfill Unit 2:	
Conditions Limiting Visibility:	
□ Snow Cover	□ Other
>>> Vegetation	□ None
Observations:	
☐ Erosion / Gullies	□ Sudden drop in impoundment level
☐ Cracking / Sloughing	☐ Actual or potential structural weakness
□ Seeps / Damp Areas	☐ Improper operation of overtopping control
□ Signs of Creep	□ Visible release
☐ Failed/eroded vegetation >100sq ft.	No observed problems
Describe findings. Identify locations on attached map. Attach	n additional pages if necessary.

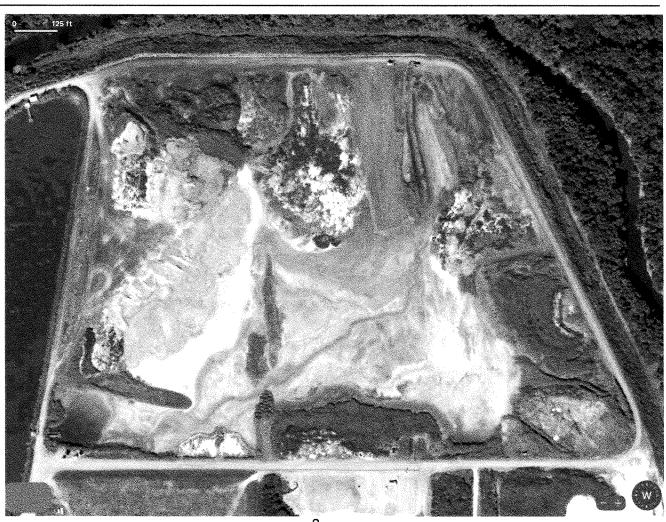
Berms - Dallman Ash Pond

Condit	ions Limiting Visibility:		
	Snow Cover		Other
P	Vegetation		None
Obser	vations:		
	Erosion / Gullies		Sudden drop in impoundment level
	Cracking / Sloughing		Actual or potential structural weakness
	Seeps / Damp Areas		Improper operation of overtopping control
	Signs of Creep		Visible release
	Failed/eroded vegetation >100sq ft.	X) No observed problems
Descri	be findings. Identify locations on attached	map. Attach add	ditional pages if necessary.

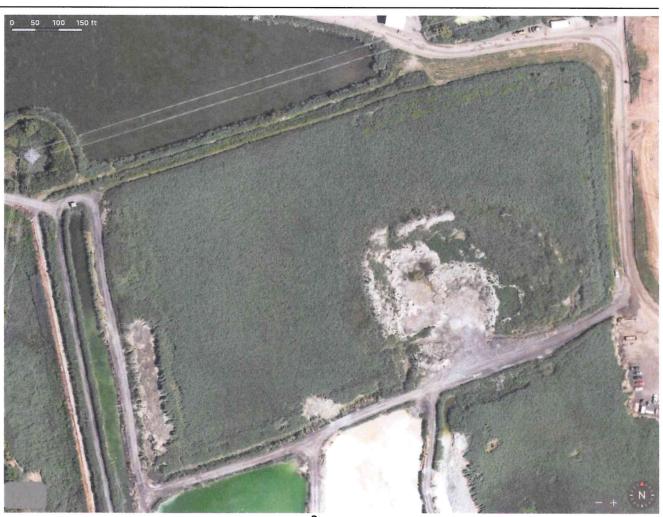
Berms – Lakeside Ash Pond

2011110	Lakeside Asiri olid		
Condit	ions Limiting Visibility:		
	Snow Cover		Other
D	Vegetation		None
Observ	vations:		
	Erosion / Gullies		Sudden drop in impoundment level
	Cracking / Sloughing		Actual or potential structural weakness
	Seeps / Damp Areas		Improper operation of overtopping control
	Signs of Creep		Visible release
	Failed/eroded vegetation >100sq ft.	X)No observed problems
Descri	be findings. Identify locations on attached map. Attac	h ad	ditional pages if necessary.
-			
0			
·

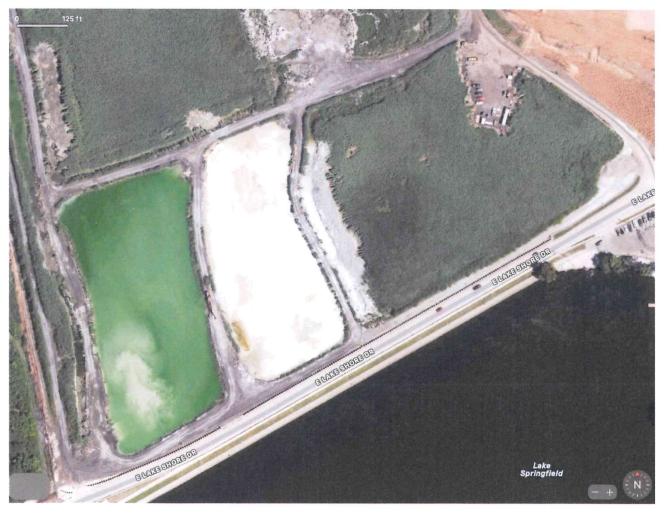
Berms - Lime Softening Ponds

z zimo contonnig i cinac		
Condit	ions Limiting Visibility:		
	Snow Cover Vegetation		None
Obser	vations: Erosion / Gullies Cracking / Sloughing Seeps / Damp Areas Signs of Creep Failed/eroded vegetation >100sq ft.		Sudden drop in impoundment level Actual or potential structural weakness Improper operation of overtopping control Visible release No observed problems
Descri	be findings. Identify locations on attached map. A	Attach add	ditional pages if necessary.
