**City Water, Light and Power  
Coal Combustion Residuals Units  
40 CFR 257 and 35 IAC 845  
Weekly Inspection Form**

Date: 7-30-25 Time: 8:00 AM Inspector(s) / Position: JIM KETCHUM

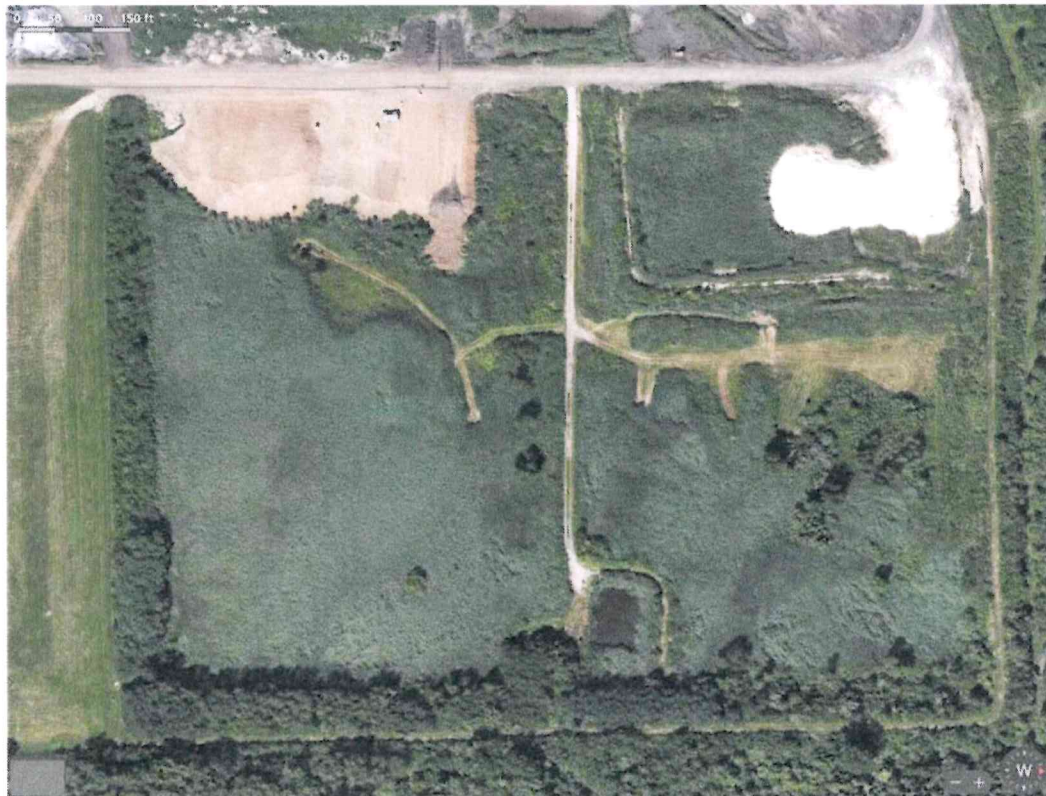
**Berms – Landfill Unit 2:**

☒ No observed problems

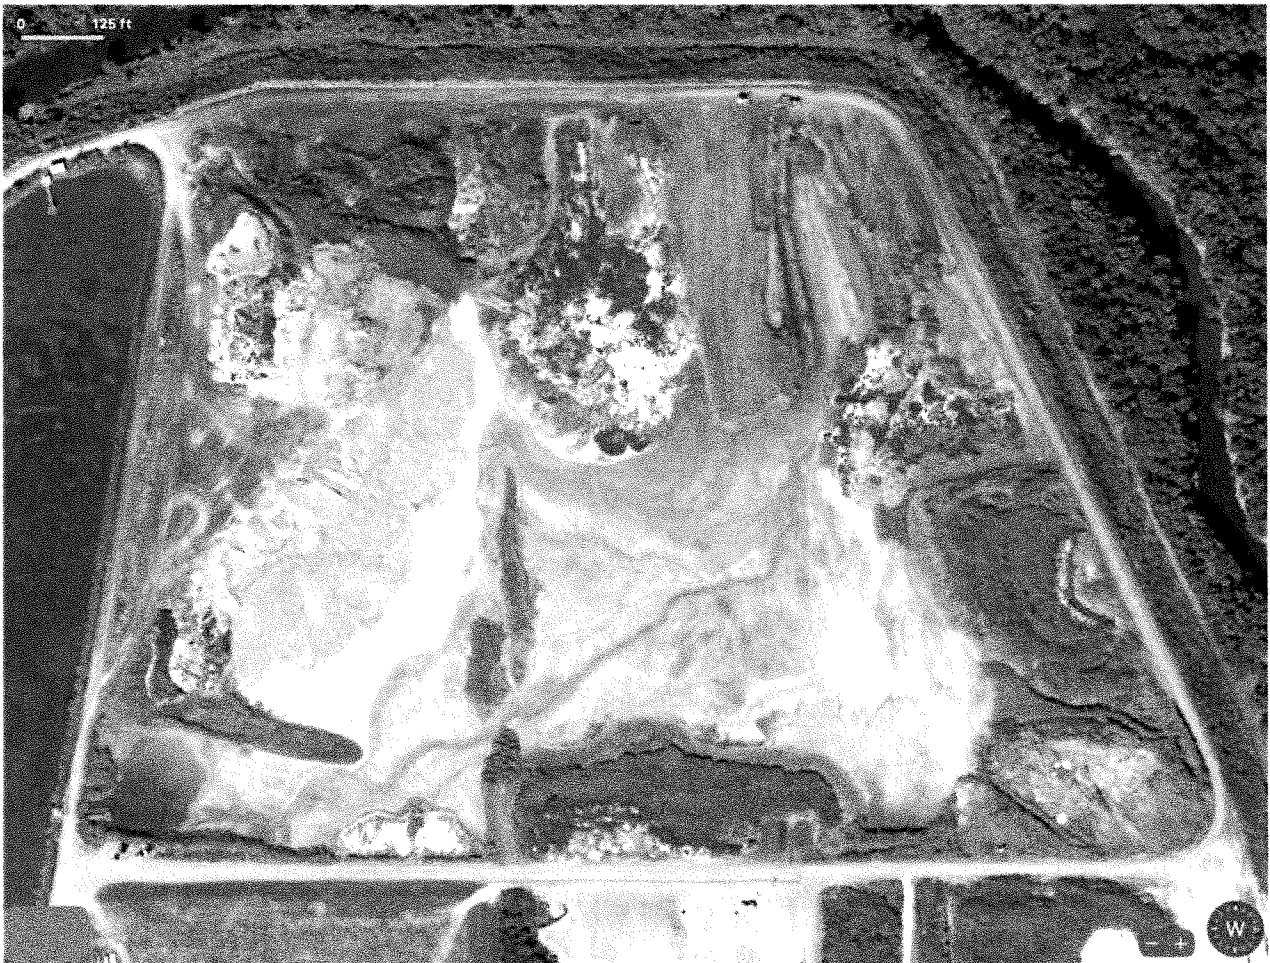
**Berms – Dallman Ash Pond**

- ☐ Sudden drop in impoundment level
- ☐ Actual or potential structural weakness
- ☐ Improper operation of overtopping control
- ☐ Visible release
- ☒ No observed problems

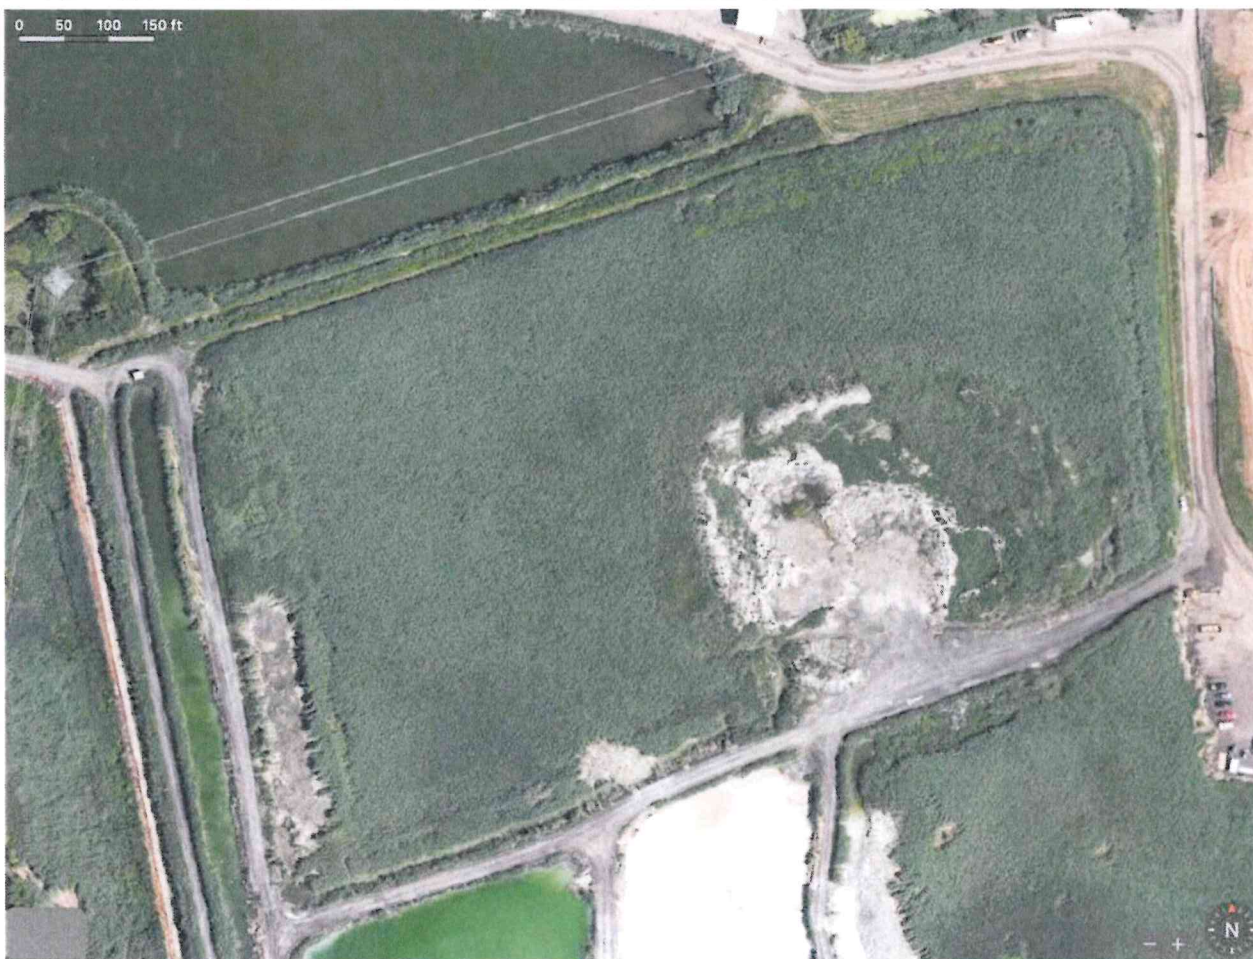
**Berms – Lakeside Ash Pond**

- ☐ Sudden drop in impoundment level
- ☐ Actual or potential structural weakness
- ☐ Improper operation of overtopping control
- ☐ Visible release
- ☒ No observed problems

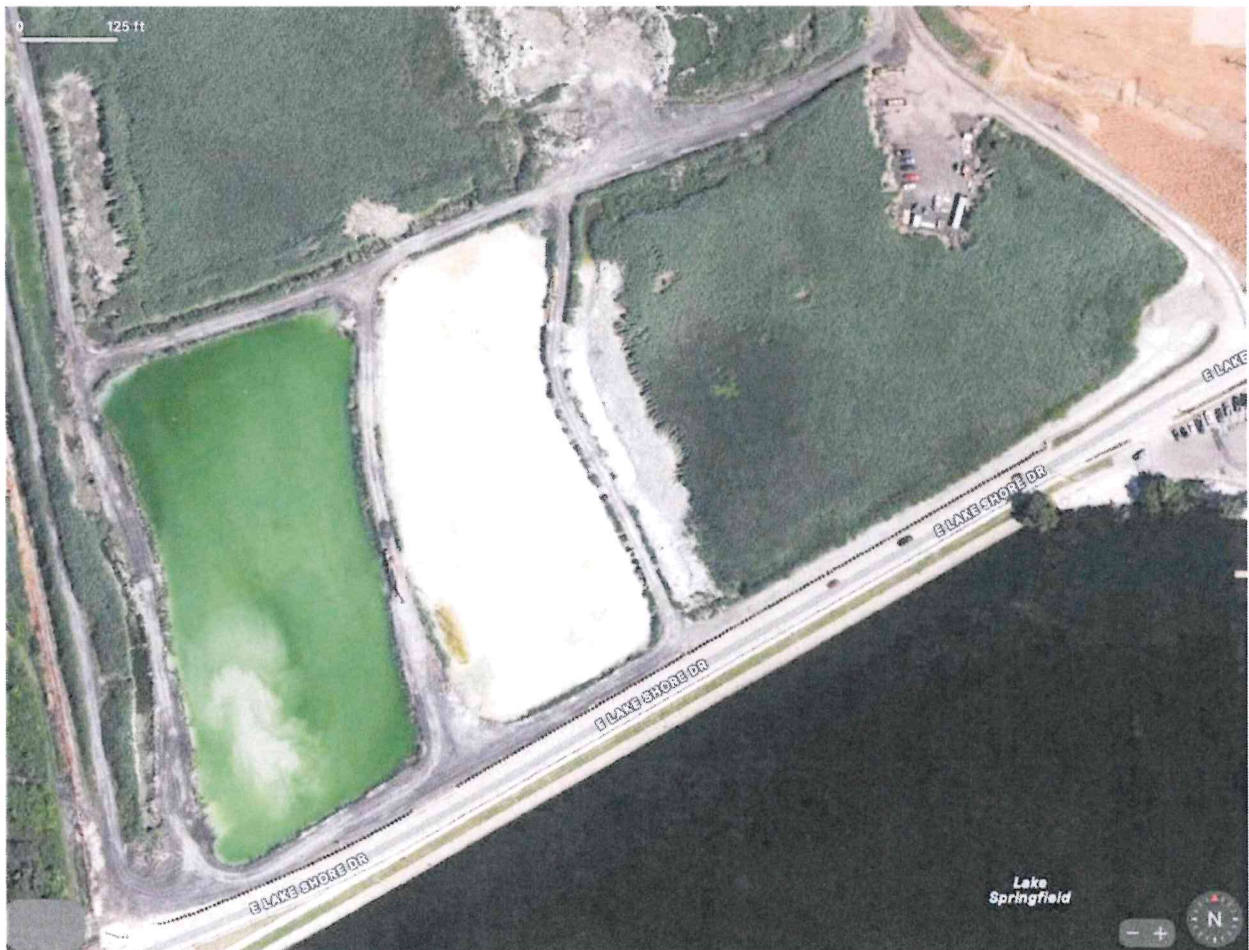
**Berms – Lime Softening Ponds**

- ☐ Sudden drop in impoundment level
- ☐ Actual or potential structural weakness
- ☐ Improper operation of overtopping control
- ☐ Visible release
- ☒ No observed problems
