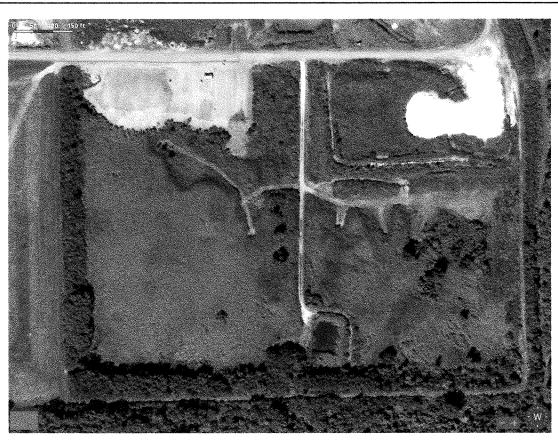
Date: 9/3/25 Time: 10:30 Inspector(s) /	Position: Schy Willnore
Site Conditions:	
Sky: Char Ground Moisture: Very Dry Tempe	rature: 72 Precipitation: None
Berms – Landfill Unit 2:	
Conditions Limiting Visibility:	
□ Snow Cover	□ Other
∀ Vegetation	□ None
/ Observations:	
□ Erosion / Gullies	□ Sudden drop in impoundment level
□ Cracking / Sloughing	☐ Actual or potential structural weakness
□ Seeps / Damp Areas	☐ Improper operation of overtopping control
☐ Signs of Creep	□ Visible release
☐ Failed/eroded vegetation >100sq ft.	No observed problems
	•
Describe findings. Identify locations on attached map. Attack	h additional pages if necessary.

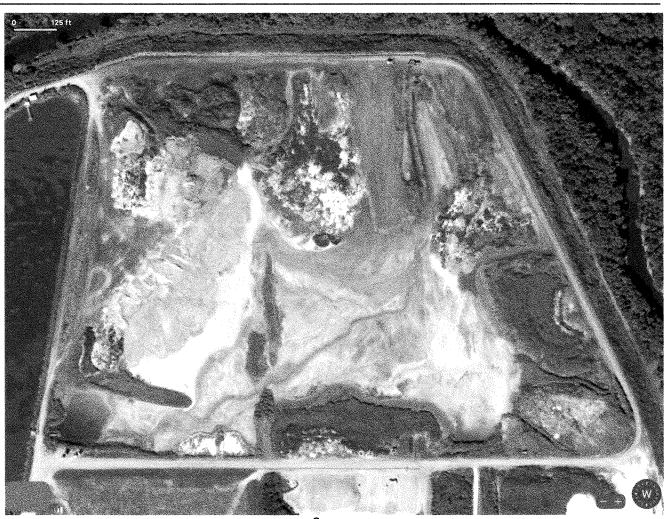
Berms - Dallman Ash Pond

Condit	ions Limiting Visibility:		
	Snow Cover		Other
X	Vegetation		None
Obsen	vations:		
	Erosion / Gullies		Sudden drop in impoundment level
	Cracking / Sloughing		Actual or potential structural weakness
	Seeps / Damp Areas		Improper operation of overtopping control
	Signs of Creep		Visible release
	Failed/eroded vegetation >100sq ft.	A	No observed problems
Descri	be findings. Identify locations on attached ma	p. Attach add	ditional pages if necessary.

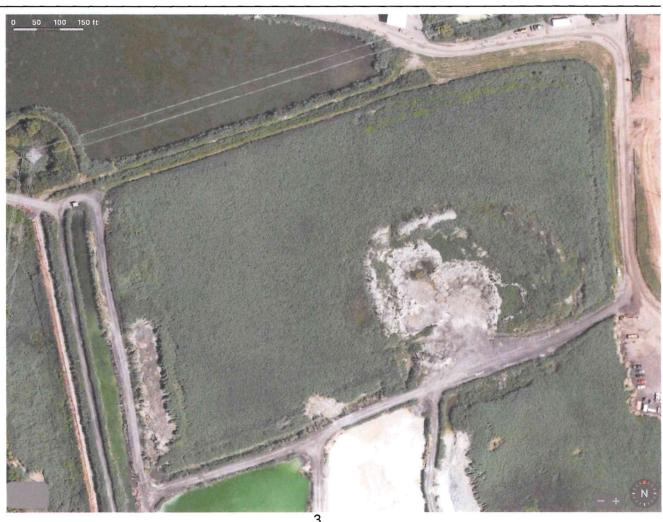
Berms	 Lakeside Ash Pond 		
Condit	ions Limiting Visibility:		
	Snow Cover		Other
×	Vegetation		None
Obser	vations:		
	Erosion / Gullies		Sudden drop in impoundment level
	Cracking / Sloughing		Actual or potential structural weakness
	Seeps / Damp Areas		Improper operation of overtopping control
	Signs of Creep		Visible release
	Failed/eroded vegetation >100sq ft.	×	No observed problems
Descri	be findings. Identify locations on attached map. Attack	h add	ditional pages if necessary.

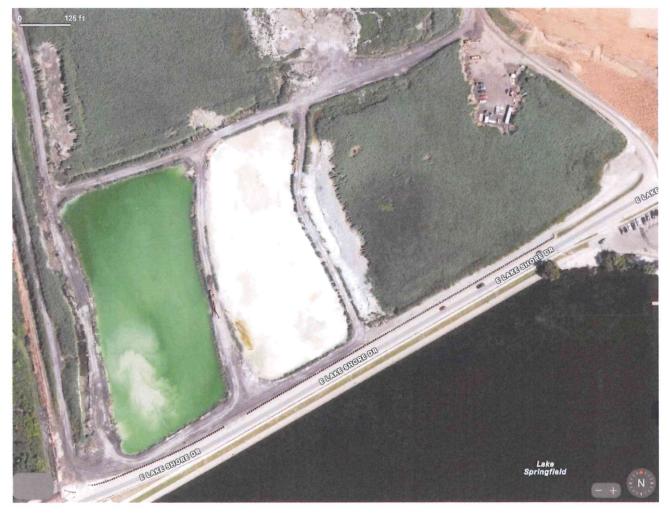
Berms – Lime Softening Ponds

Condit	ions Limiting Visibility: Snow Cover Vegetation		Other	
Obser	vations: Erosion / Gullies Cracking / Sloughing Seeps / Damp Areas Signs of Creep Failed/eroded vegetation >100sq ft.		Sudden drop in impoundment level Actual or potential structural weakness Improper operation of overtopping control Visible release No observed problems	
Describe findings. Identify locations on attached map. Attach additional pages if necessary.
