/ / Weekly inspection form				
Date: 9/24/25 Time: 10:45 Inspector(s) / 1	Posi	tion: Schy William		
Site Conditions:		,		
Sky: Overlast Ground Moisture: Champ Temper	atur	re: 70 Precipitation: None		
,				
Berms – Landfill Unit 2:				
Conditions Limiting Visibility:				
□ Snow Cover		Other		
Vegetation		None		
Observations:				
□ Erosion / Gullies		Sudden drop in impoundment level		
☐ Cracking / Sloughing		Actual or potential structural weakness		
□ Seeps / Damp Areas		Improper operation of overtopping control		
□ Signs of Creep		Visible release		
☐ Failed/eroded vegetation >100sq ft.	X	No observed problems		
Describe findings. Identify locations on attached map. Attach additional pages if necessary.

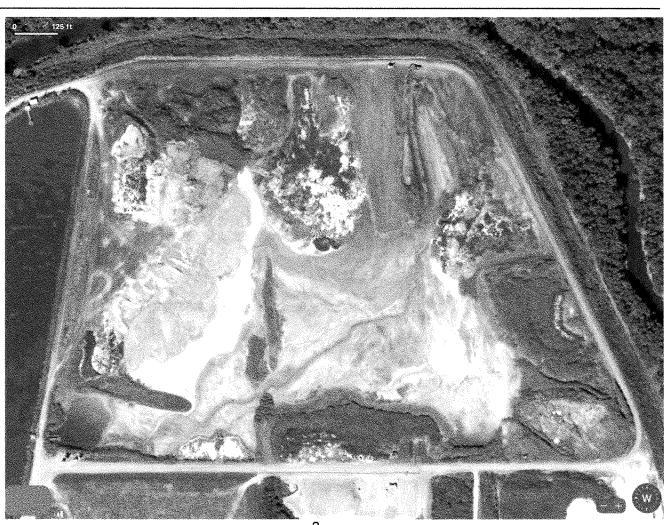
Berms - Dallman Ash Pond Conditions Limiting Visibility: □ Snow Cover □ Other ∨egetation □ None Observations: □ Erosion / Gullies ☐ Sudden drop in impoundment level □ Cracking / Sloughing ☐ Actual or potential structural weakness □ Seeps / Damp Areas ☐ Improper operation of overtopping control □ Signs of Creep □ Visible release ☐ Failed/eroded vegetation >100sq ft. No observed problems Describe findings. Identify locations on attached map. Attach additional pages if necessary.

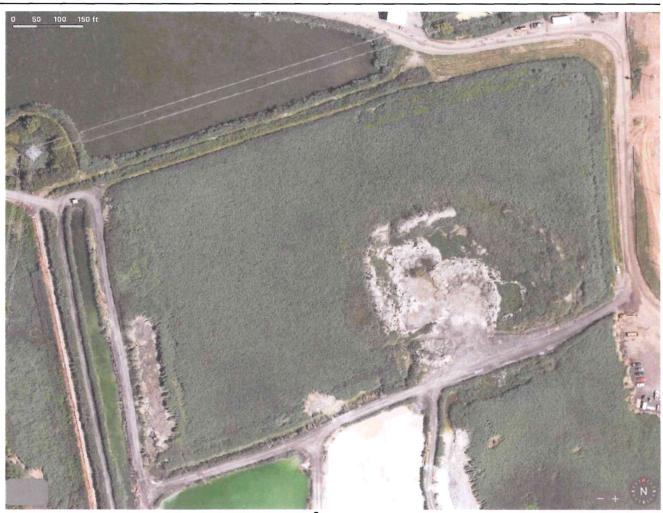
Berms - Lakeside Ash Pond

Eurosido Asir i Orid		
Conditio	ons Limiting Visibility:		
	Snow Cover		Other
X	Vegetation		None
Observa	ations:		
	Erosion / Gullies		Sudden drop in impoundment level
	Cracking / Sloughing		Actual or potential structural weakness
	Seeps / Damp Areas		Improper operation of overtopping control
	Signs of Creep		Visible release
□ F	Failed/eroded vegetation >100sq ft.	X	No observed problems
Describe findings. Identify locations on attached map. Attach additional pages if necessary.

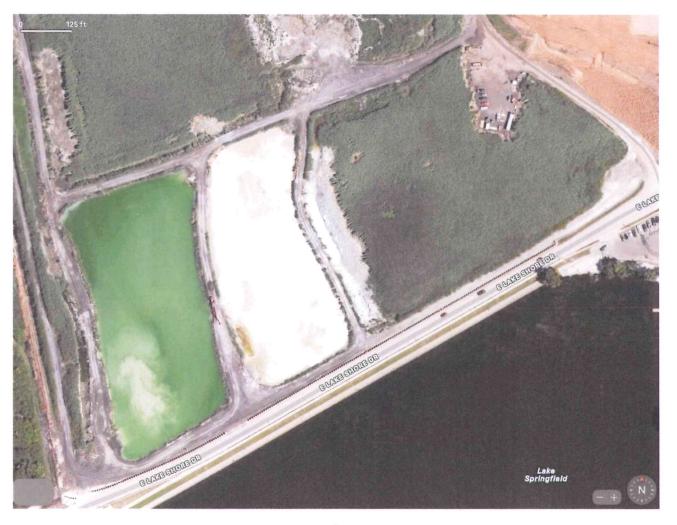
Berms – Lime Softening Ponds

Delilli	s – Linie Soitening Ponds				
Condit	ions Limiting Visibility: Snow Cover Vegetation		OtherNone		
Obser	vations: Erosion / Gullies Cracking / Sloughing Seeps / Damp Areas Signs of Creep Failed/eroded vegetation >100sq ft.	D D D D	Sudden drop in impoundment level Actual or potential structural weakness Improper operation of overtopping control Visible release No observed problems		
Describe findings. Identify locations on attached map. Attach additional pages if necessary.					
	· · · · · · · · · · · · · · · · · · ·
