Date: 10-1-25 Time: 8:30 km Inspector(s) / I	Posi	tion: JIM KETCHUM	
Site Conditions:			
Sky: Sunny Ground Moisture: DRY Temper	ratur	re: 63°F Precipitation: NONE	
Berms – Landfill Unit 2: Conditions Limiting Visibility:			
□ Snow Cover		Other	
▼ Vegetation		None	
Observations:			
☐ Erosion / Gullies		Sudden drop in impoundment level	
□ Cracking / Sloughing		Actual or potential structural weakness	
□ Seeps / Damp Areas		Improper operation of overtopping control	
☐ Signs of Creep		Visible release	
☐ Failed/eroded vegetation >100sq ft.	X	No observed problems	
Describe findings. Identify locations on attached map. Attach additional pages if necessary.

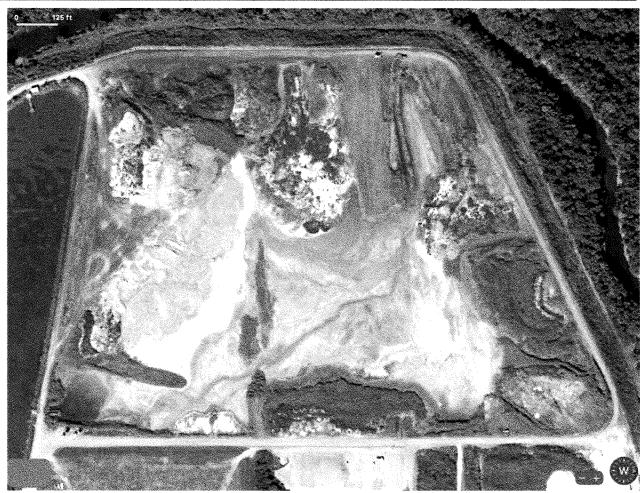
Berms - Dallman Ash Pond

Condit	ions Limiting Visibility:		
	Snow Cover		Other
X	Vegetation		None
Obser	vations:		
	Erosion / Gullies		Sudden drop in impoundment level
	Cracking / Sloughing		Actual or potential structural weakness
	Seeps / Damp Areas		Improper operation of overtopping control
	Signs of Creep		Visible release
	Failed/eroded vegetation >100sq ft.	X	No observed problems
Describe findings. Identify locations on attached map. Attach additional pages if necessary.

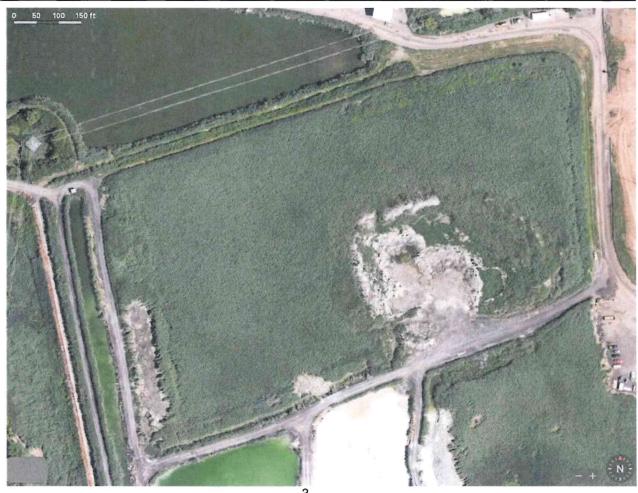
berms	- Lakeside Ash Pond		
Condit	ions Limiting Visibility:		
	Snow Cover		Other
X	Vegetation		None
Obser	vations:		
	Erosion / Gullies		Sudden drop in impoundment level
	Cracking / Sloughing		Actual or potential structural weakness
	Seeps / Damp Areas		Improper operation of overtopping control
	Signs of Creep		Visible release
	Failed/eroded vegetation >100sq ft.	X	No observed problems
Docori	be findings. Identify locations on attached map. Attacl	a add	litional pages if pagesany
Descri	be findings, identity locations on attached map. Attach	i aud	illional pages il necessary.

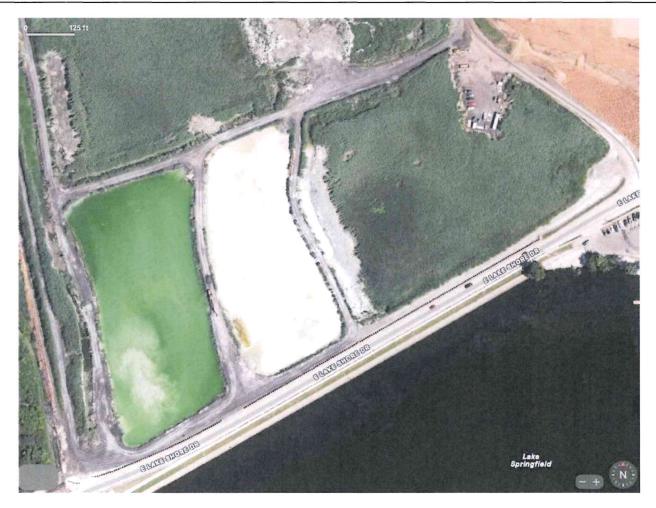
Berms - Lime Softening Ponds

Condit	tions Limiting Visibility: Snow Cover Vegetation		OtherNone
Obser	vations: Erosion / Gullies Cracking / Sloughing Seeps / Damp Areas Signs of Creep Failed/eroded vegetation >100sq ft.		Sudden drop in impoundment level Actual or potential structural weakness Improper operation of overtopping control Visible release No observed problems
Descri	be findings. Identify locations on attached map. Attac	h add	ditional pages if necessary.
