**City Water, Light and Power**  
**Coal Combustion Residuals Units**  
**40 CFR 257 and 35 IAC 845**  
**Weekly Inspection Form**

Date: 10-8-25 Time: 13:00 Inspector(s) / Position: Staley

**Berms – Landfill Unit 2:**

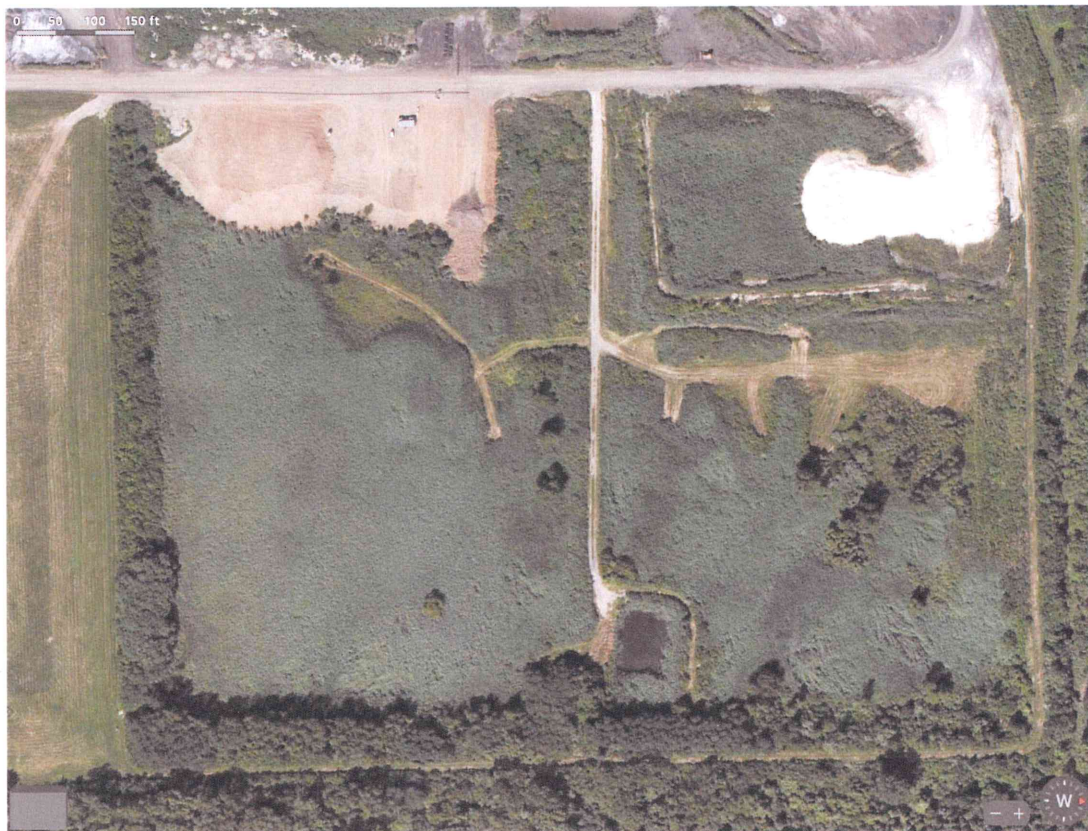
mowed week of 10-6-25

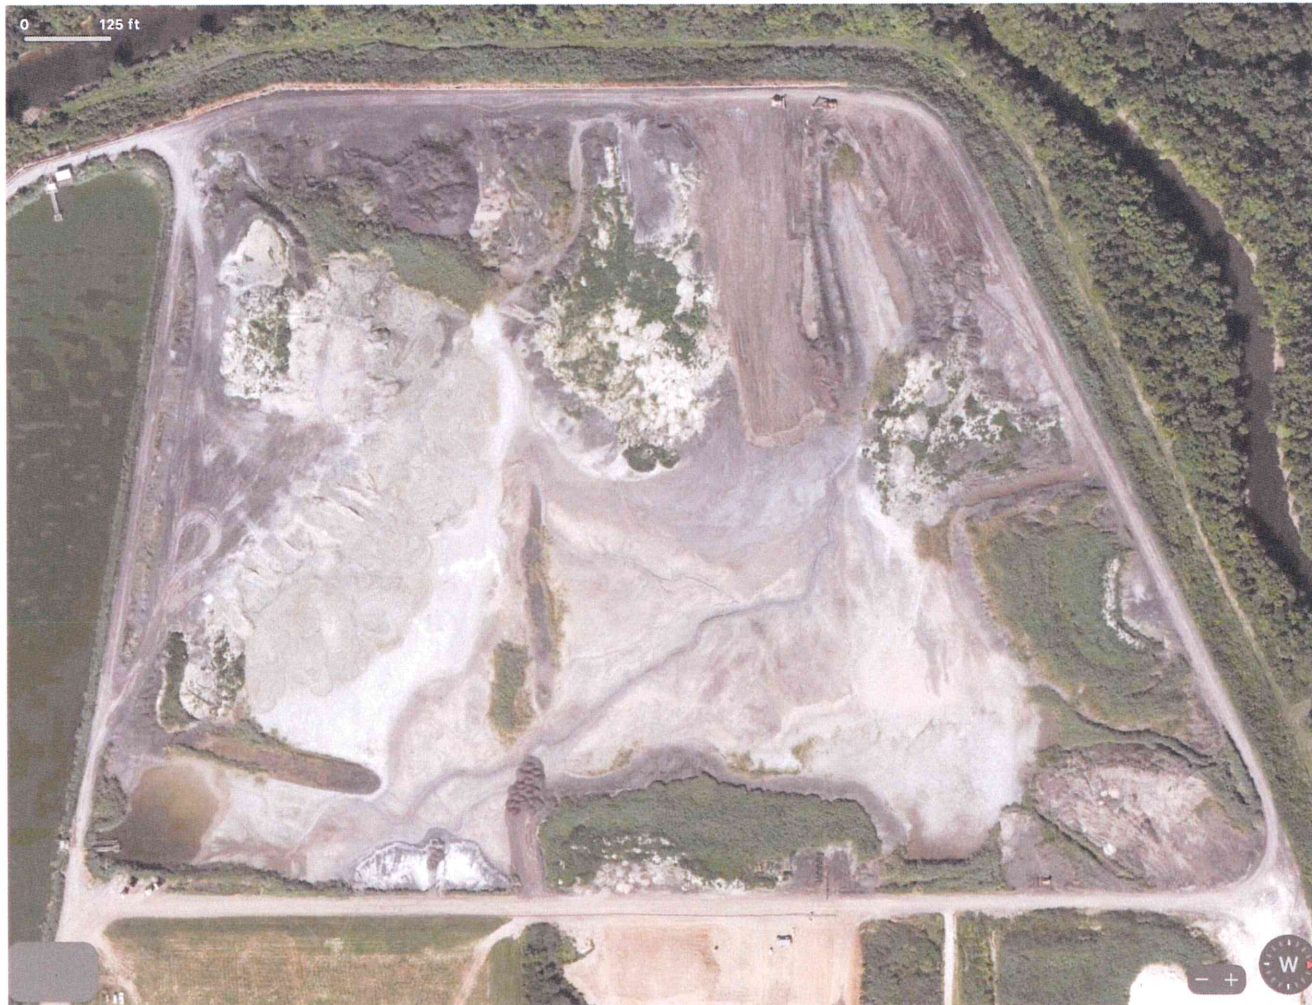
**Berms – Dallman Ash Pond**

*mowed on 10-6-25*

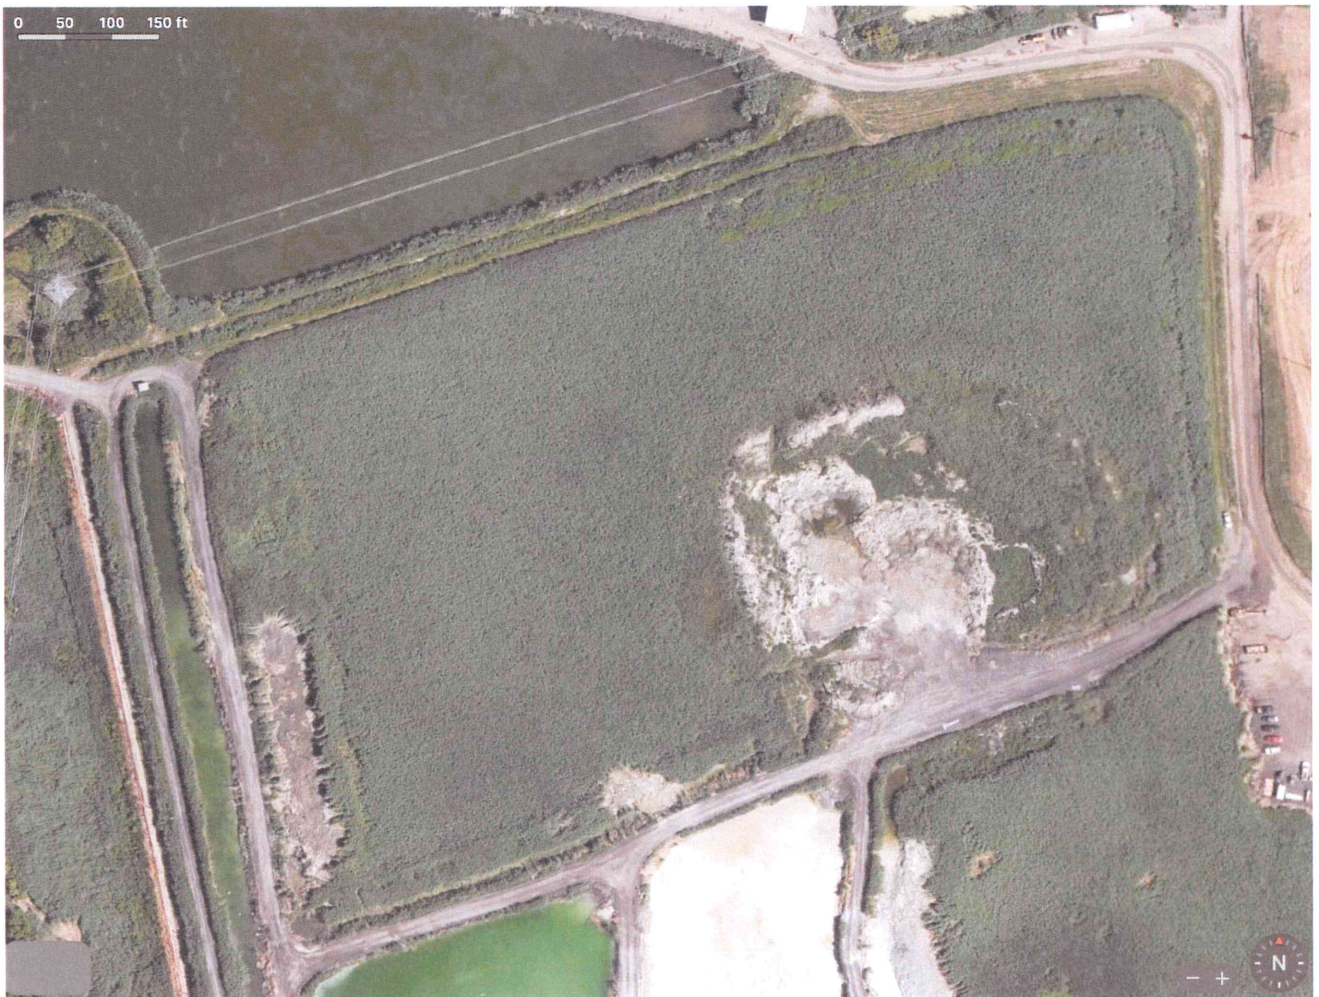
**Berms – Lakeside Ash Pond**

*mowed 10-6-25*

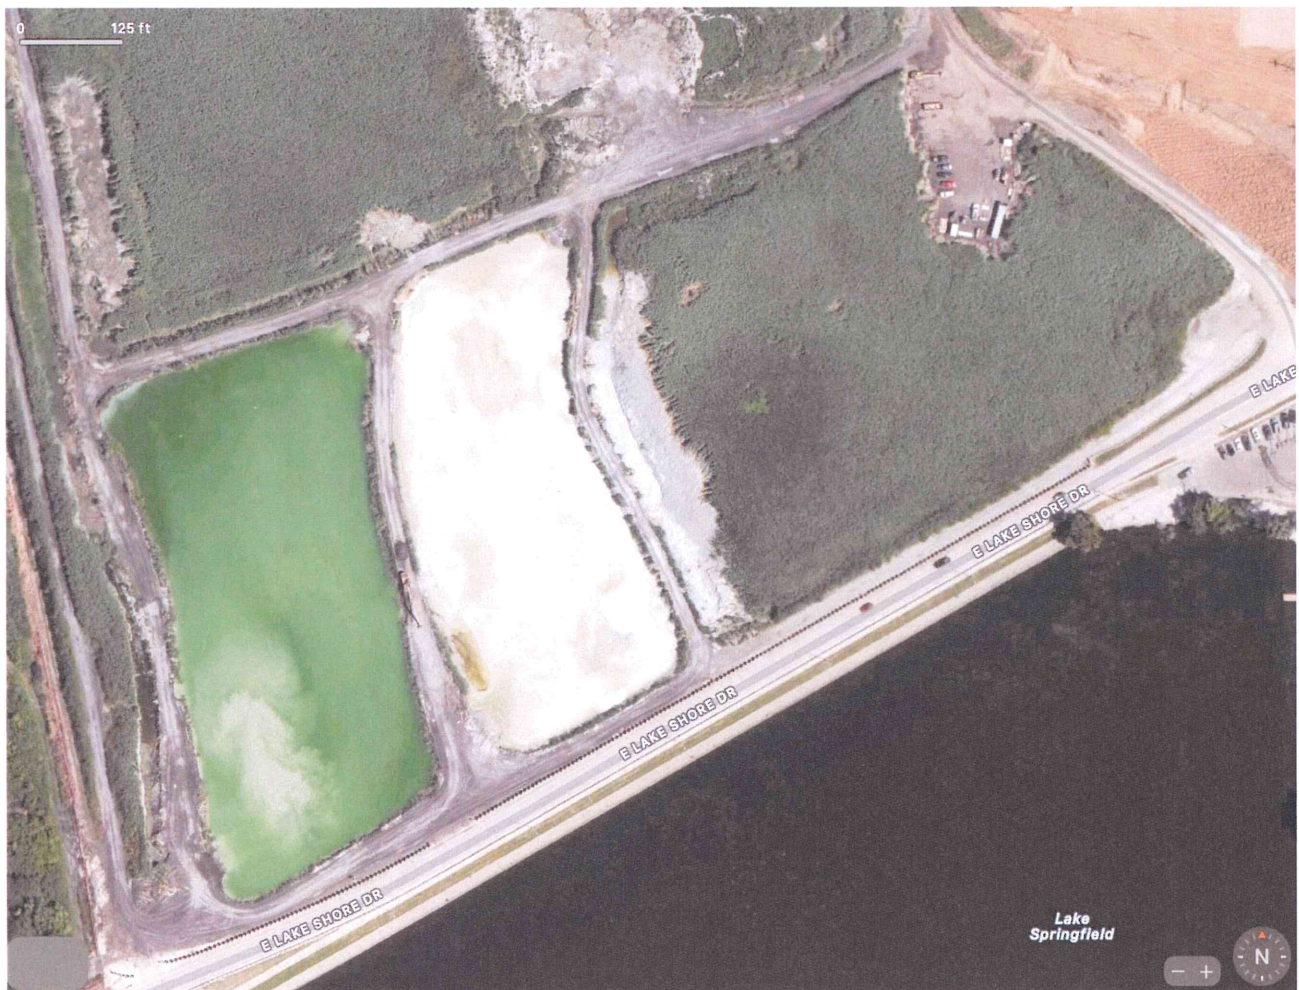
**Berms – Lime Softening Ponds**

*mowed 10-6-25*
