**City Water, Light and Power  
Coal Combustion Residuals Units  
40 CFR 257 and 35 IAC 845  
Weekly Inspection Form**

Date: 10/19/25 Time: 12:50 Inspector(s) / Position: Schuy Willmore

**Berms – Landfill Unit 2:**

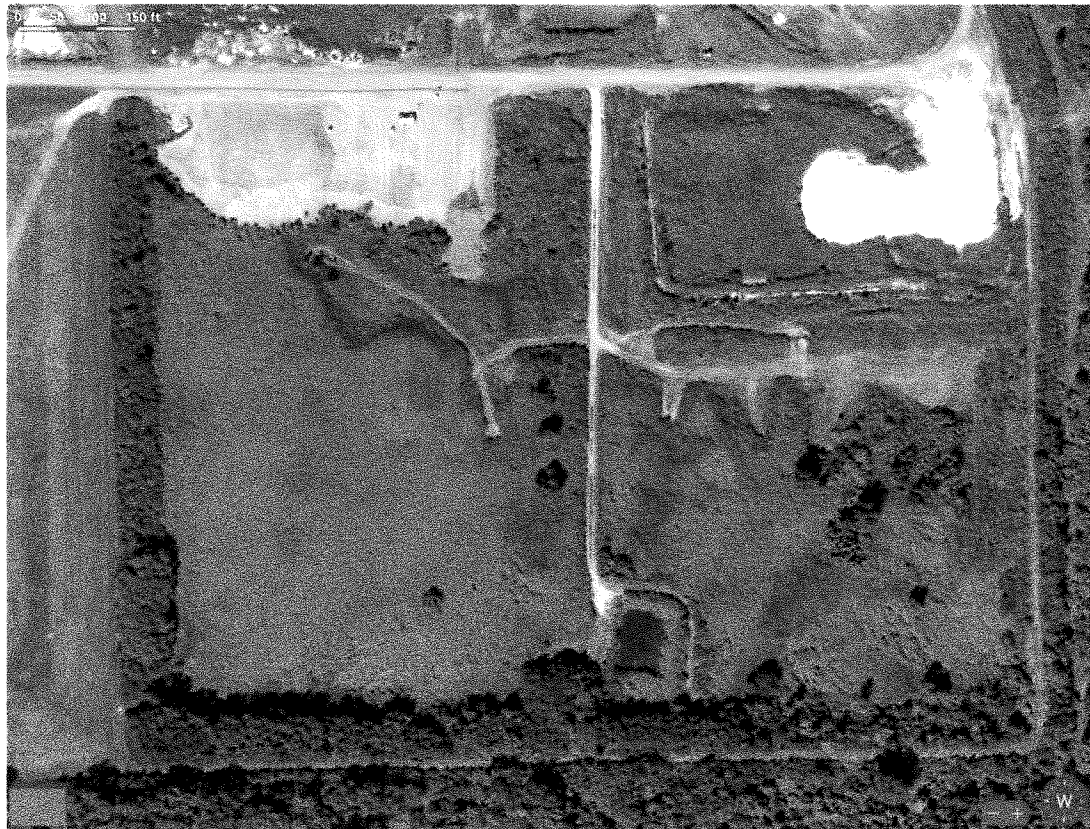
- ☐ Sudden drop in impoundment level
- ☐ Actual or potential structural weakness
- ☐ Improper operation of overtopping control
- ☐ Visible release
- ☒ No observed problems

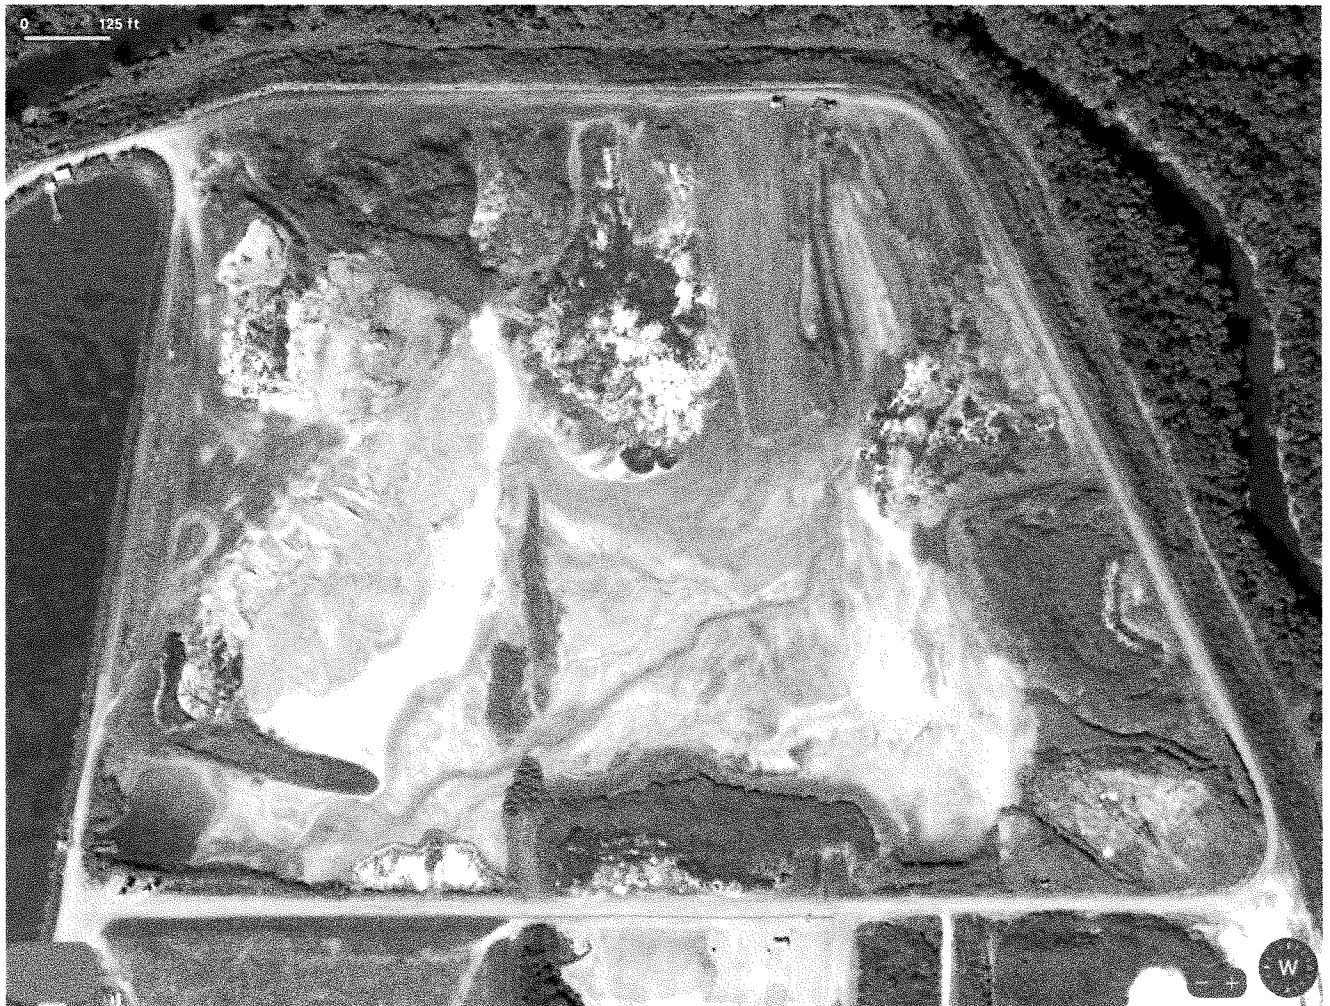
**Berms – Dallman Ash Pond**

- ☐ Sudden drop in impoundment level
- ☐ Actual or potential structural weakness
- ☐ Improper operation of overtopping control
- ☐ Visible release
- ☒ No observed problems

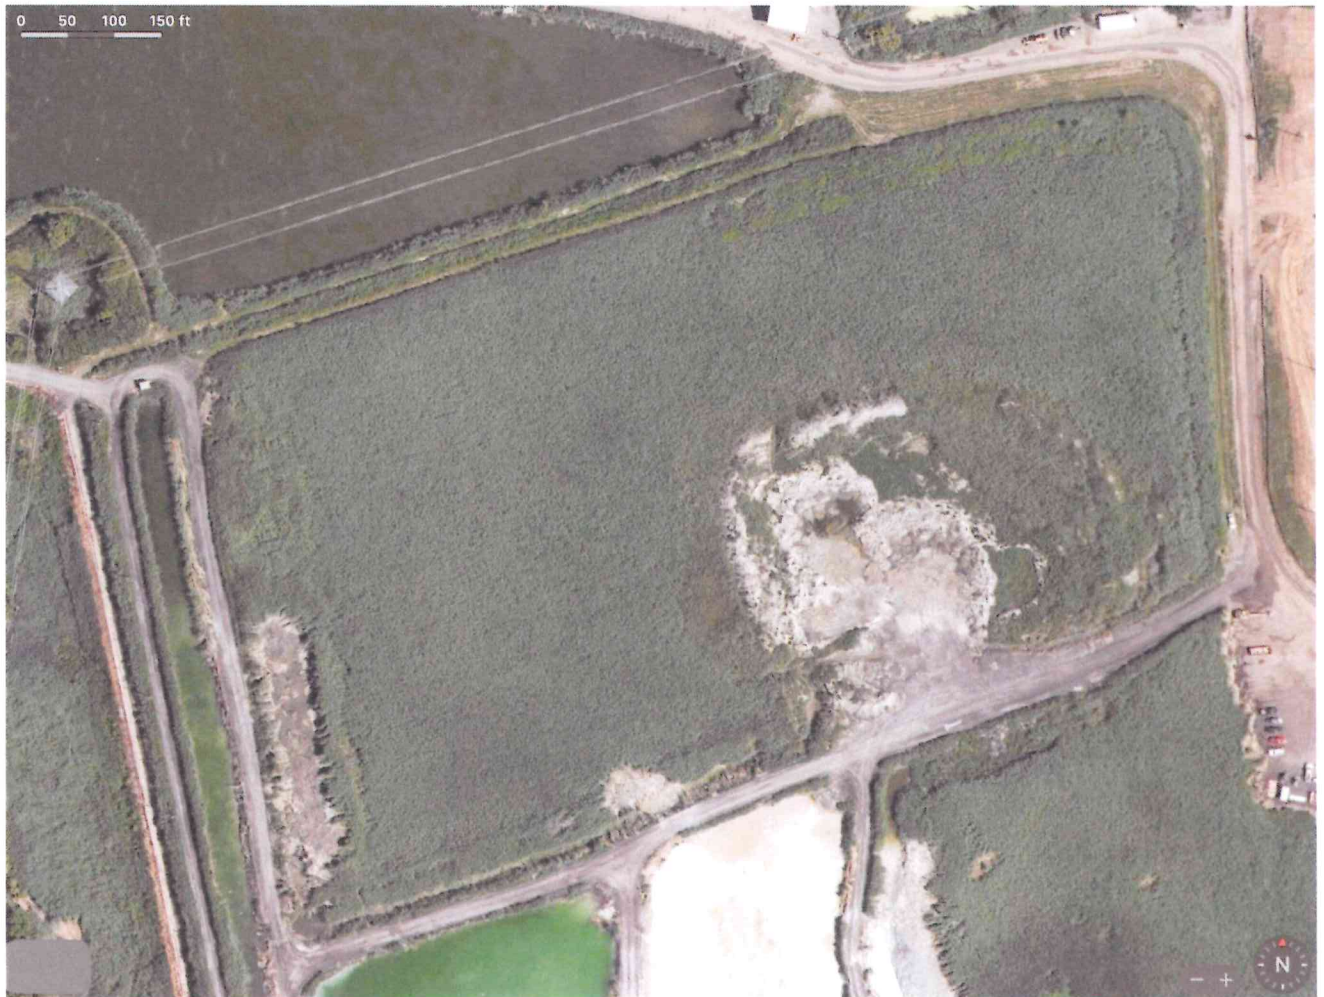
**Berms – Lakeside Ash Pond**

- ☐ Sudden drop in impoundment level
- ☐ Actual or potential structural weakness
- ☐ Improper operation of overtopping control
- ☐ Visible release
- ☒ No observed problems

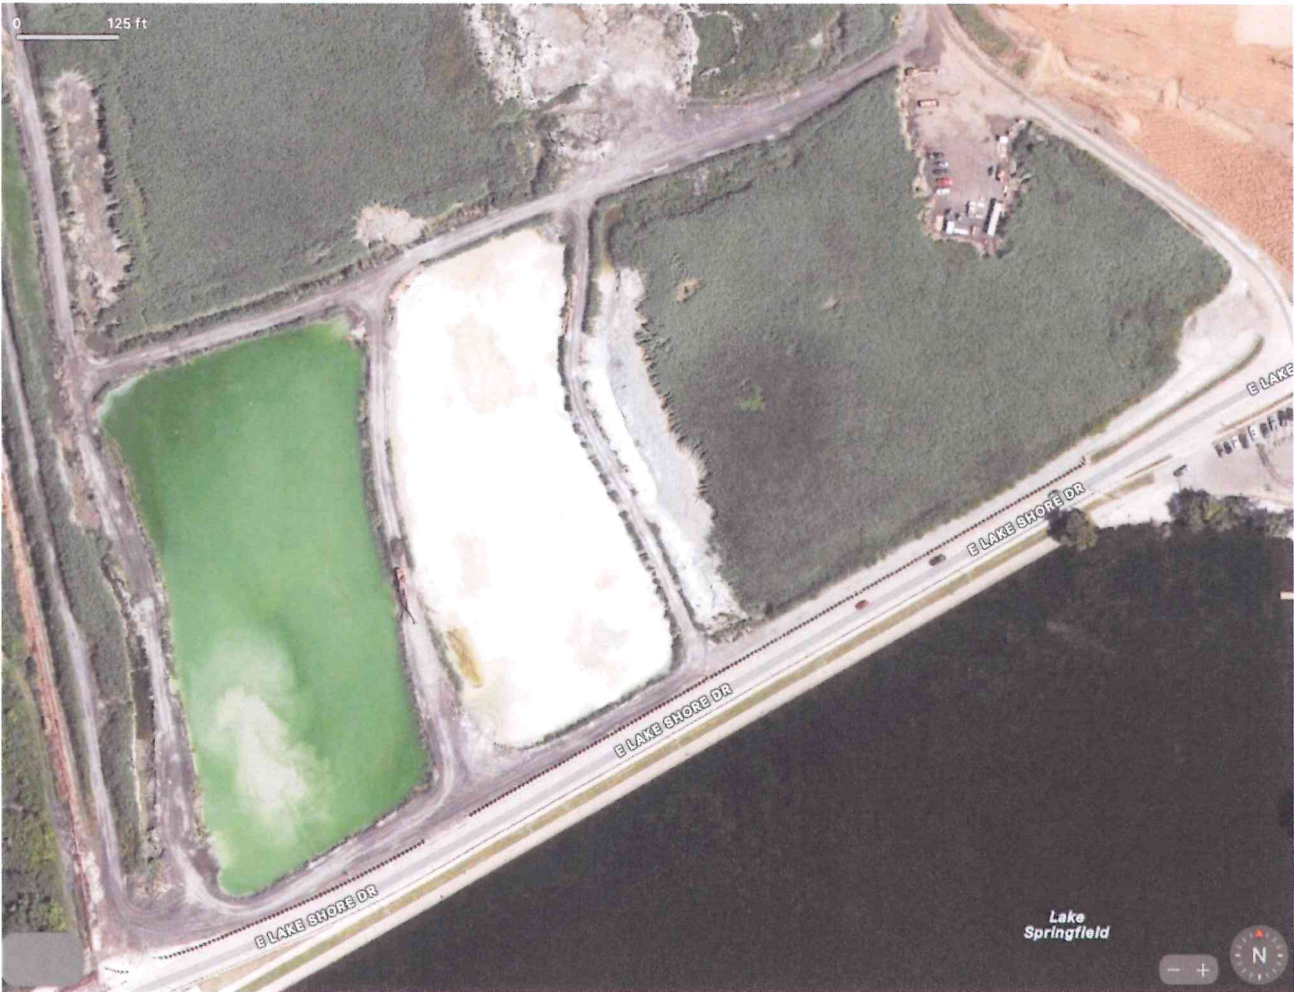
**Berms – Lime Softening Ponds**

- ☐ Sudden drop in impoundment level
- ☐ Actual or potential structural weakness
- ☐ Improper operation of overtopping control
- ☐ Visible release
- ☒ No observed problems
