**City Water, Light and Power
Coal Combustion Residuals Units
40 CFR 257 and 35 IAC 845
Weekly Inspection Form**

Date: 11-19-25 Time: 10:45 Inspector(s) / Position: Staley

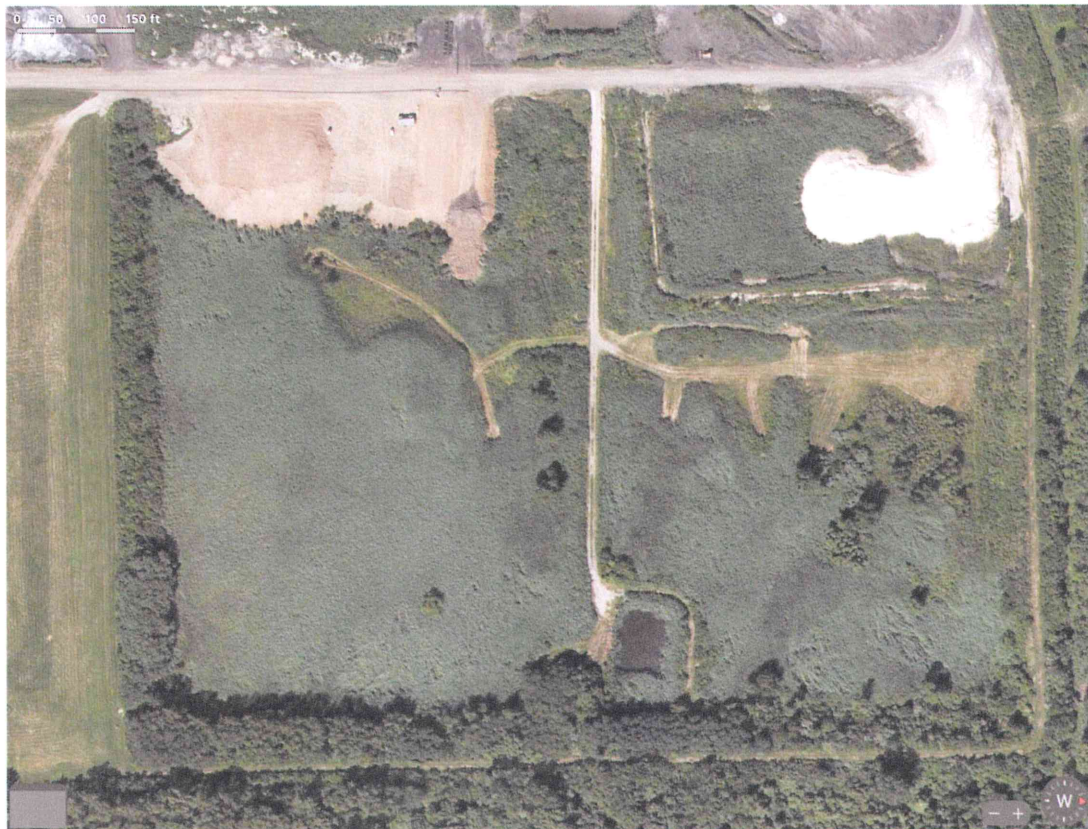
Berms – Landfill Unit 2:

- ☐ Sudden drop in impoundment level
- ☐ Actual or potential structural weakness
- ☐ Improper operation of overtopping control
- ☐ Visible release
- ☒ No observed problems

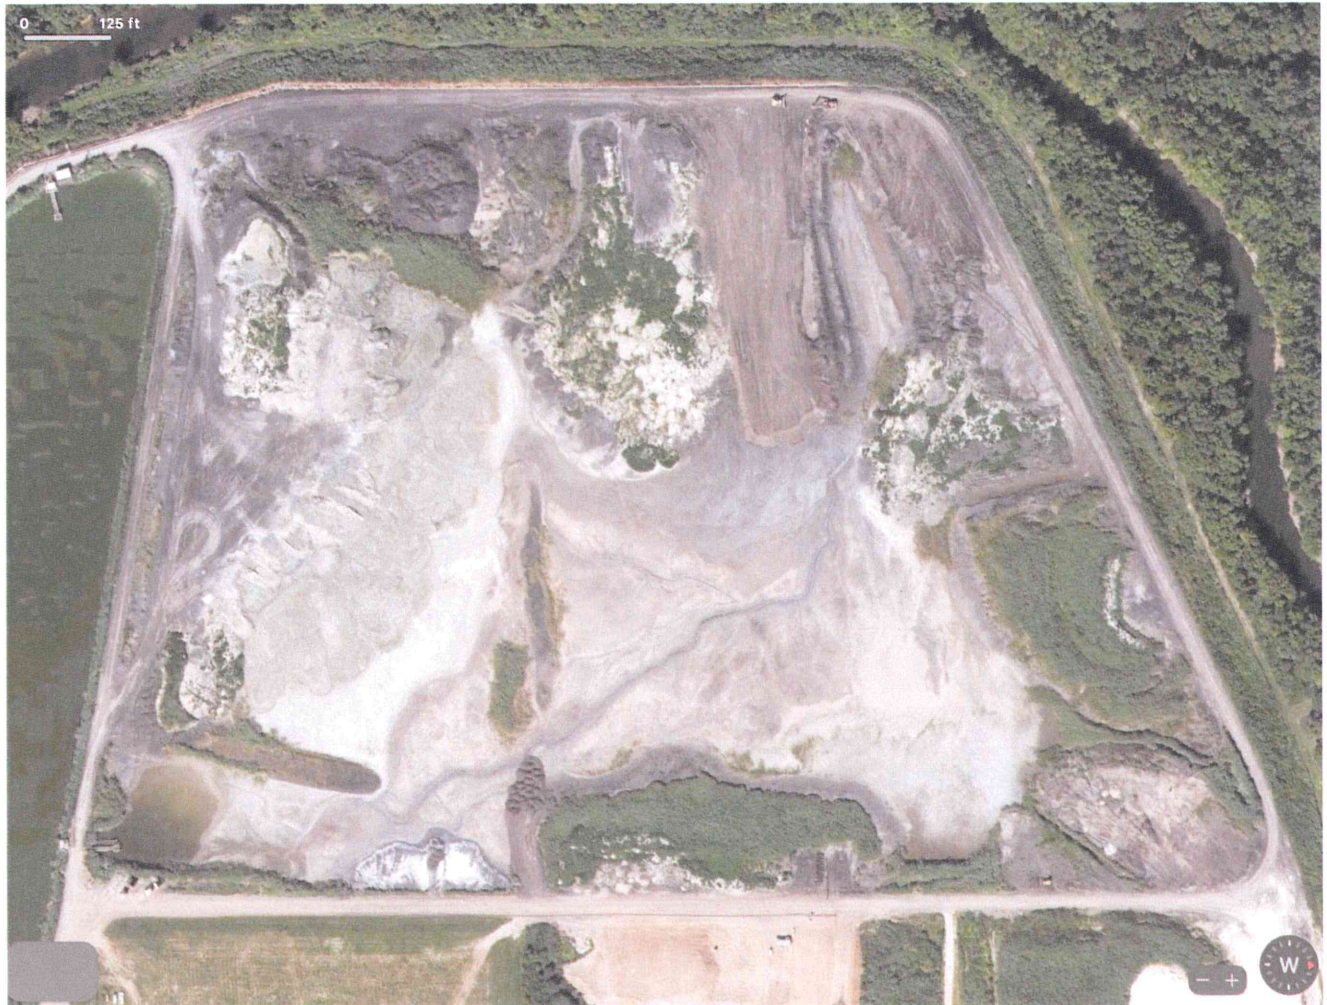
Berms – Dallman Ash Pond

| <input type="checkbox"/> Failed/eroded vegetation >100sq ft. | <input checked="" type="checkbox"/> No observed problems |

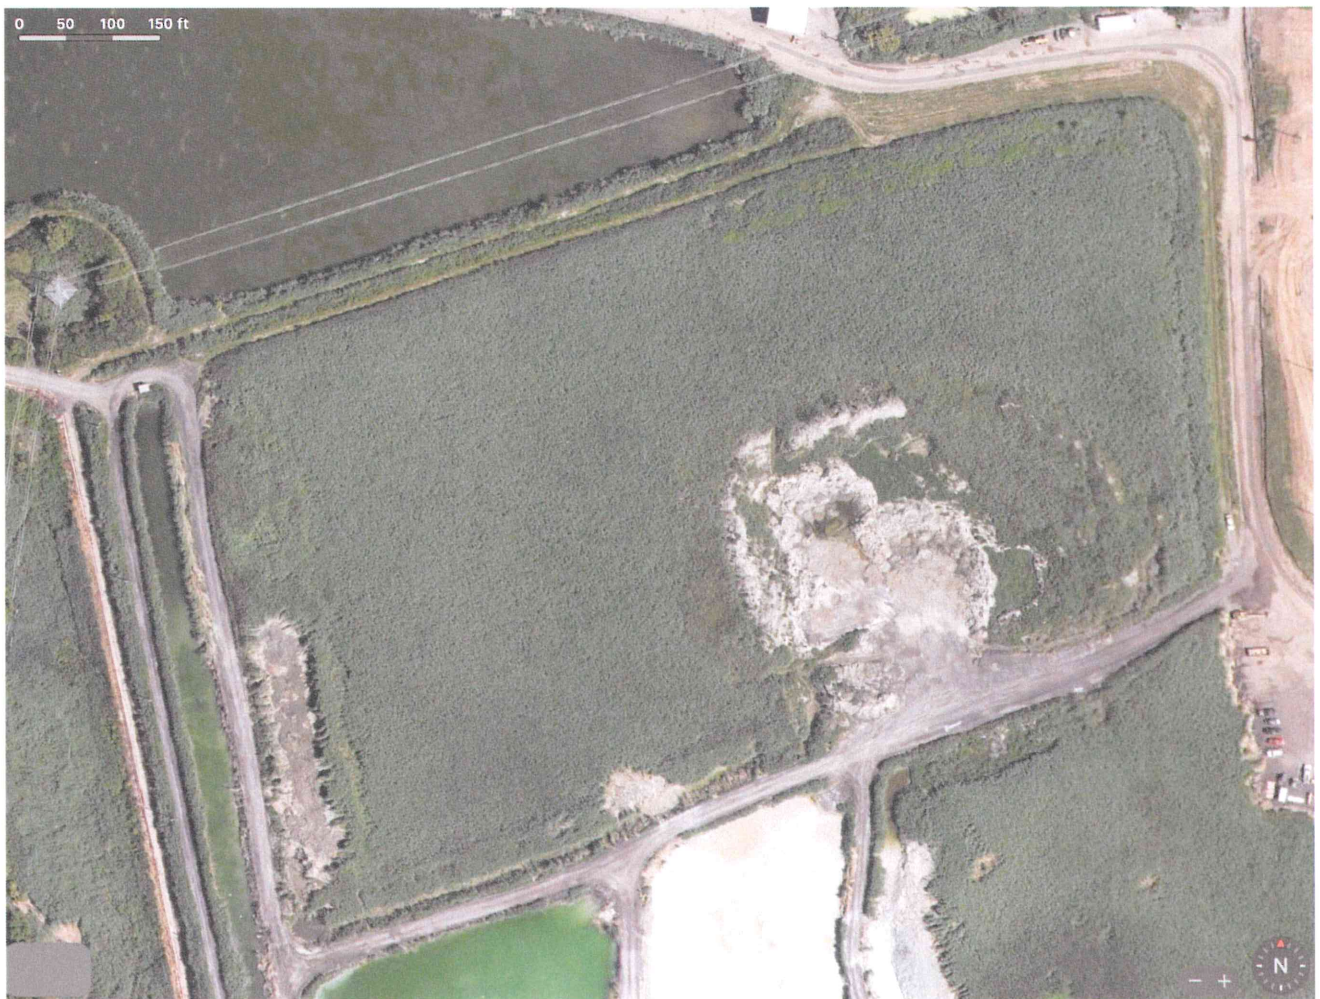
Berms – Lakeside Ash Pond

- ☐ Sudden drop in impoundment level
- ☐ Actual or potential structural weakness
- ☐ Improper operation of overtopping control
- ☐ Visible release
- ☒ No observed problems

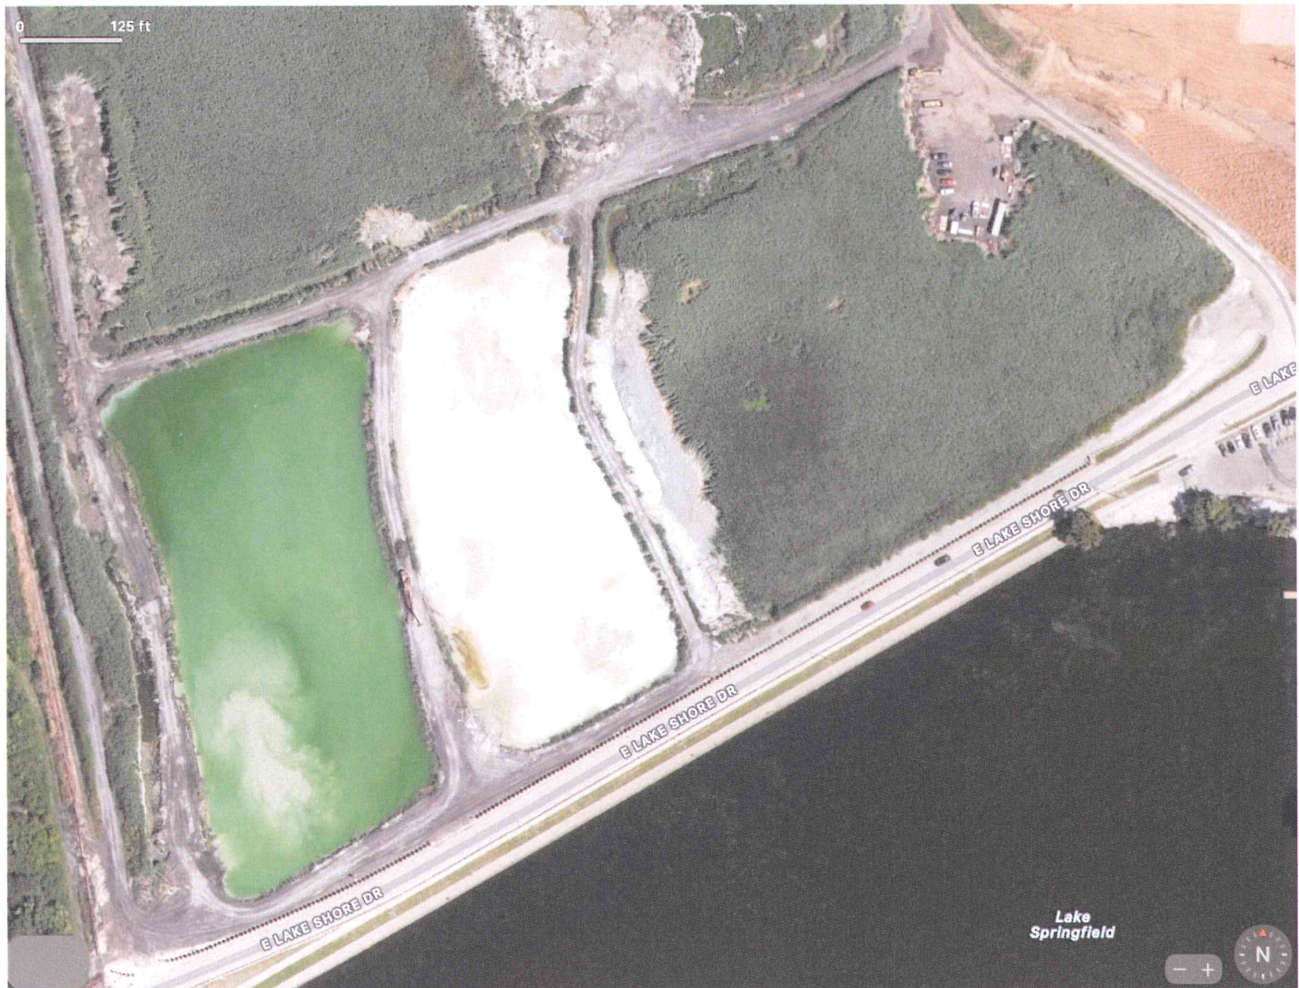
Berms – Lime Softening Ponds

- ☐ Sudden drop in impoundment level
- ☐ Actual or potential structural weakness
- ☐ Improper operation of overtopping control
- ☐ Visible release
- ☒ No observed problems
