**City Water, Light and Power**  
**Coal Combustion Residuals Units**  
**40 CFR 257 and 35 IAC 845**  
**Weekly Inspection Form**

Date: 11-26-25 Time: 1:00 Inspector(s) / Position: Staley

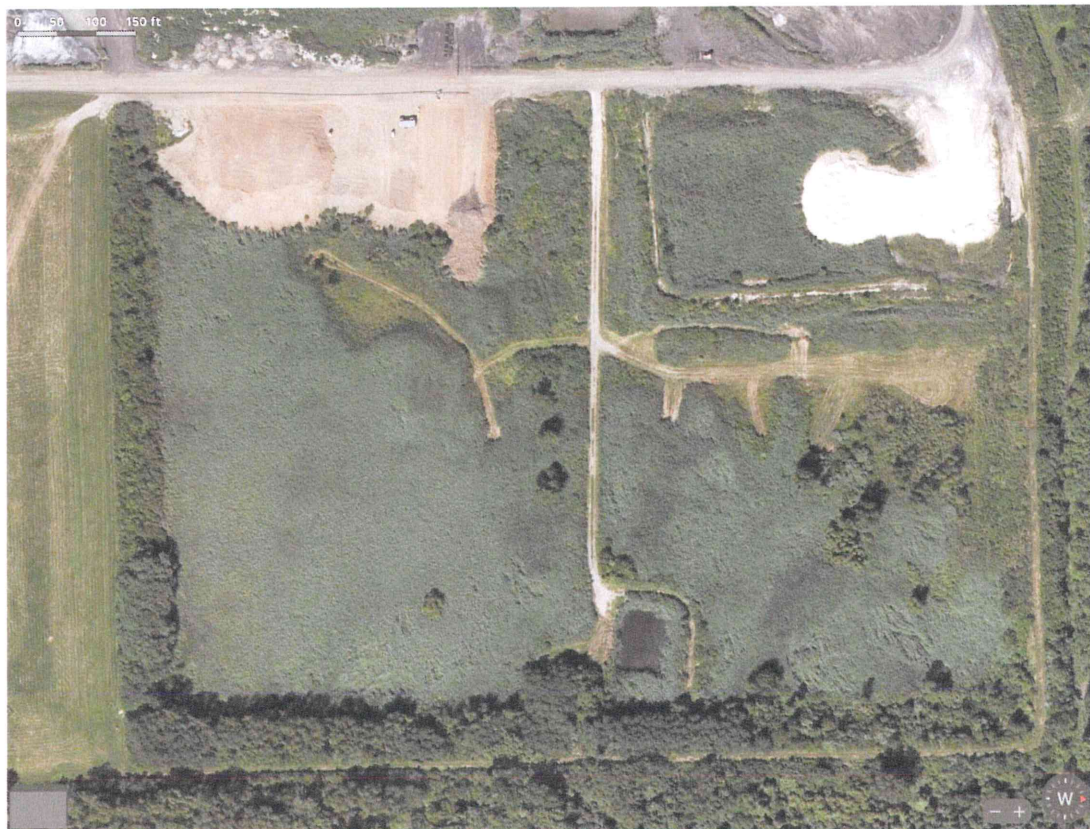
**Berms – Landfill Unit 2:**

- ☐ Sudden drop in impoundment level
- ☐ Actual or potential structural weakness
- ☐ Improper operation of overtopping control
- ☐ Visible release
- ☒ No observed problems

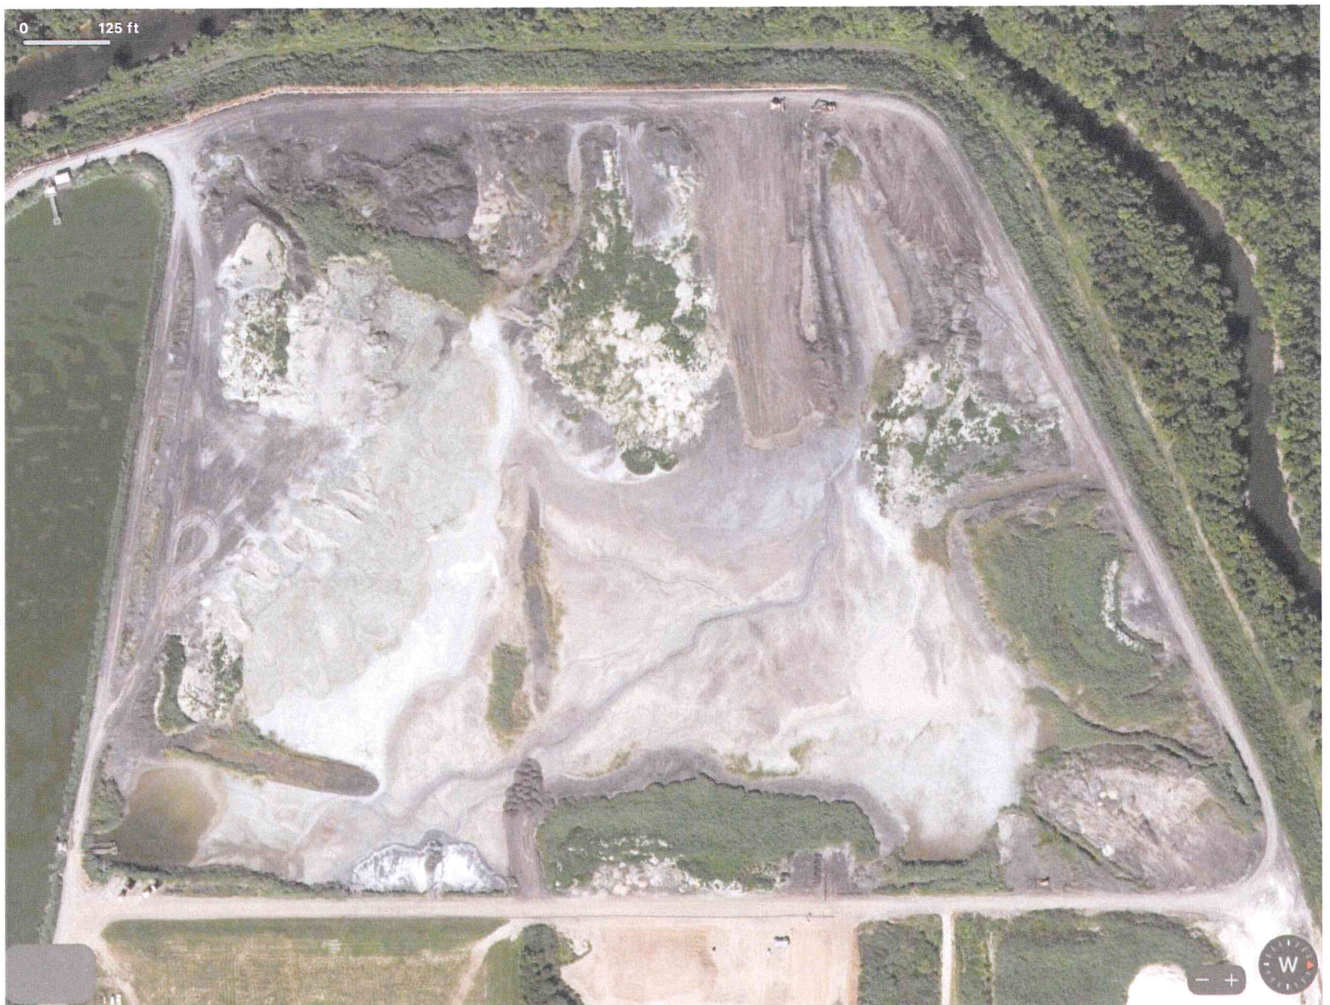
**Berms – Dallman Ash Pond**

- ☐ Sudden drop in impoundment level
- ☐ Actual or potential structural weakness
- ☐ Improper operation of overtopping control
- ☐ Visible release
- ☒ No observed problems

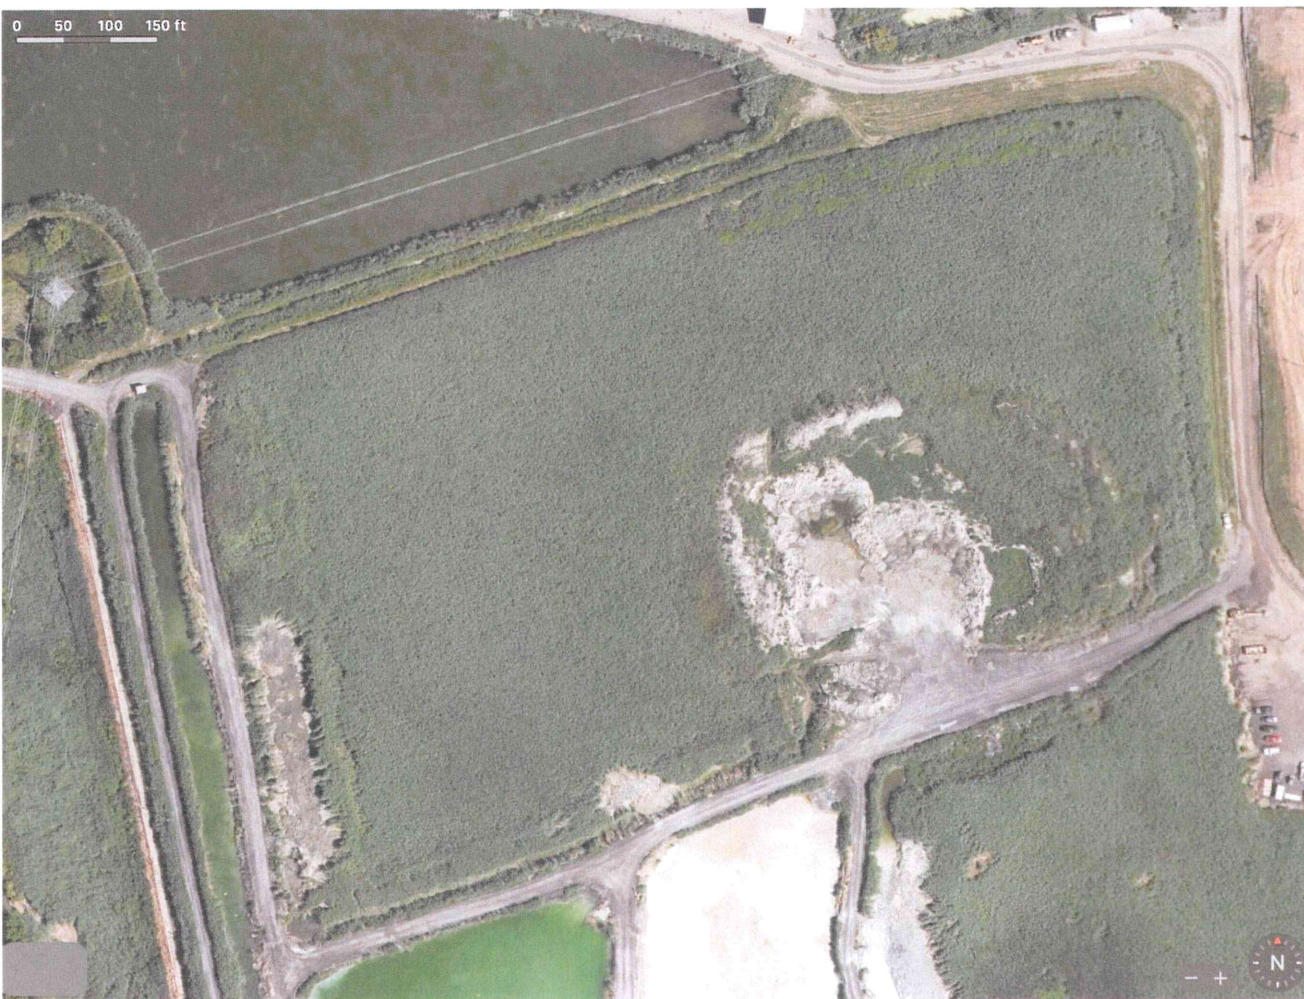
**Berms – Lakeside Ash Pond**

- ☐ Sudden drop in impoundment level
- ☐ Actual or potential structural weakness
- ☐ Improper operation of overtopping control
- ☐ Visible release
- ☒ No observed problems

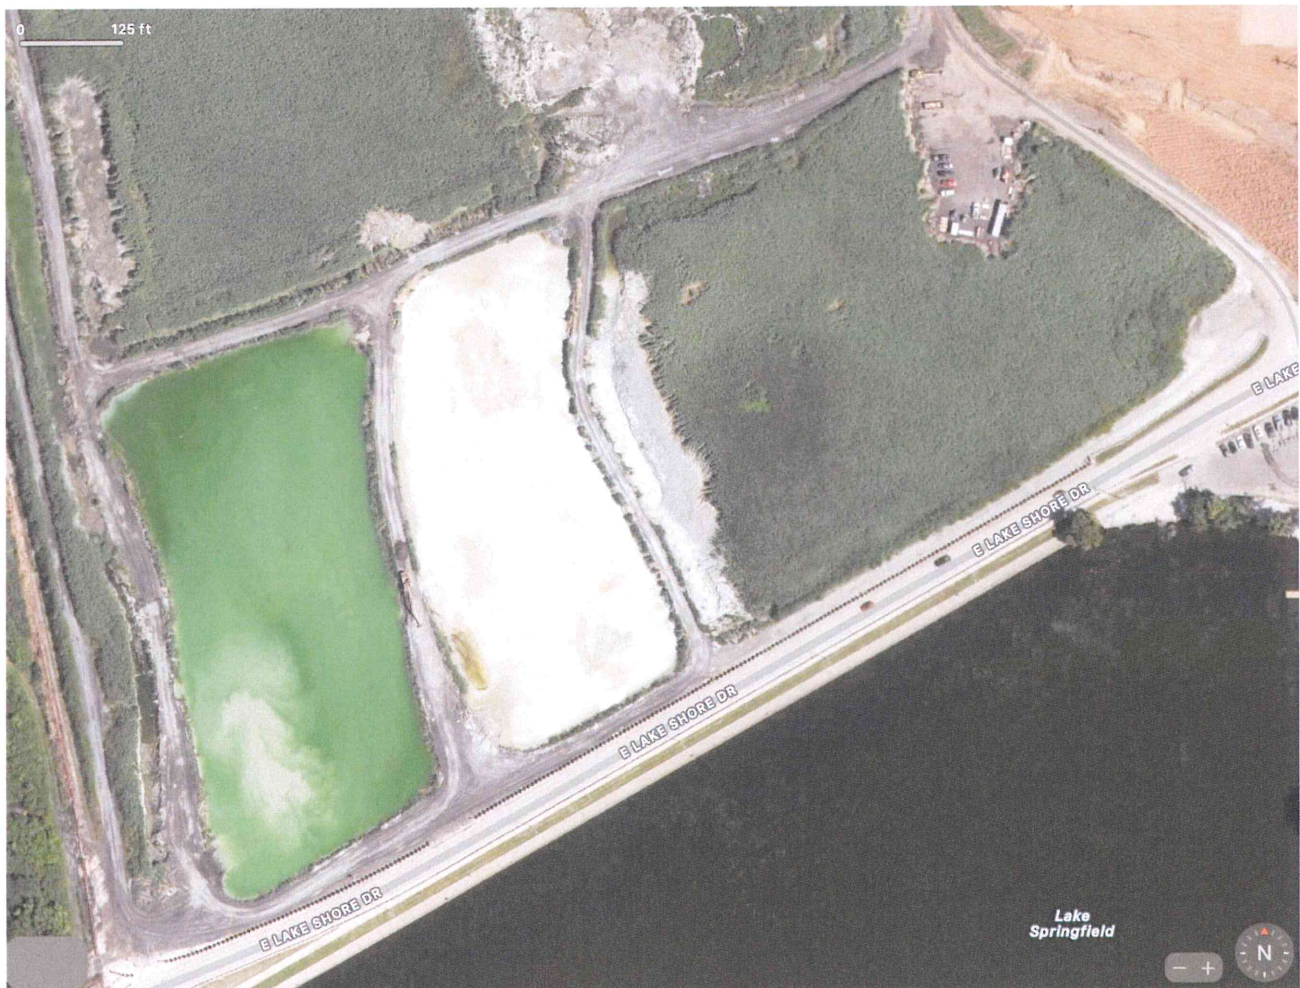
**Berms – Lime Softening Ponds**

- ☐ Sudden drop in impoundment level
- ☐ Actual or potential structural weakness
- ☐ Improper operation of overtopping control
- ☐ Visible release
- ☒ No observed problems
