City Water, Light and Power
Coal Combustion Residuals Units
40 CFR 257 and 35 IAC 845
Weekly Inspection Form

Date: 12-30-25 Time: 11:00 Inspector(s) / Position: Staley

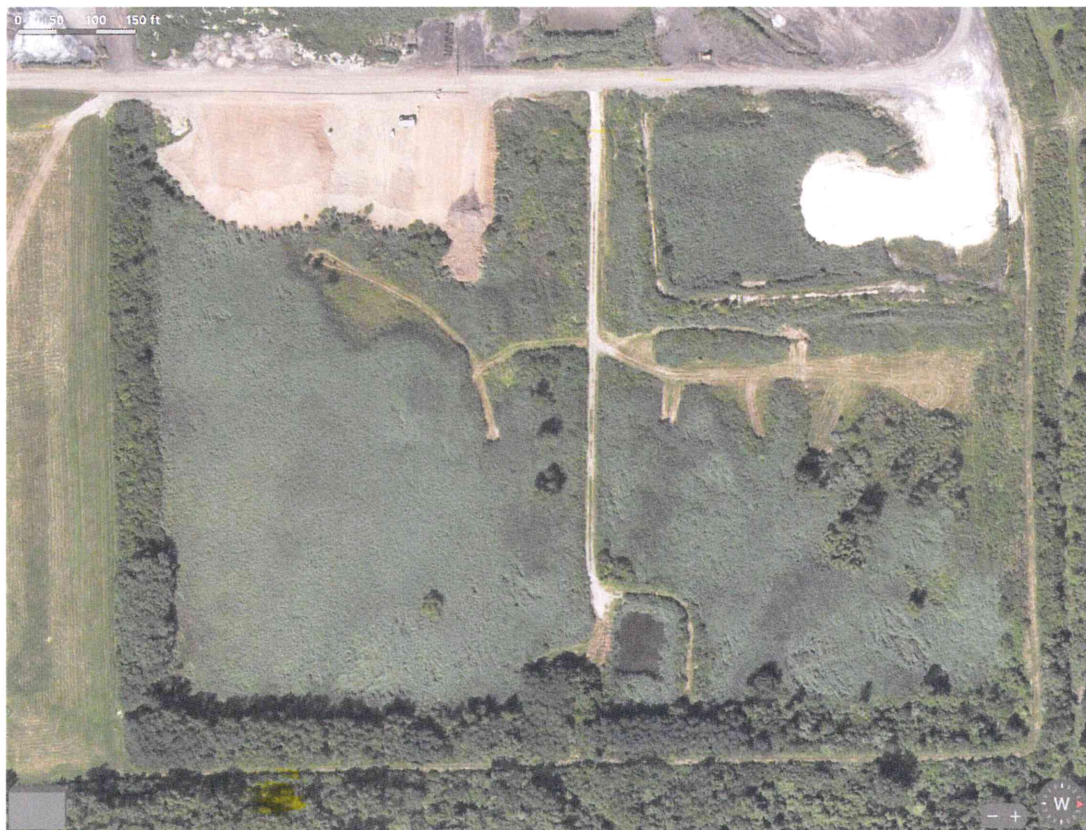
Berms – Landfill Unit 2:

- ☐ Sudden drop in impoundment level
- ☐ Actual or potential structural weakness
- ☐ Improper operation of overtopping control
- ☐ Visible release
- ☒ No observed problems

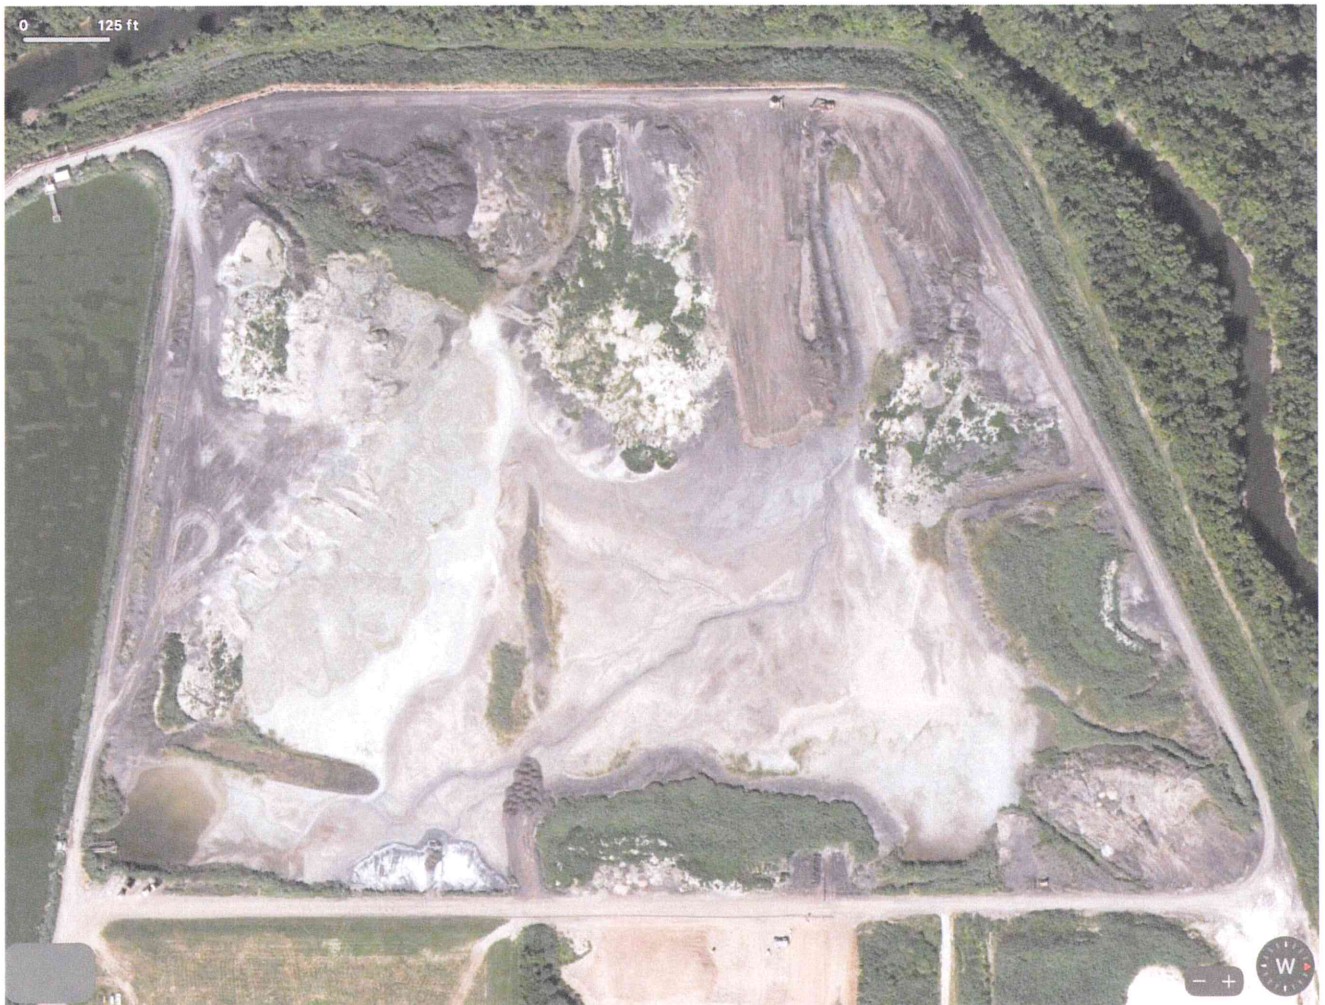
Berms – Dallman Ash Pond

| <input type="checkbox"/> Failed/eroded vegetation >100sq ft. | <input checked="" type="checkbox"/> No observed problems |

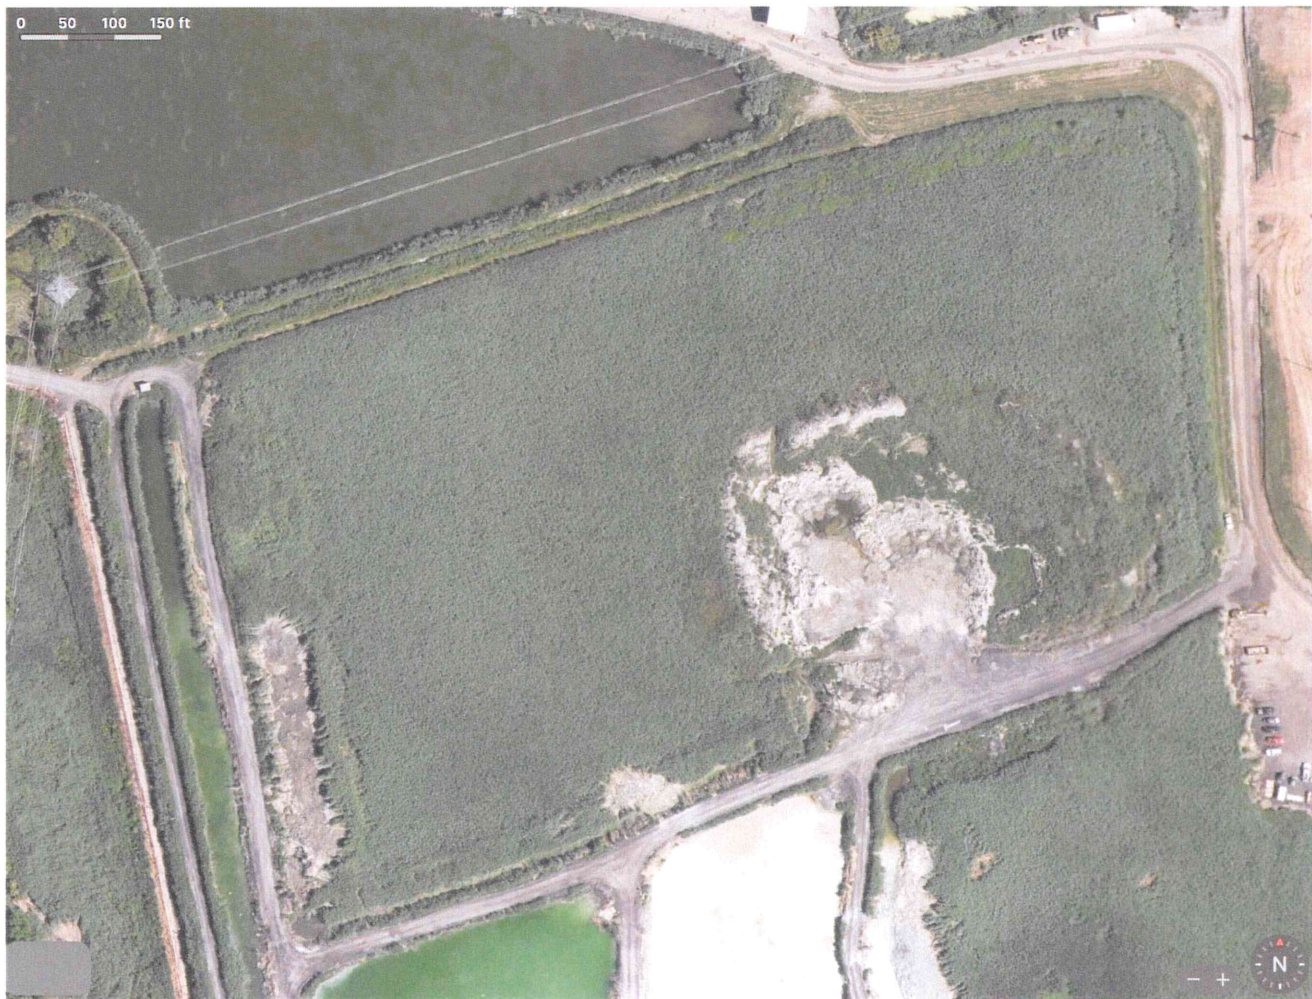
Berms – Lakeside Ash Pond

- ☐ Sudden drop in impoundment level
- ☐ Actual or potential structural weakness
- ☐ Improper operation of overtopping control
- ☐ Visible release
- ☒ No observed problems

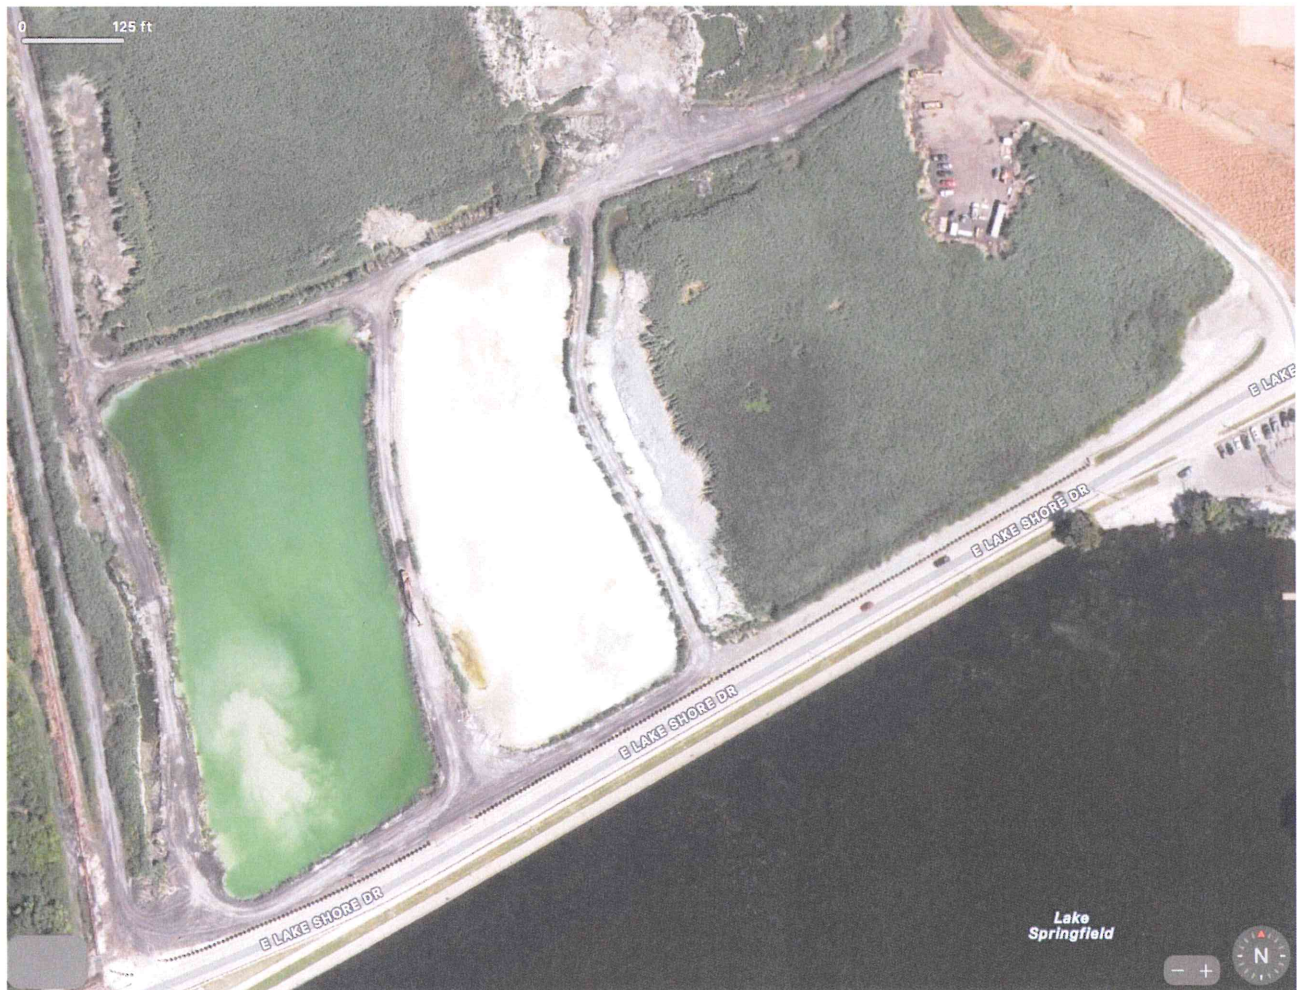
Berms – Lime Softening Ponds

- ☐ Sudden drop in impoundment level
- ☐ Actual or potential structural weakness
- ☐ Improper operation of overtopping control
- ☐ Visible release
- ☒ No observed problems
