City Water, Light and Power
Coal Combustion Residuals Units
40 CFR 257 and 35 IAC 845
Weekly Inspection Form

Date: 1/7/26 Time: 1:35 Inspector(s) / Position: Schy Willmore

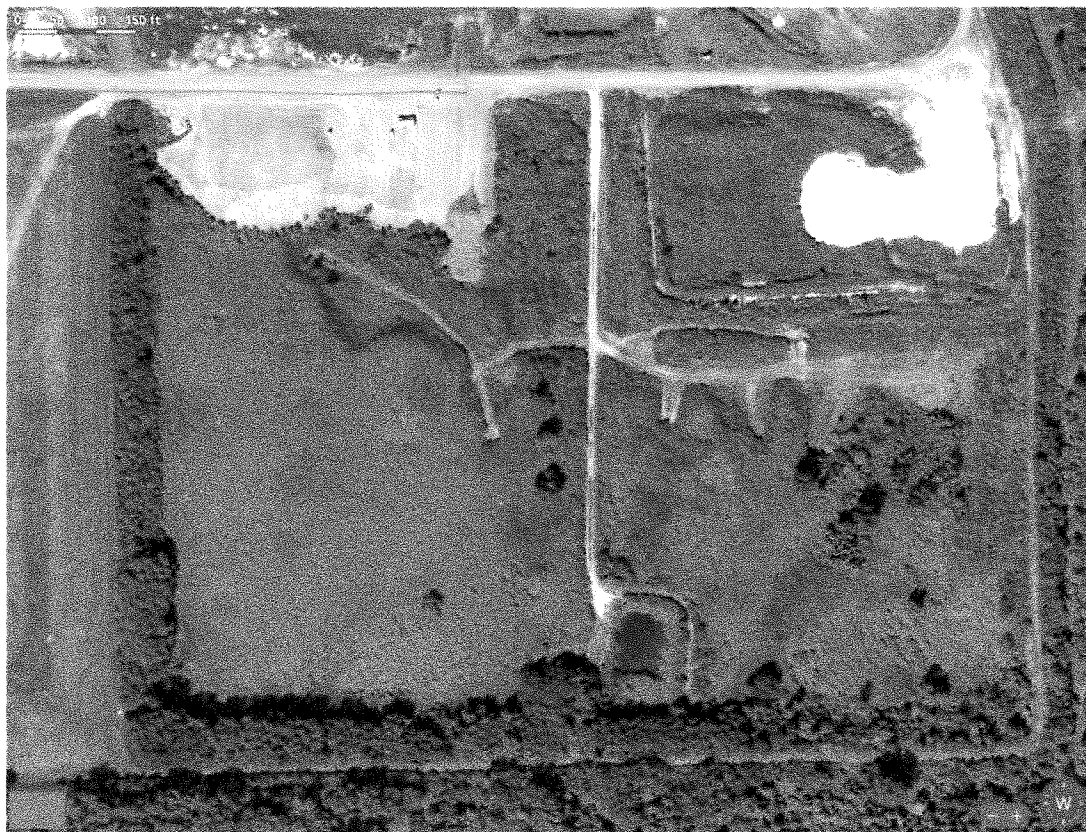
Berms – Landfill Unit 2:

- ☐ Sudden drop in impoundment level
- ☐ Actual or potential structural weakness
- ☐ Improper operation of overtopping control
- ☐ Visible release
- ☒ No observed problems

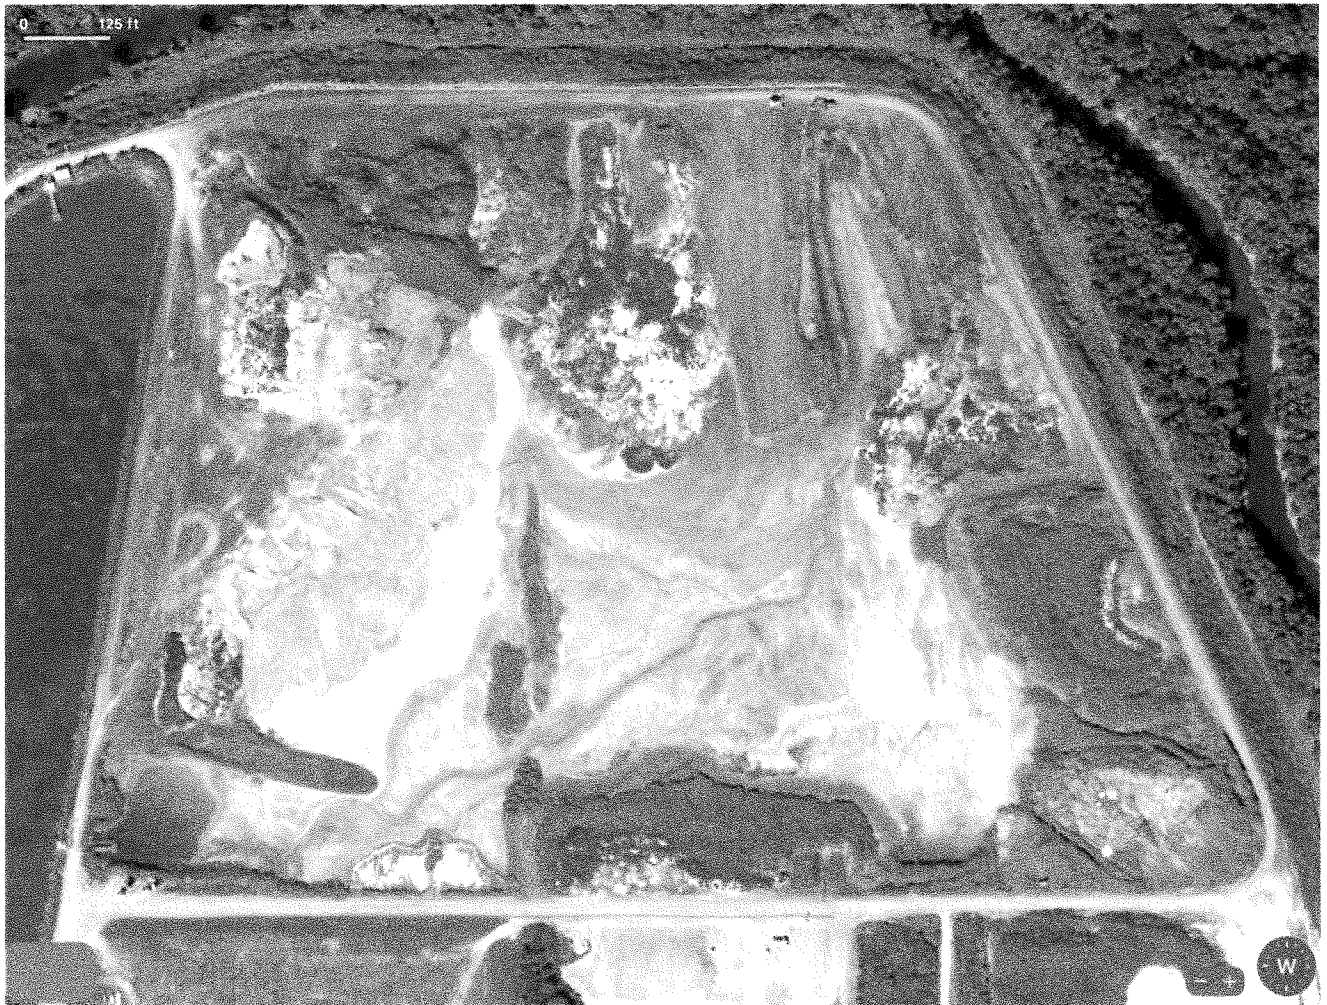
Berms – Dallman Ash Pond

| <input type="checkbox"/> Failed/eroded vegetation >100sq ft. | <input checked="" type="checkbox"/> No observed problems |

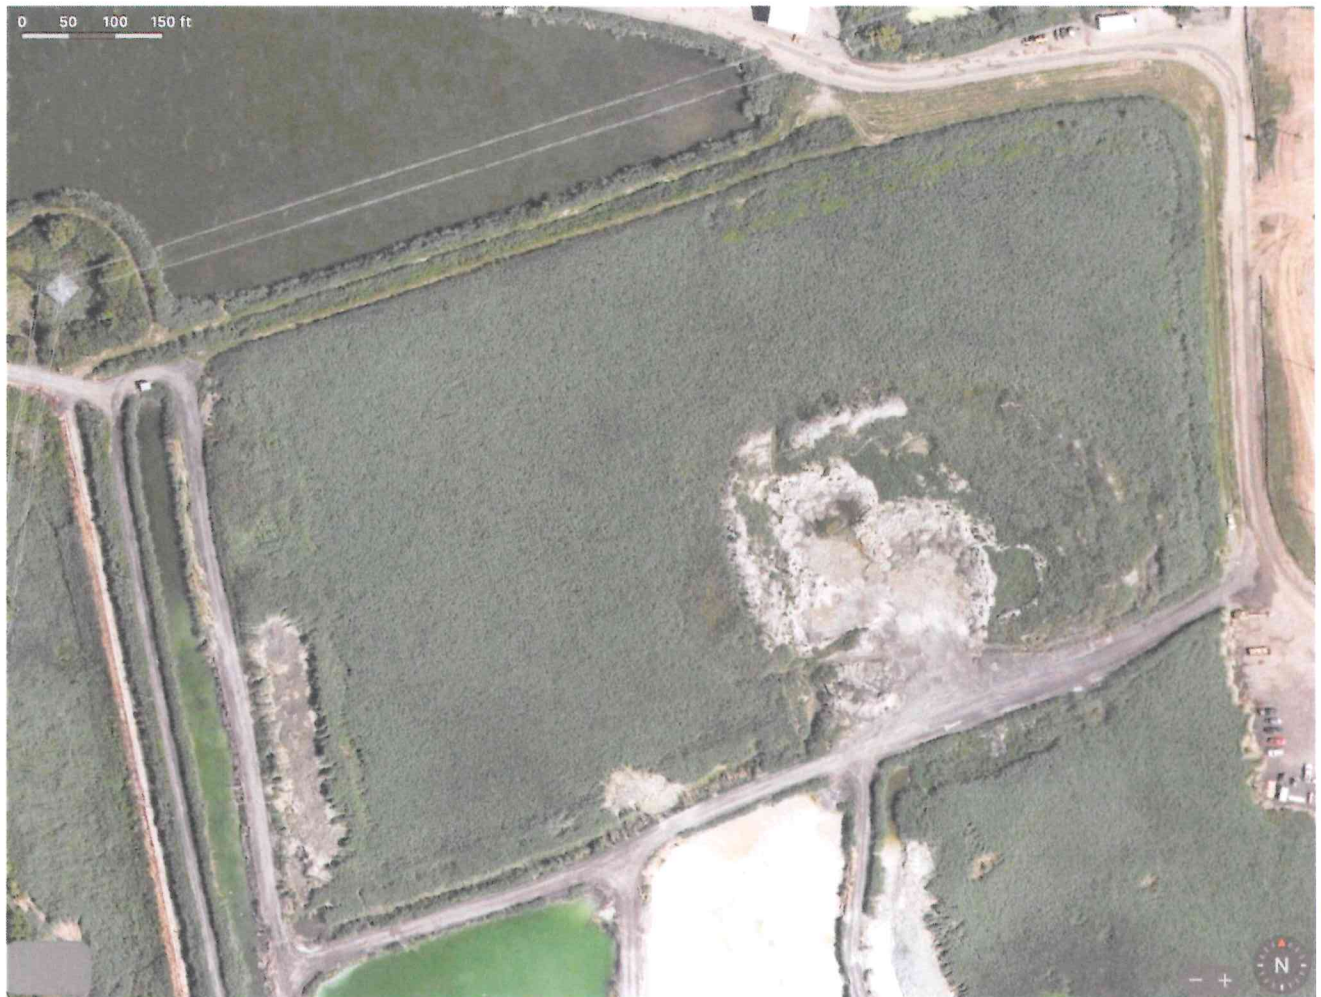
Berms – Lakeside Ash Pond

- ☐ Sudden drop in impoundment level
- ☐ Actual or potential structural weakness
- ☐ Improper operation of overtopping control
- ☐ Visible release
- ☒ No observed problems

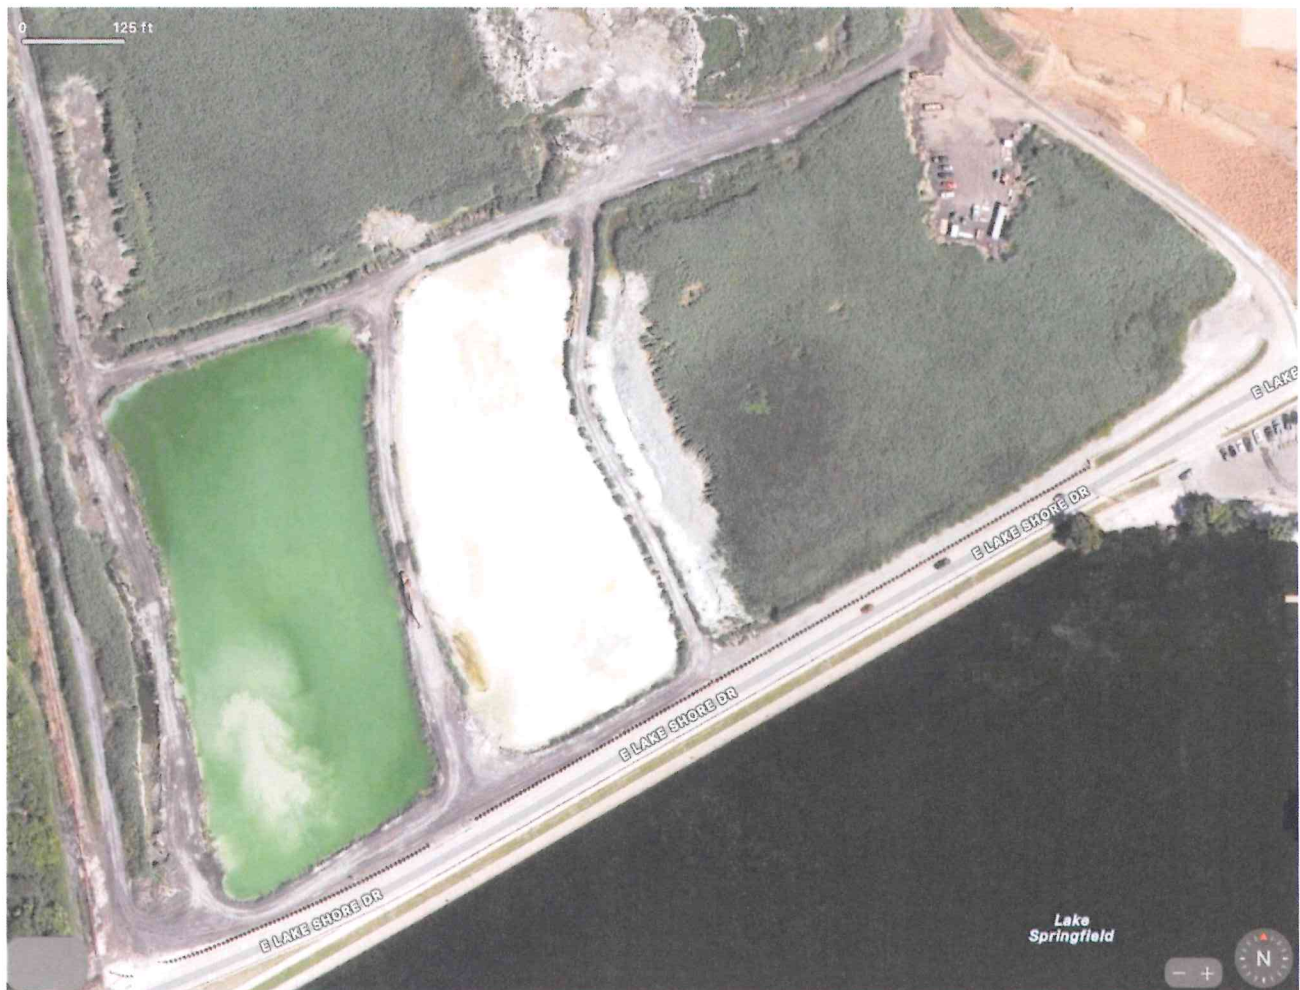
Berms – Lime Softening Ponds

- ☐ Sudden drop in impoundment level
- ☐ Actual or potential structural weakness
- ☐ Improper operation of overtopping control
- ☐ Visible release
- ☒ No observed problems
