**City Water, Light and Power  
Coal Combustion Residuals Units  
40 CFR 257 and 35 IAC 845  
Weekly Inspection Form**

Date: 3-18-26 Time: 9:45 AM Inspector(s) / Position: JIM KETCHUM

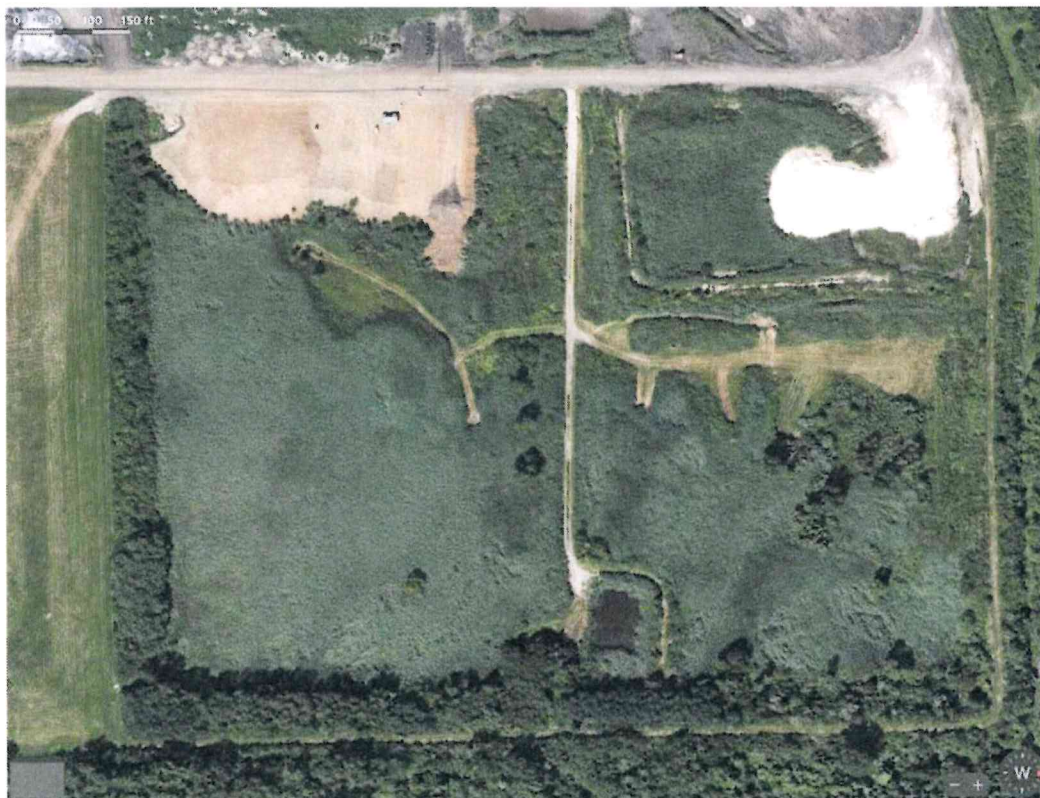
**Berms – Landfill Unit 2:**

| <input type="checkbox"/> Failed/eroded vegetation >100sq ft. | <input checked="" type="checkbox"/> No observed problems |

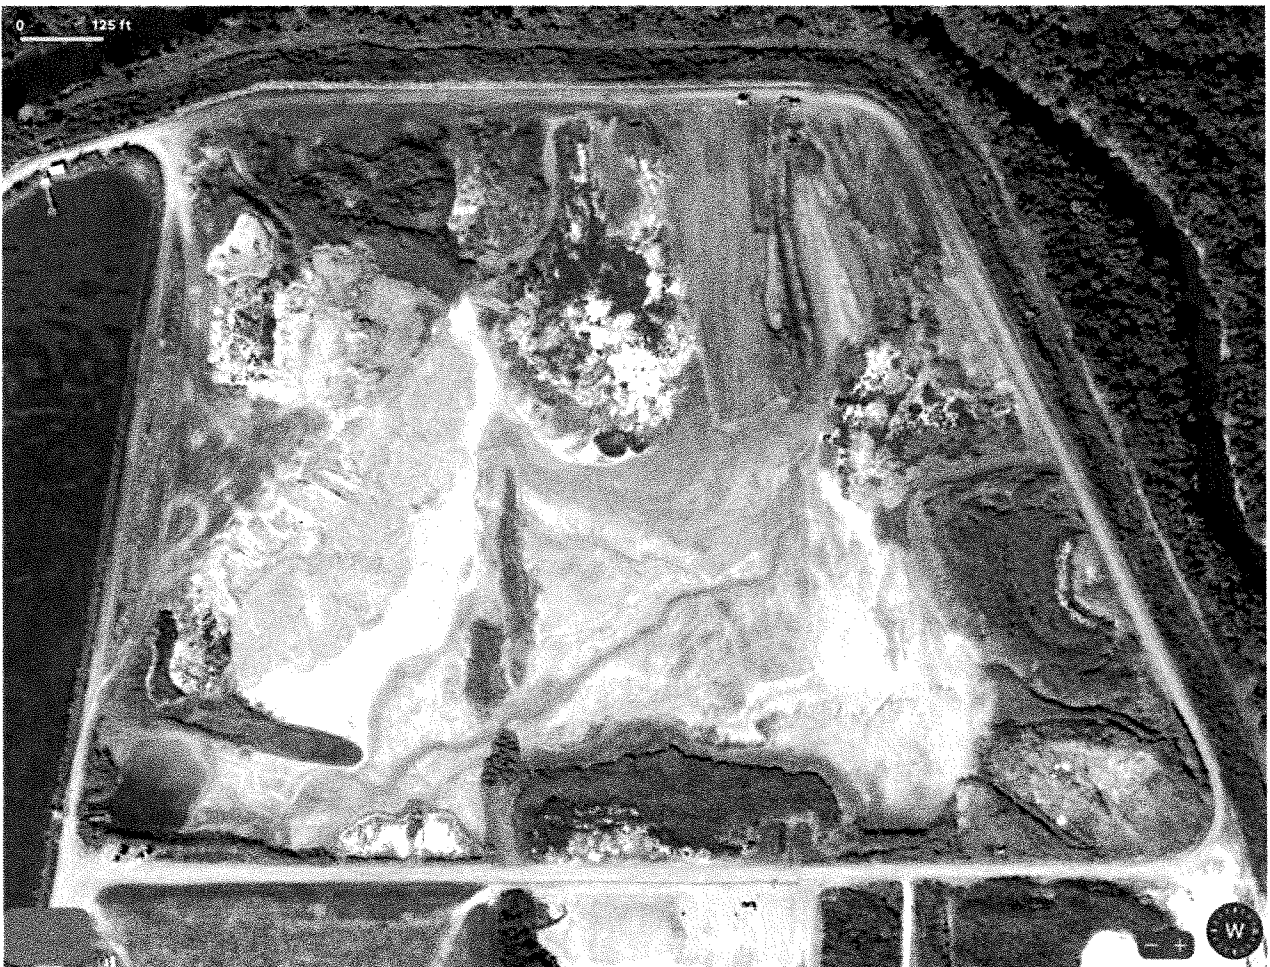
**Berms – Dallman Ash Pond**

| <input type="checkbox"/> Failed/eroded vegetation >100sq ft. | <input checked="" type="checkbox"/> No observed problems |

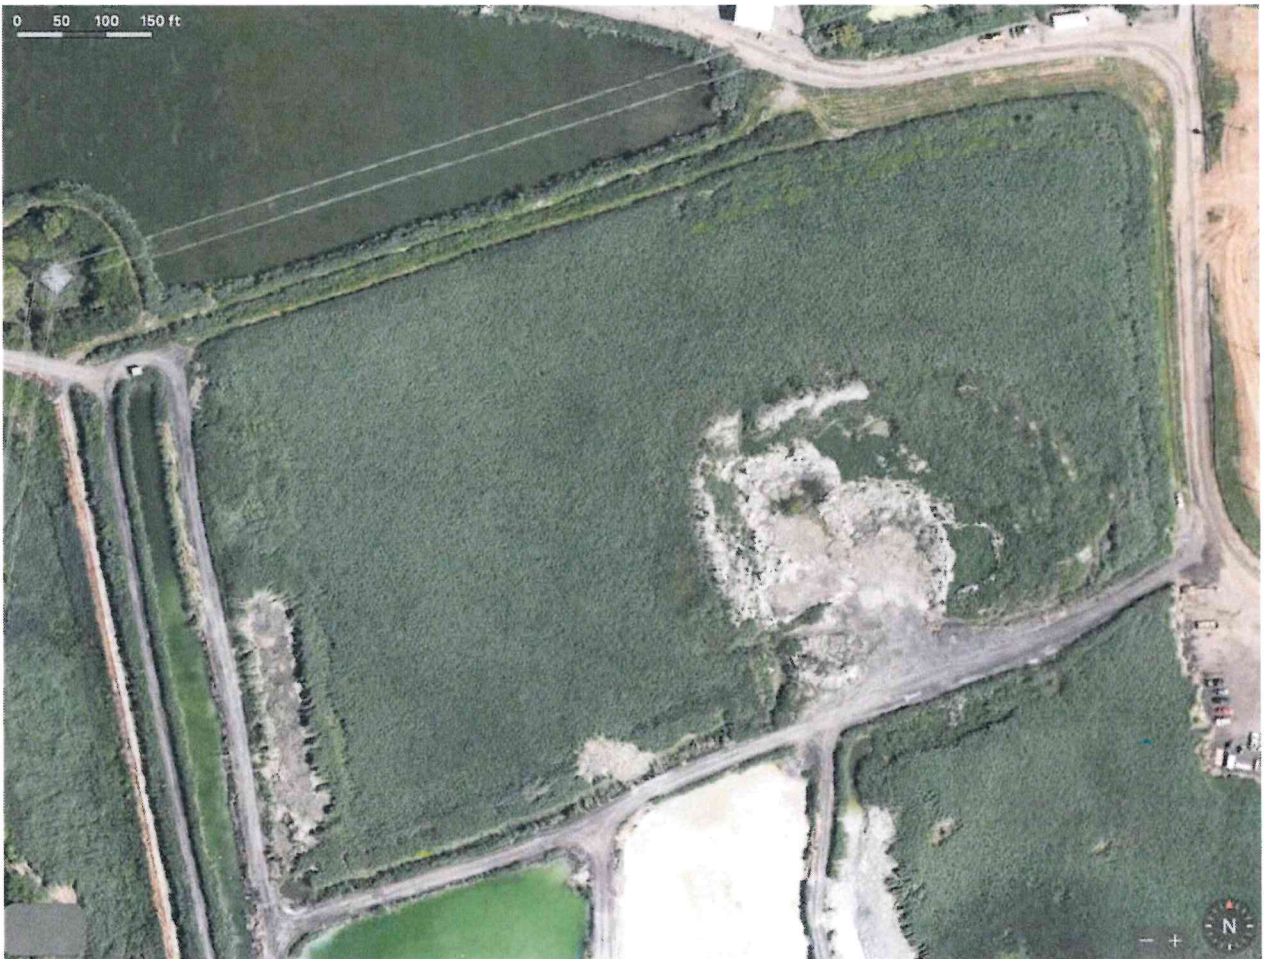
**Berms – Lakeside Ash Pond**

| <input type="checkbox"/> Failed/eroded vegetation >100sq ft. | <input checked="" type="checkbox"/> No observed problems |
