**City Water, Light and Power  
Coal Combustion Residuals Units  
40 CFR 257 and 35 IAC 845  
Weekly Inspection Form**

Date: 4/1/26 Time: 12:40 Inspector(s) / Position: Schy Willmore

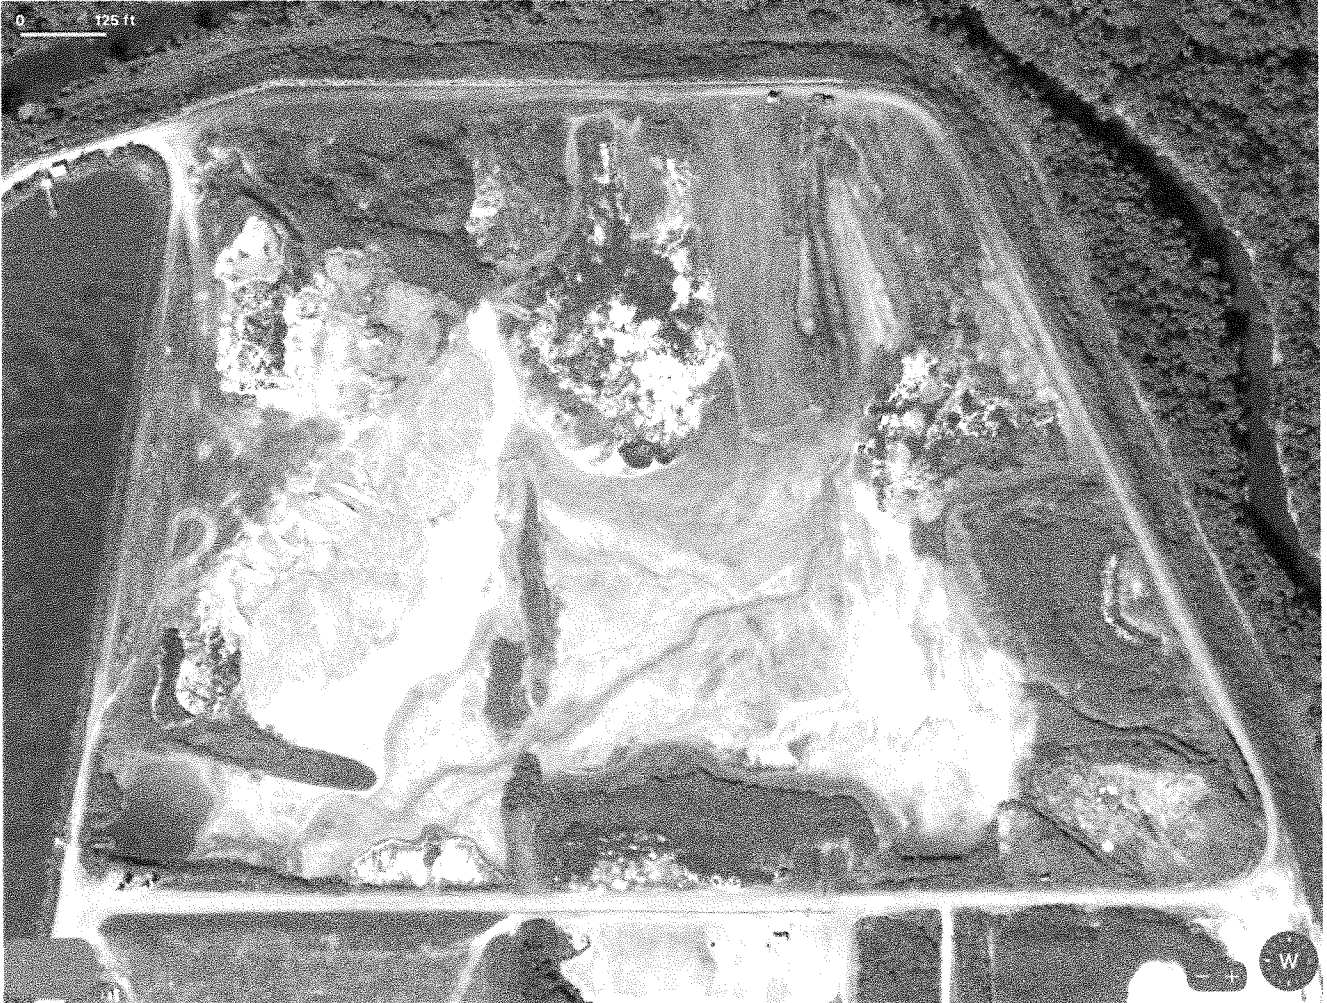
**Berms – Dallman Ash Pond**

| <input type="checkbox"/> Failed/eroded vegetation >100sq ft. | <input checked="" type="checkbox"/> No observed problems |

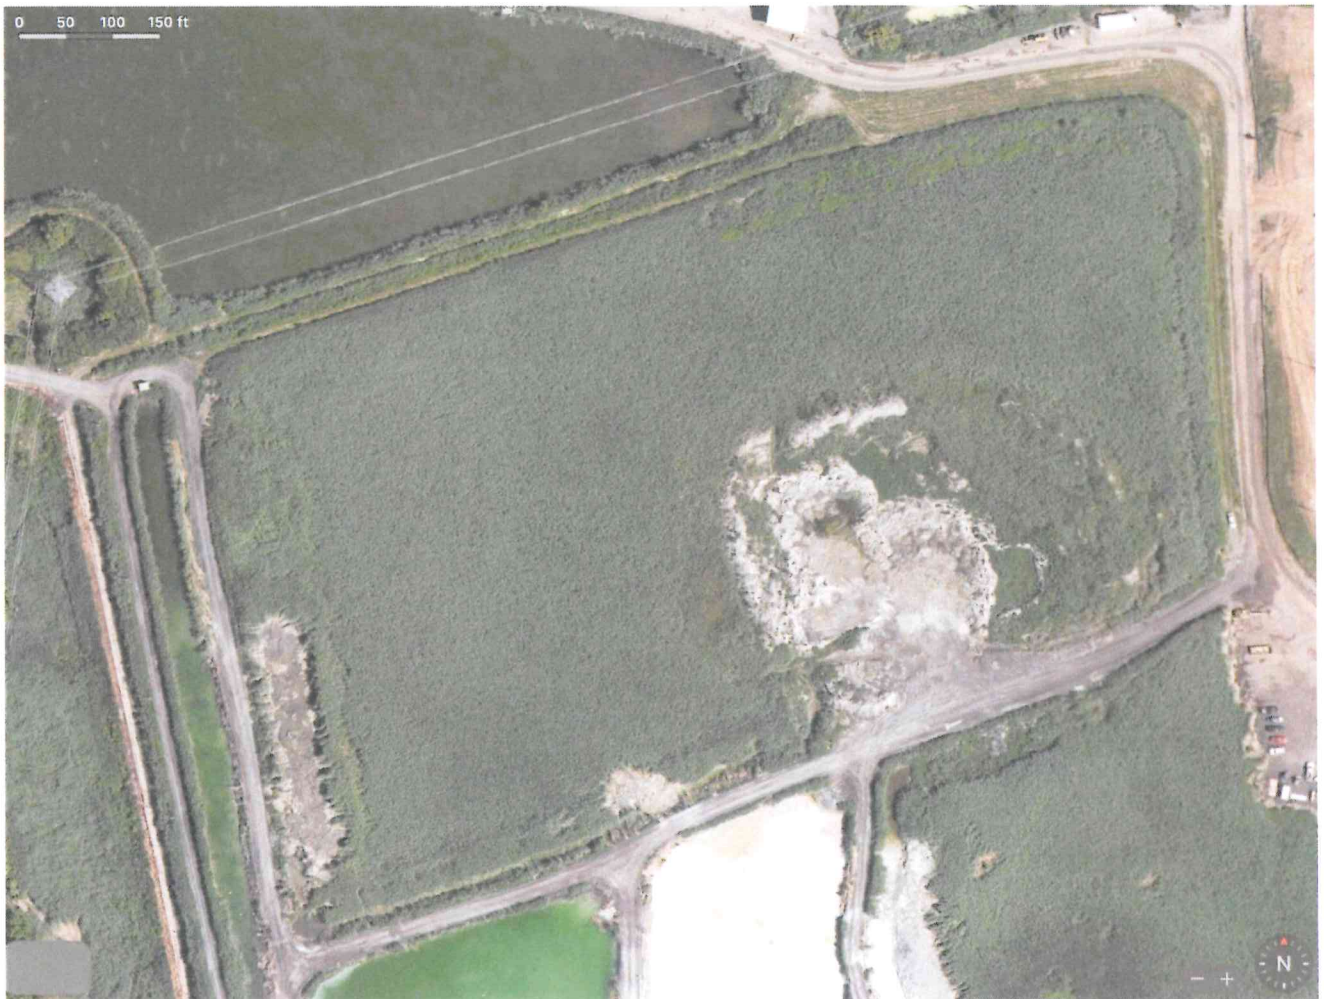
**Berms – Lakeside Ash Pond**

| <input type="checkbox"/> Failed/eroded vegetation >100sq ft. | <input checked="" type="checkbox"/> No observed problems |
