**City Water, Light and Power
Coal Combustion Residuals Units
40 CFR 257 and 35 IAC 845
Weekly Inspection Form**

Date: 6-5-26 Time: 8:30 Inspector(s) / Position: Stalaj

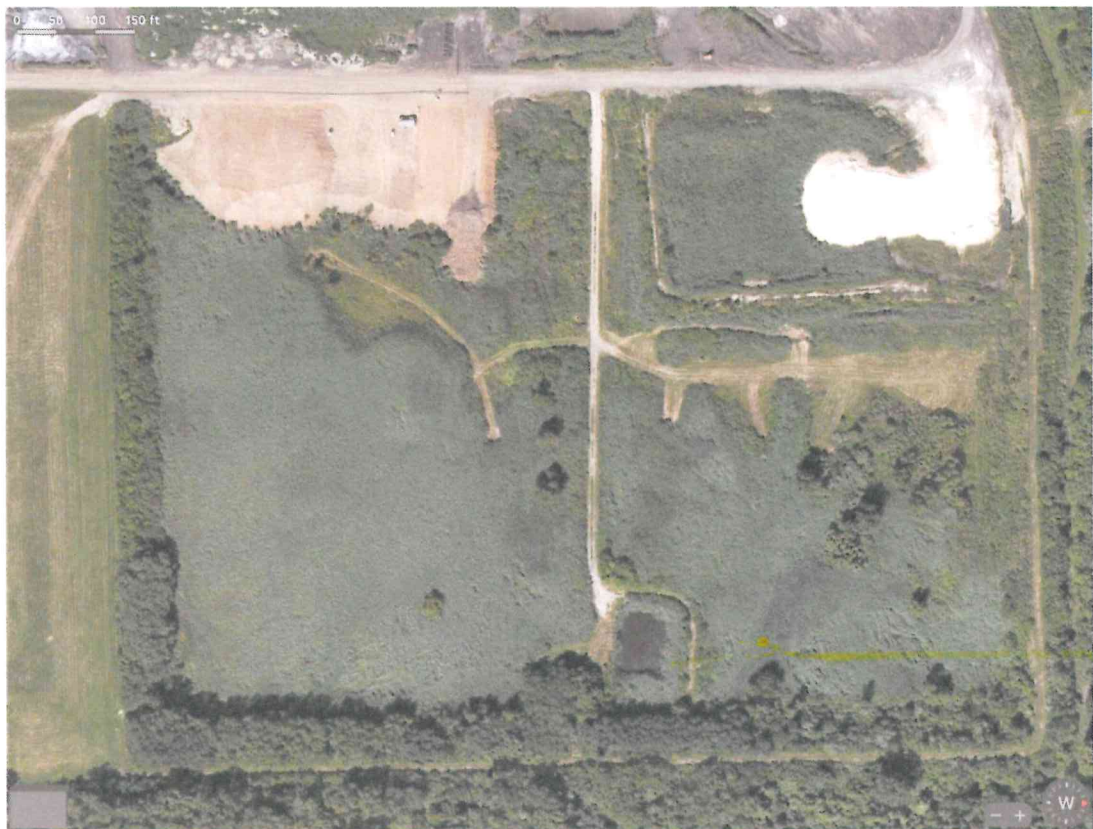
Berms – Landfill Unit 2:

| <input type="checkbox"/> Failed/eroded vegetation >100sq ft. | <input checked="" type="checkbox"/> No observed problems |

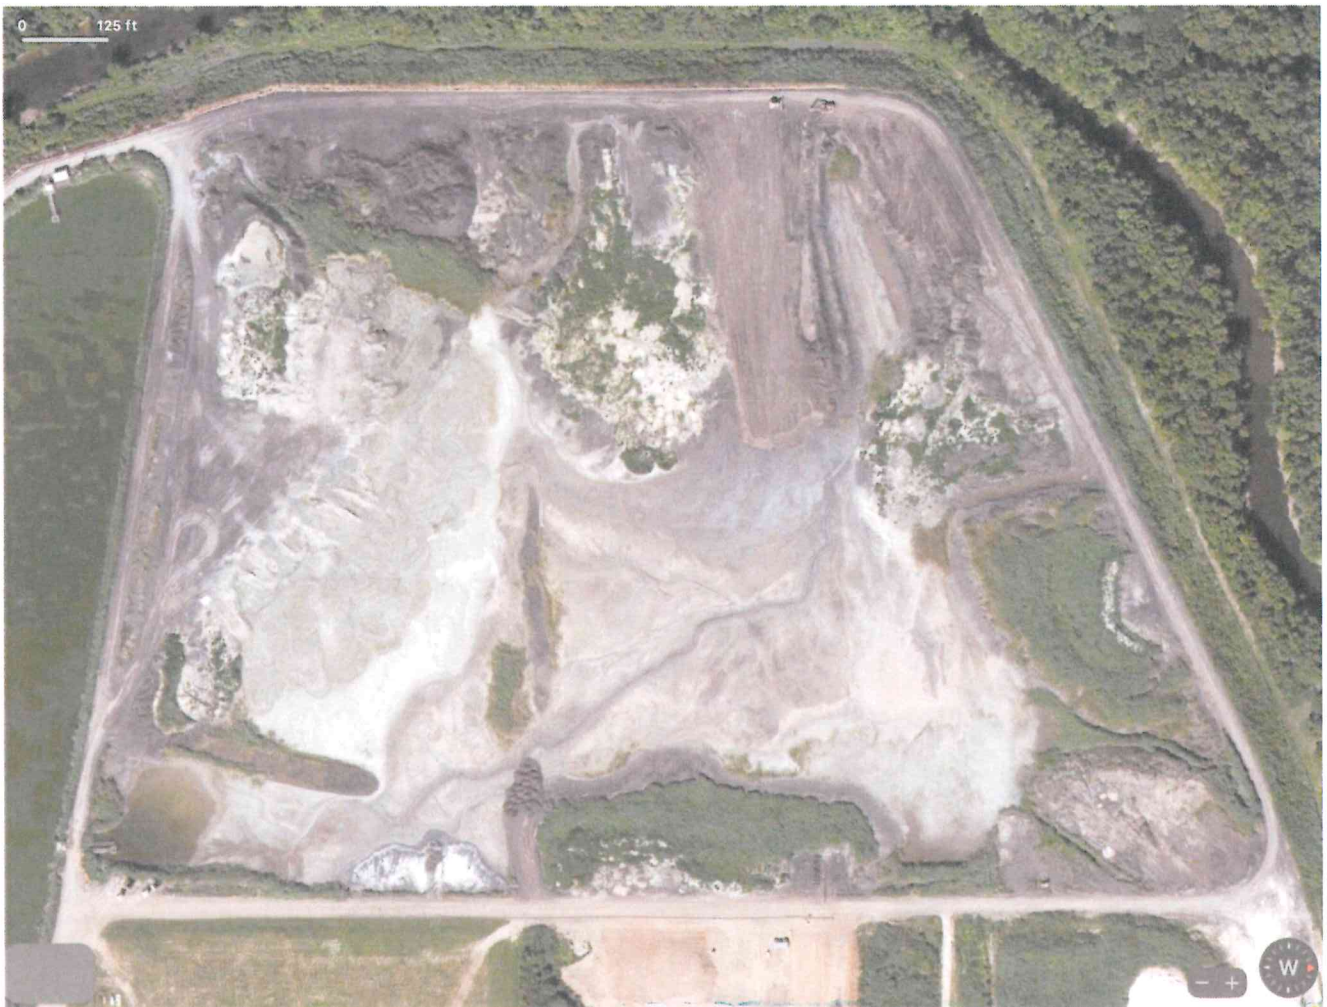
Berms – Dallman Ash Pond

| <input type="checkbox"/> Failed/eroded vegetation >100sq ft. | <input checked="" type="checkbox"/> No observed problems |

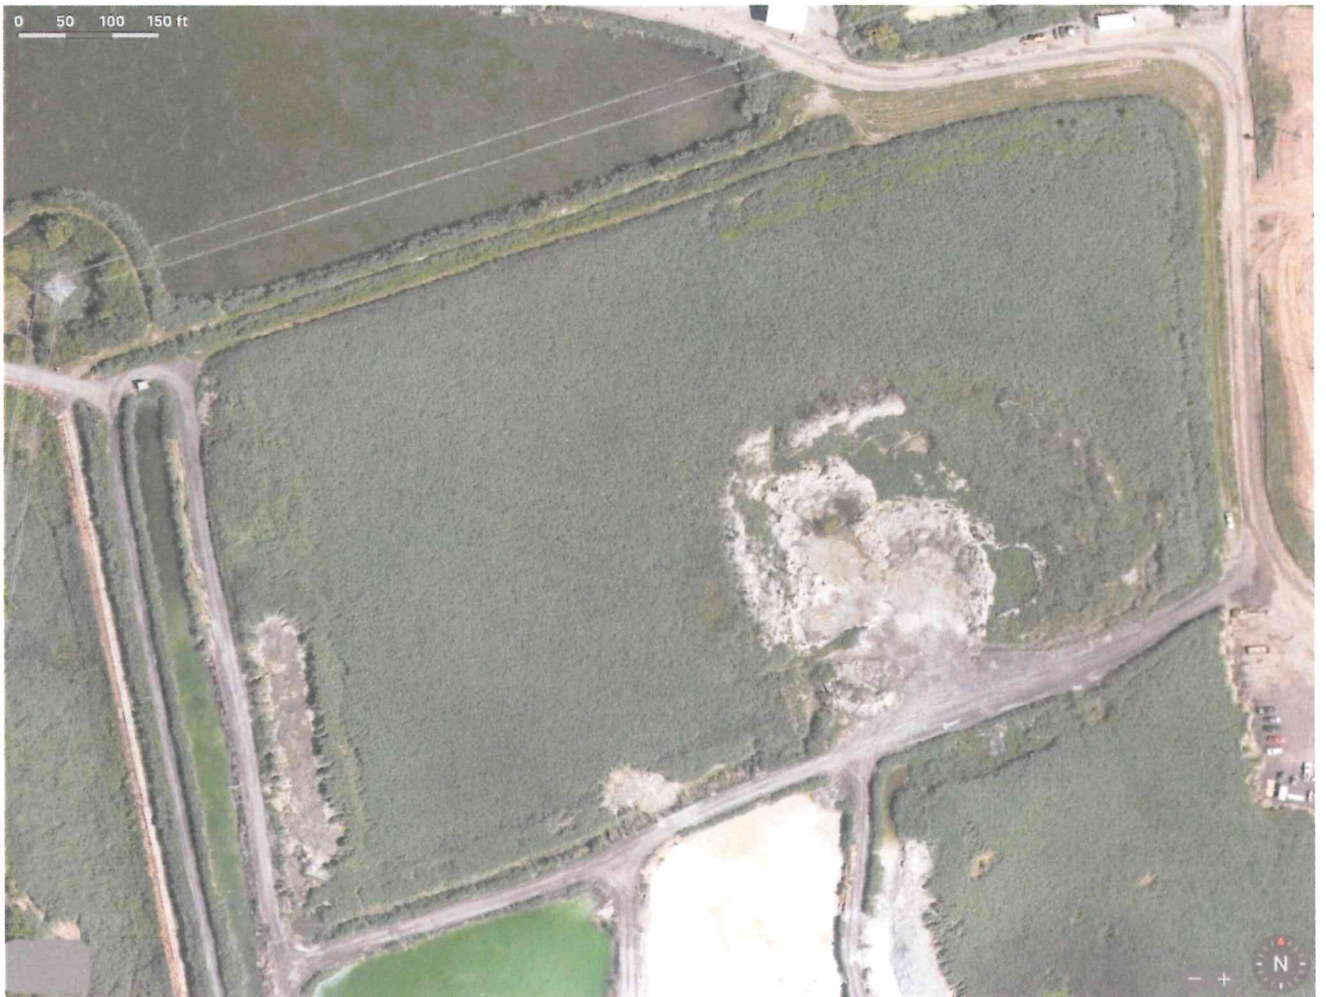
Berms – Lakeside Ash Pond

| <input type="checkbox"/> Failed/eroded vegetation >100sq ft. | <input checked="" type="checkbox"/> No observed problems |

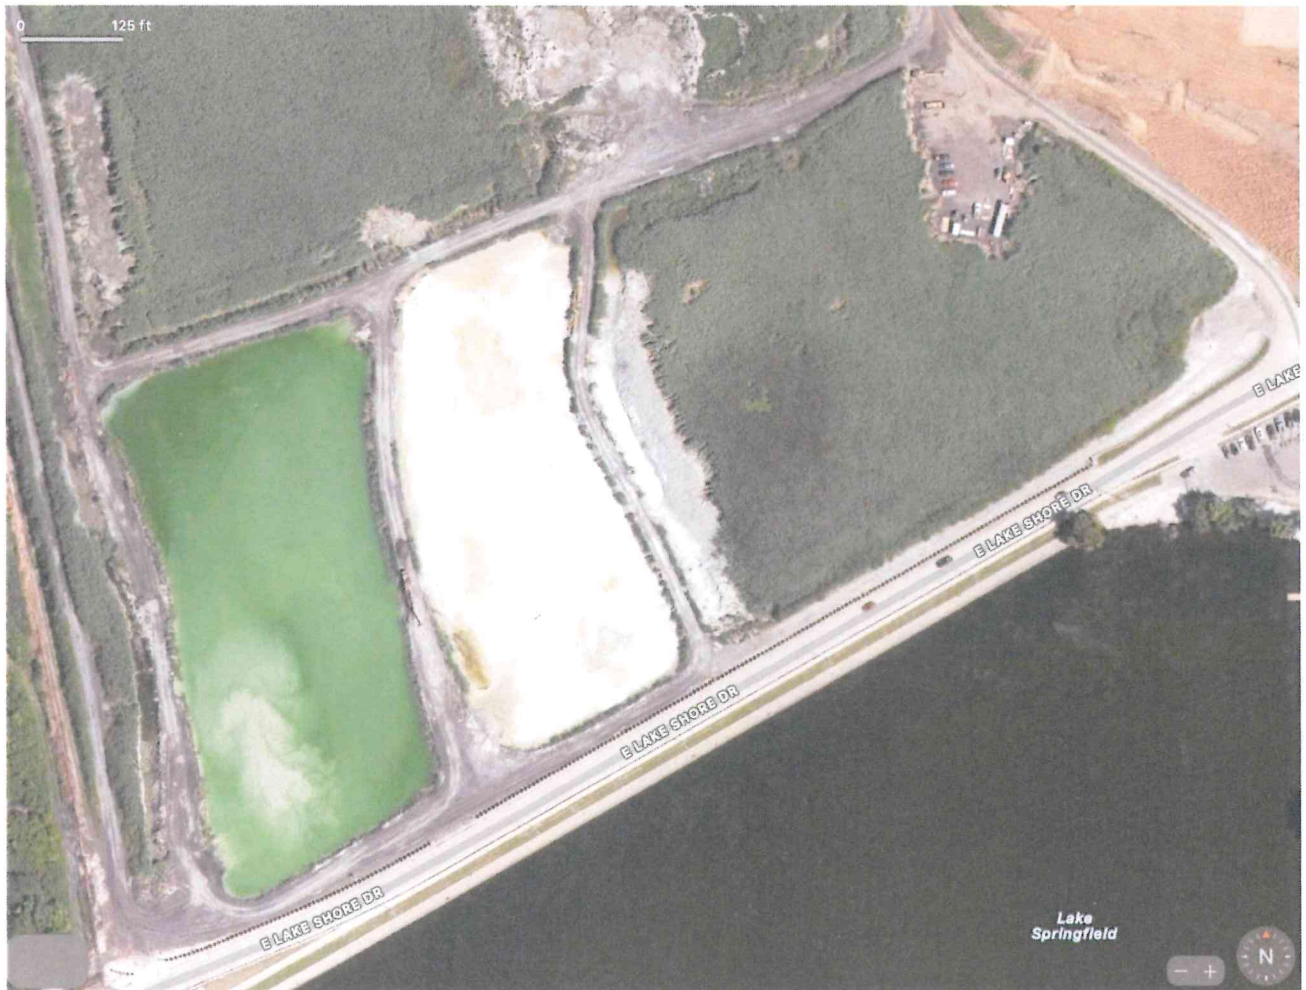
Berms – Lime Softening Ponds

| <input type="checkbox"/> Failed/eroded vegetation >100sq ft. | <input checked="" type="checkbox"/> No observed problems |
