City Water, Light, and Power  
Coal Combustion Residual Units

35 IAC 845 Weekly Inspection Form

Date 7-21-21 Time 8:45

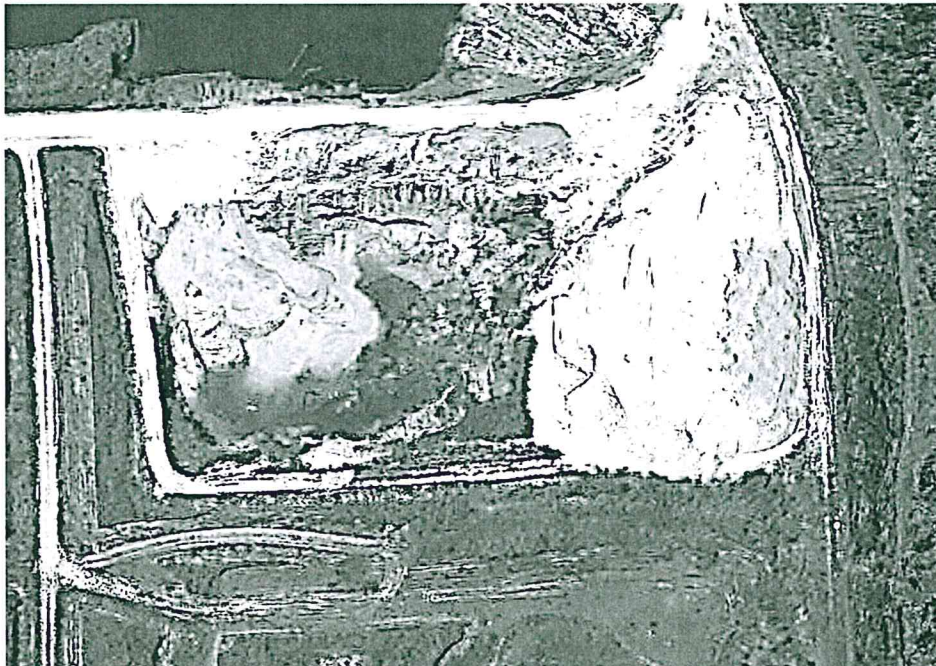
Berms – Landfill Unit 2:

☒ No observed problems

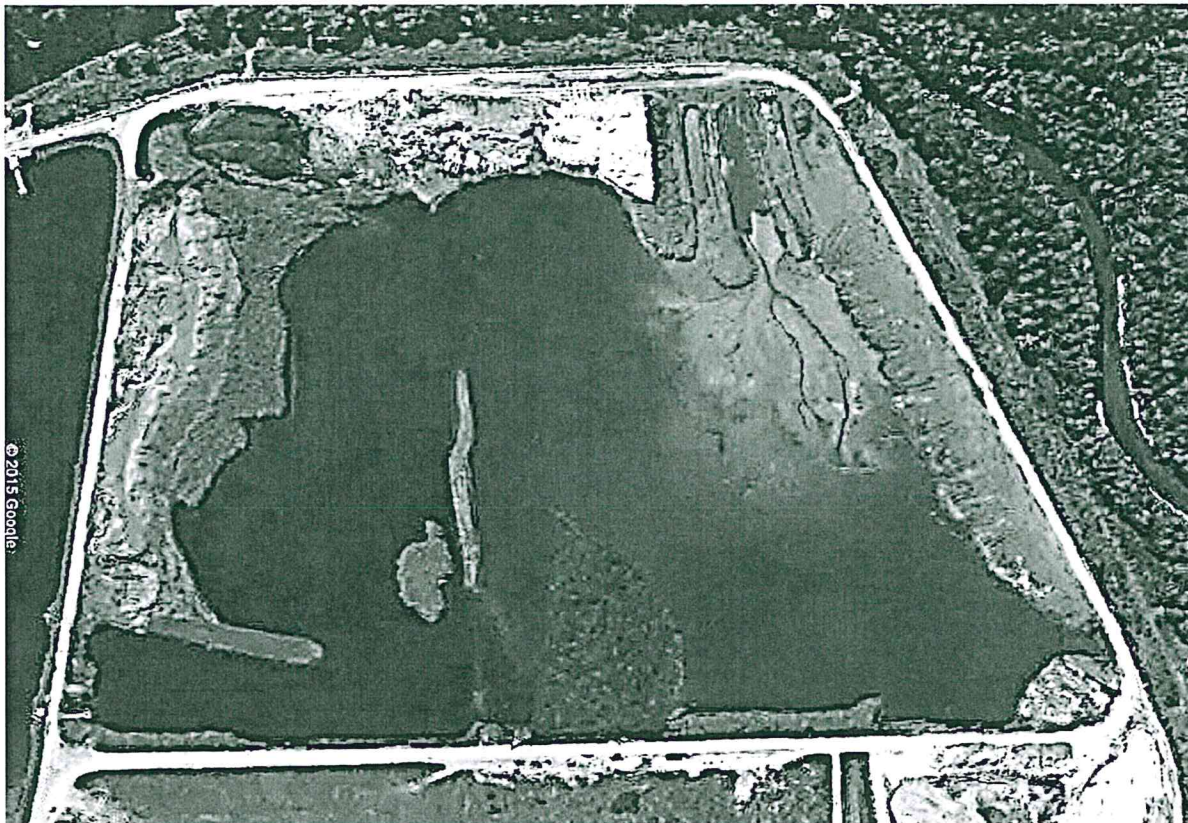
**Berms – Dallman Ash Pond**

☒ No observed problems

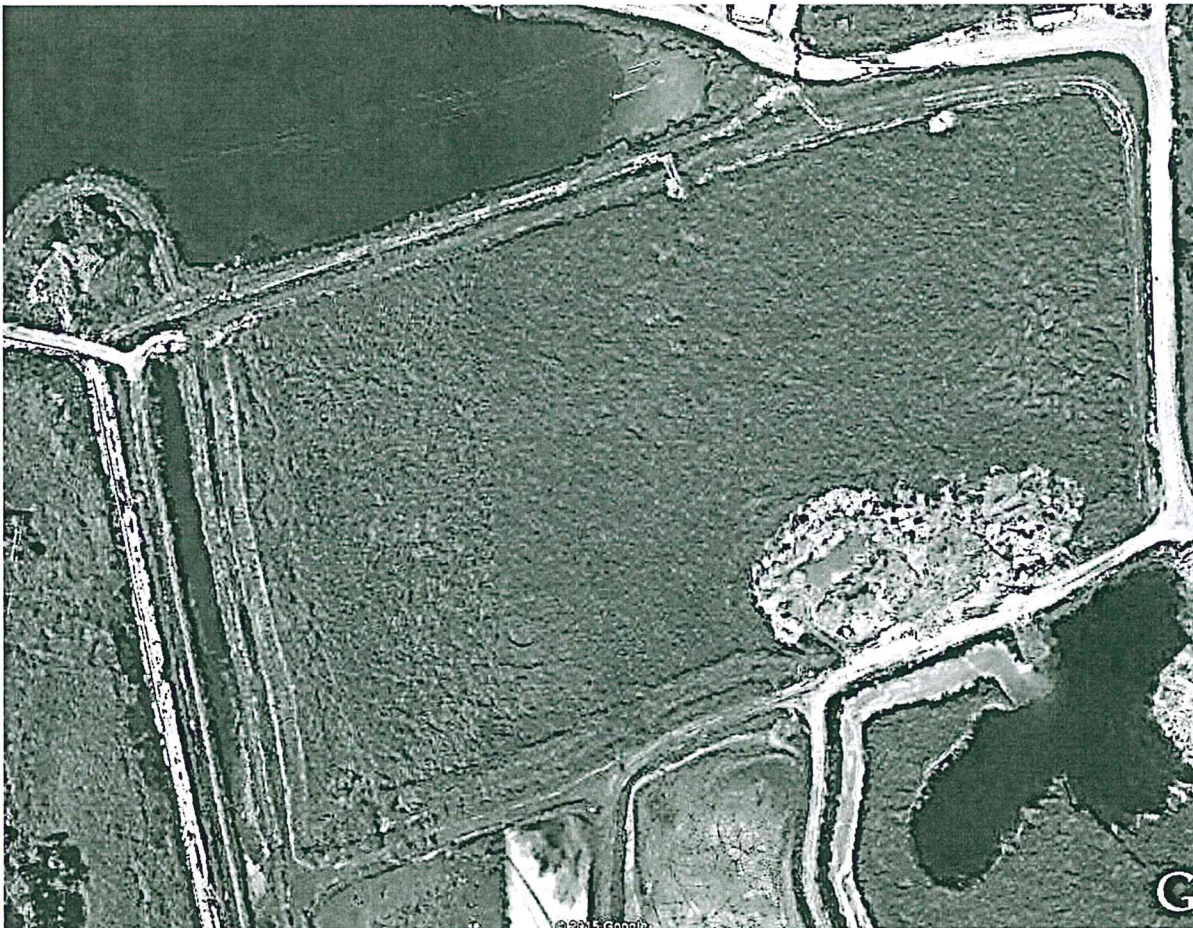
**Berms – Lakeside Ash Pond**

☒ No observed problems

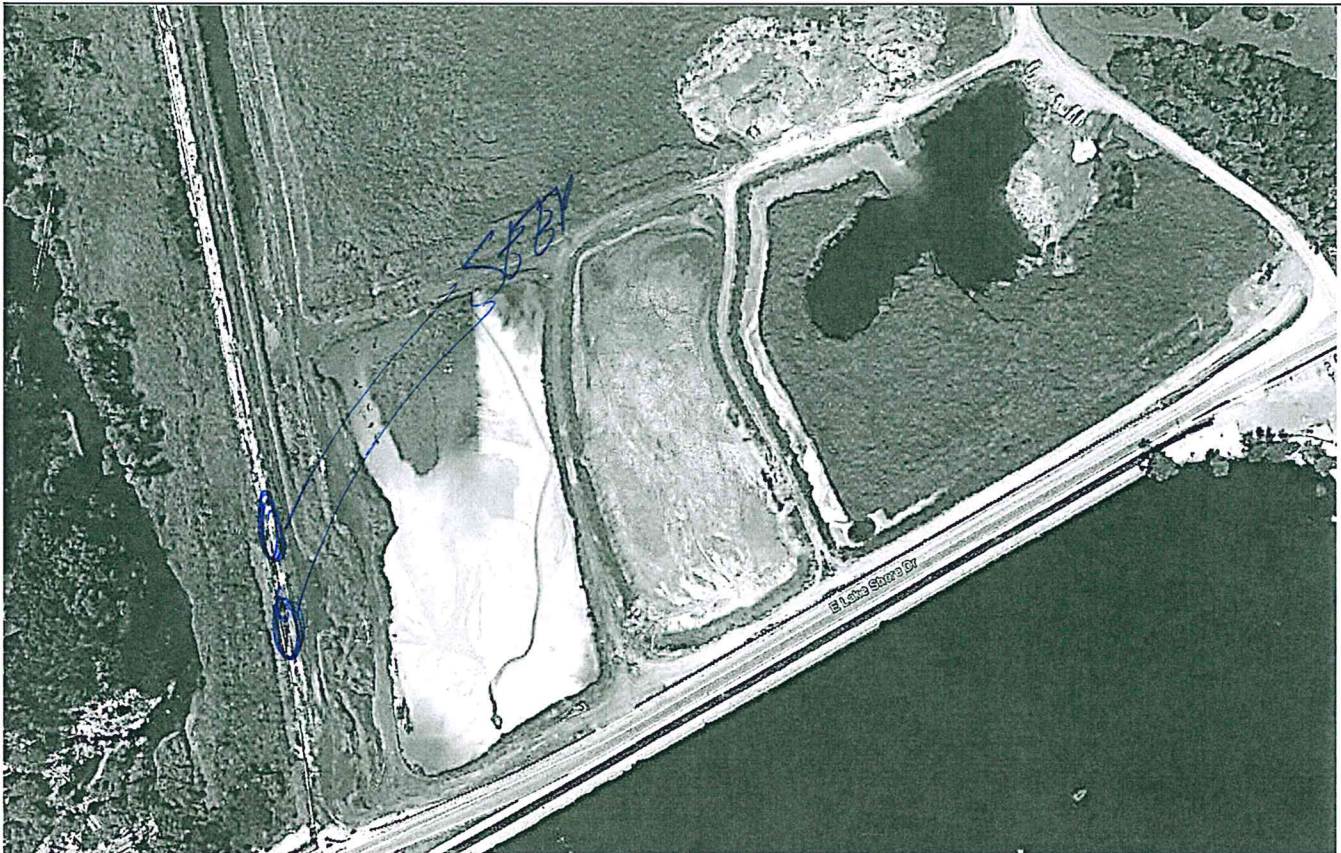
**Berms – Lime Softening Ponds**

☒ Seeps / Damp Areas

*2 Seeps along West edge. Reporting to sump area*
