**City Water, Light and Power**  
**Coal Combustion Residuals Units**  
**40 CFR 257 and 35 IAC 845**  
**Weekly Inspection Form**

Date: 7-8-26 Time: 9:00 Inspector(s) / Position: Staley

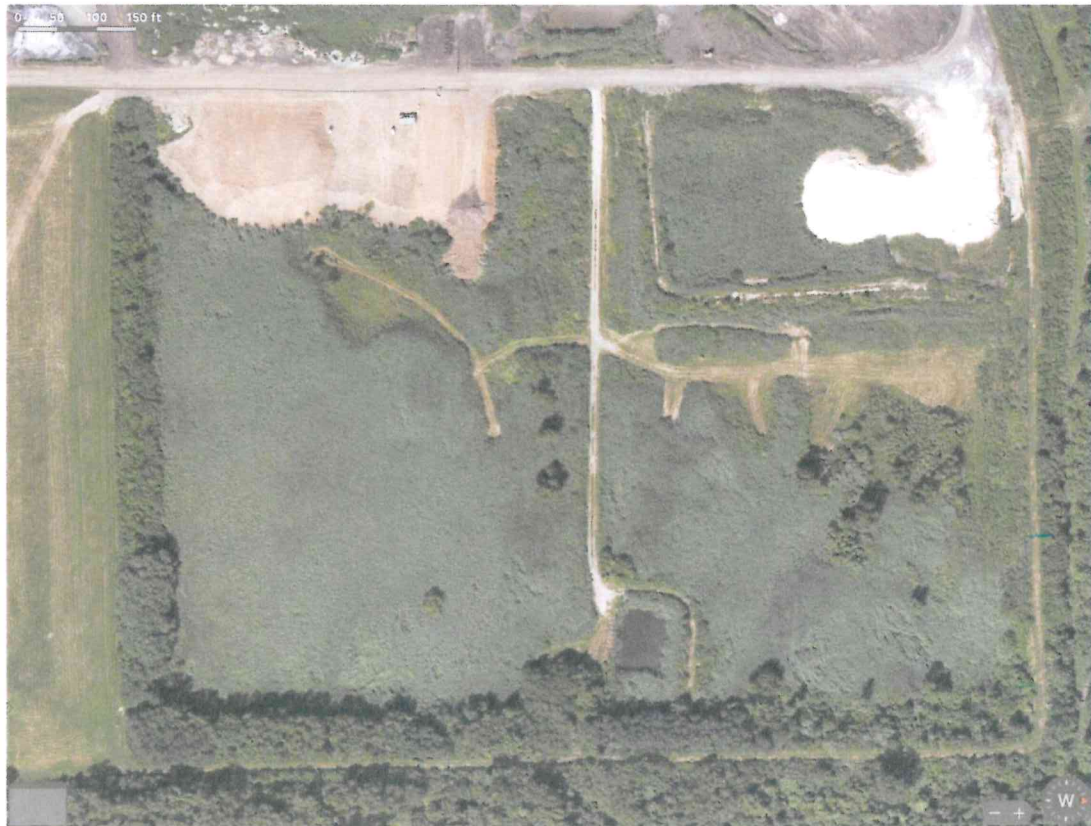
**Berms – Landfill Unit 2:**

- ☐ Sudden drop in impoundment level  
☐ Actual or potential structural weakness  
☐ Improper operation of overtopping control  
☐ Visible release  
☒ No observed problems

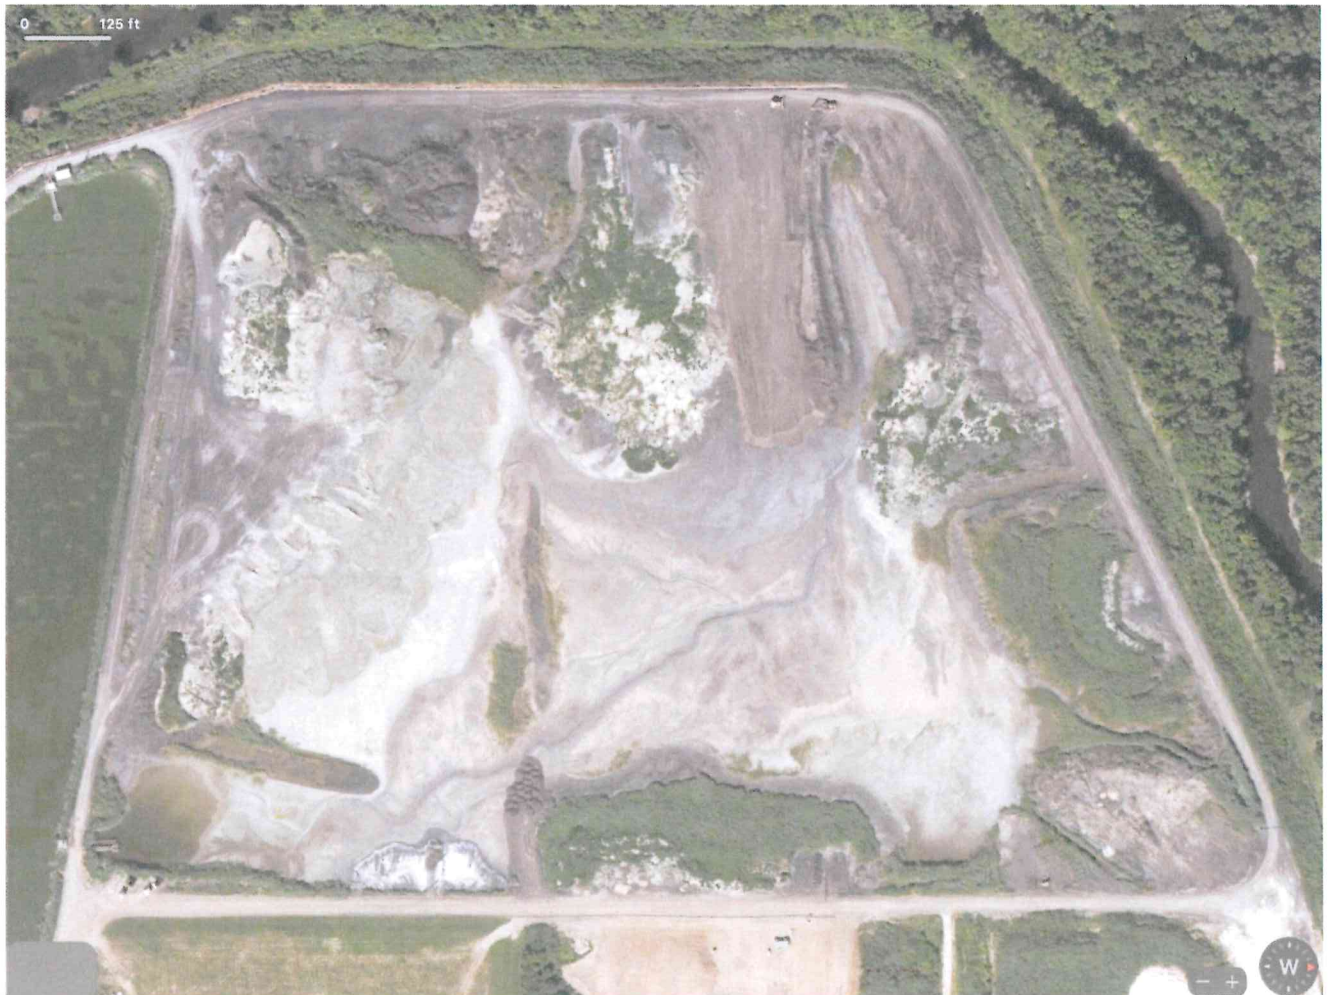
**Berms – Dallman Ash Pond**

- ☐ Sudden drop in impoundment level
- ☐ Actual or potential structural weakness
- ☐ Improper operation of overtopping control
- ☐ Visible release
- ☒ No observed problems

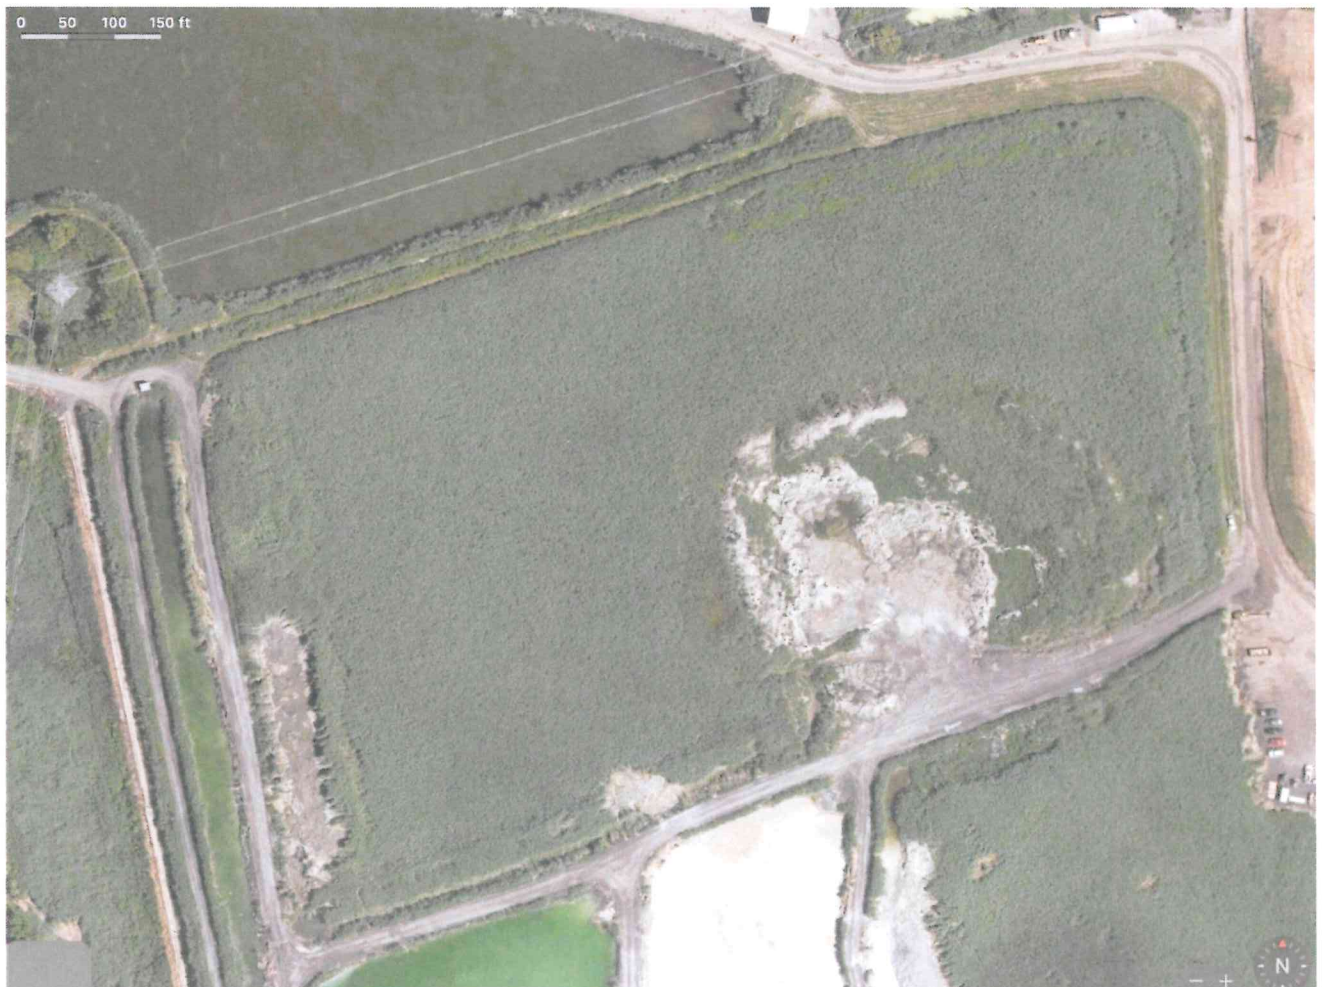
**Berms – Lakeside Ash Pond**

- ☐ Sudden drop in impoundment level
- ☐ Actual or potential structural weakness
- ☐ Improper operation of overtopping control
- ☐ Visible release
- ☒ No observed problems

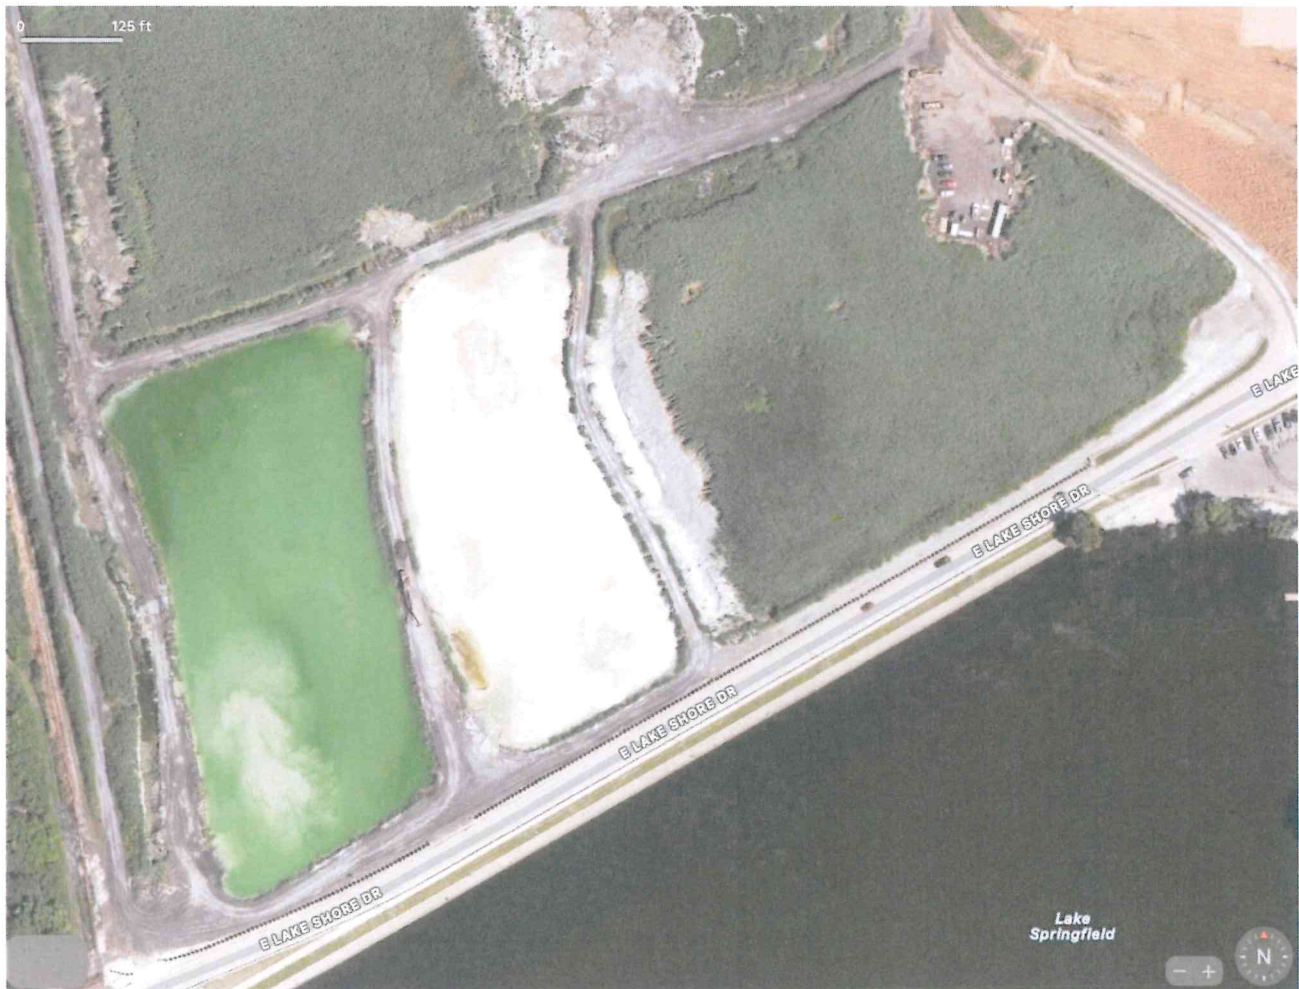
**Berms – Lime Softening Ponds**

- ☐ Sudden drop in impoundment level
- ☐ Actual or potential structural weakness
- ☐ Improper operation of overtopping control
- ☐ Visible release
- ☒ No observed problems
