City Water, Light and Power  
Coal Combustion Residuals Units  
40 CFR 257 and 35 IAC 845  
Weekly Inspection Form

Date: 8/26/26 Time: 9:37 Inspector(s) / Position: Scy Willmore

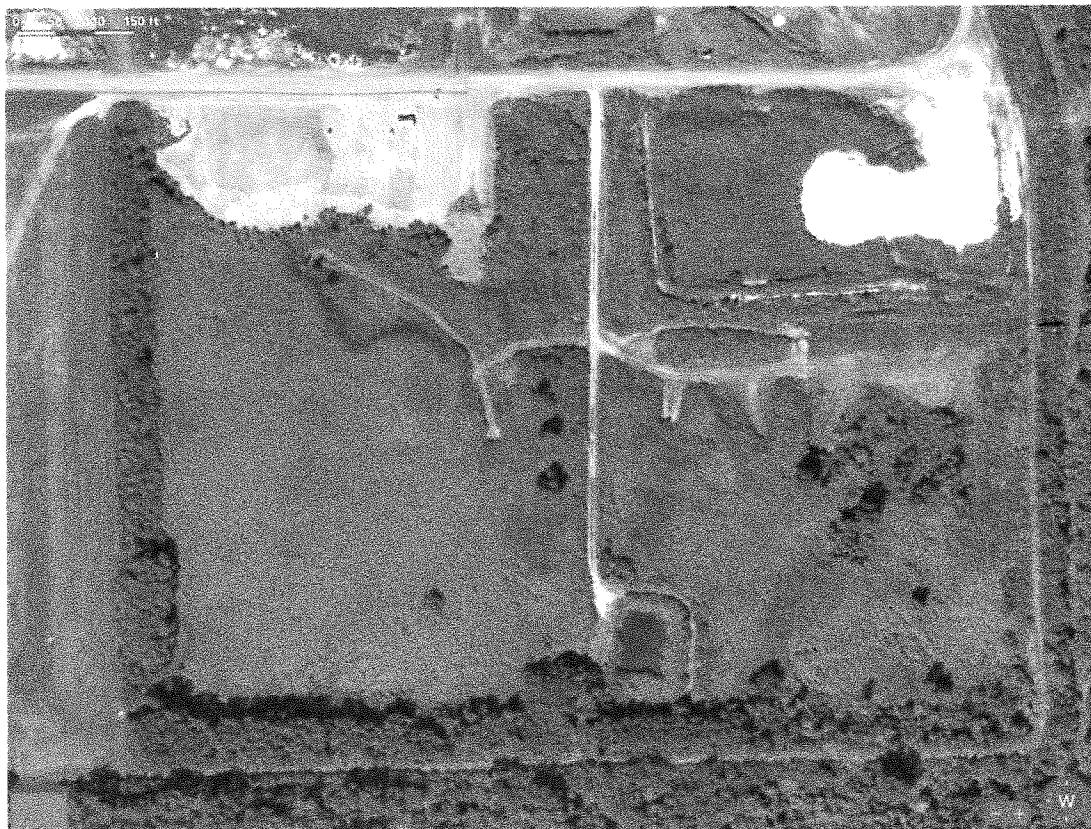
**Berms – Landfill Unit 2:**

- ☐ Sudden drop in impoundment level  
☐ Actual or potential structural weakness  
☐ Improper operation of overtopping control  
☐ Visible release  
☒ No observed problems

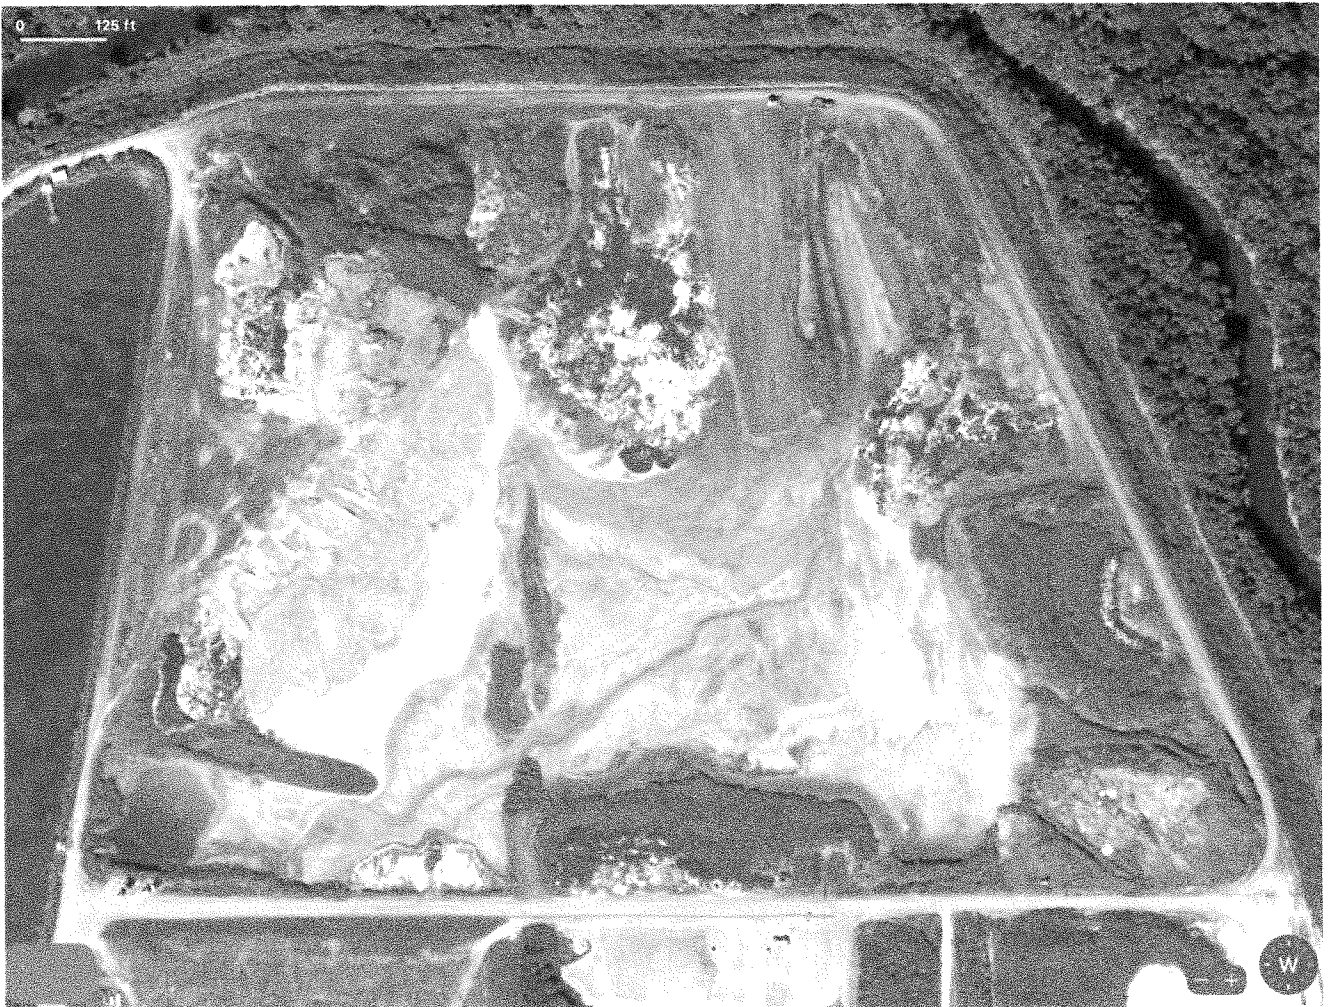
**Berms – Dallman Ash Pond**

☒ No observed problems

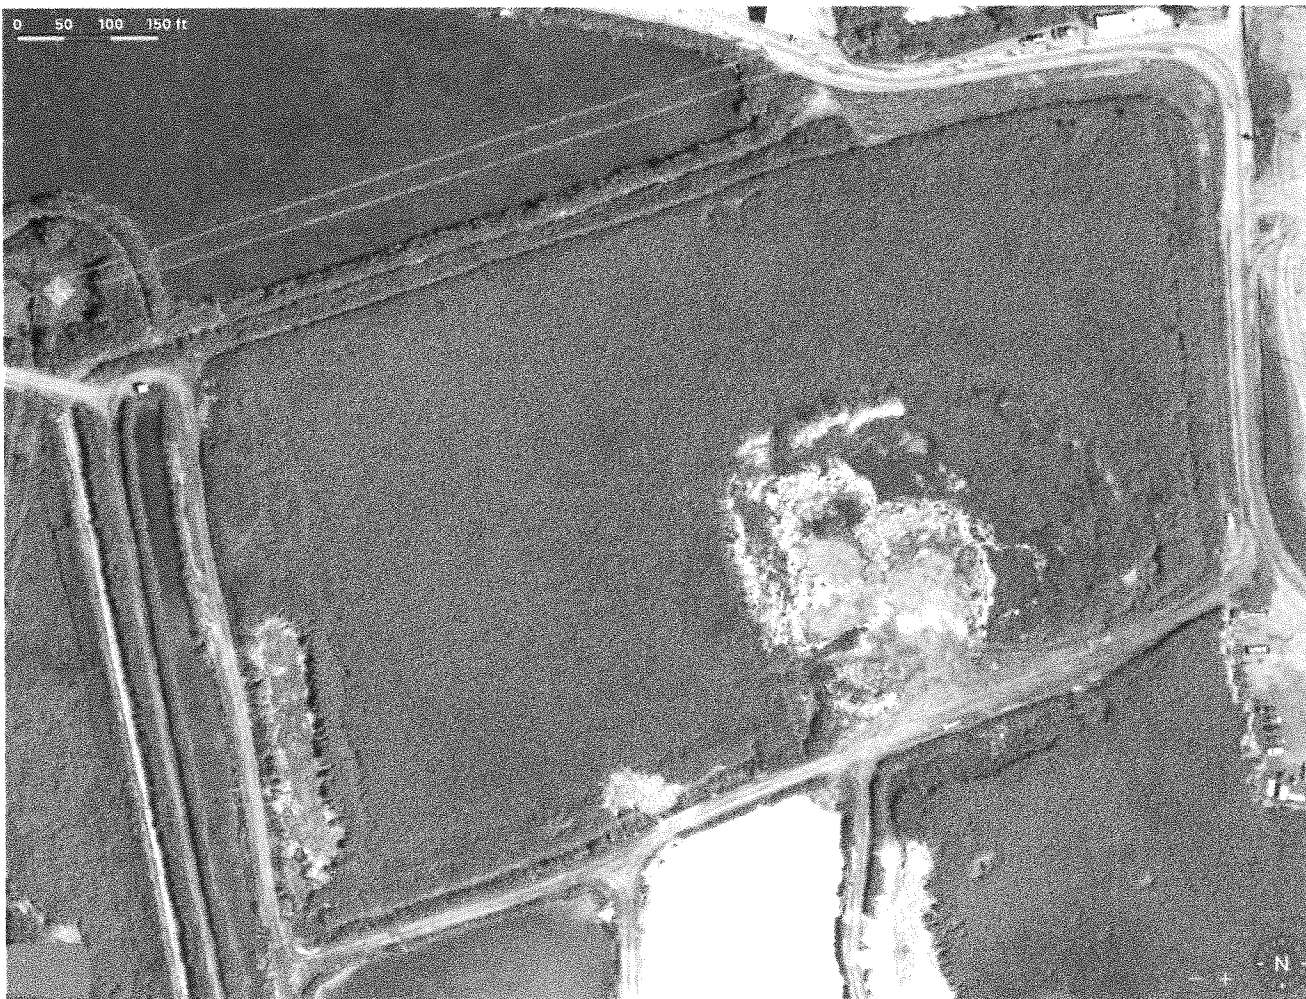
**Berms – Lakeside Ash Pond**

☒ No observed problems

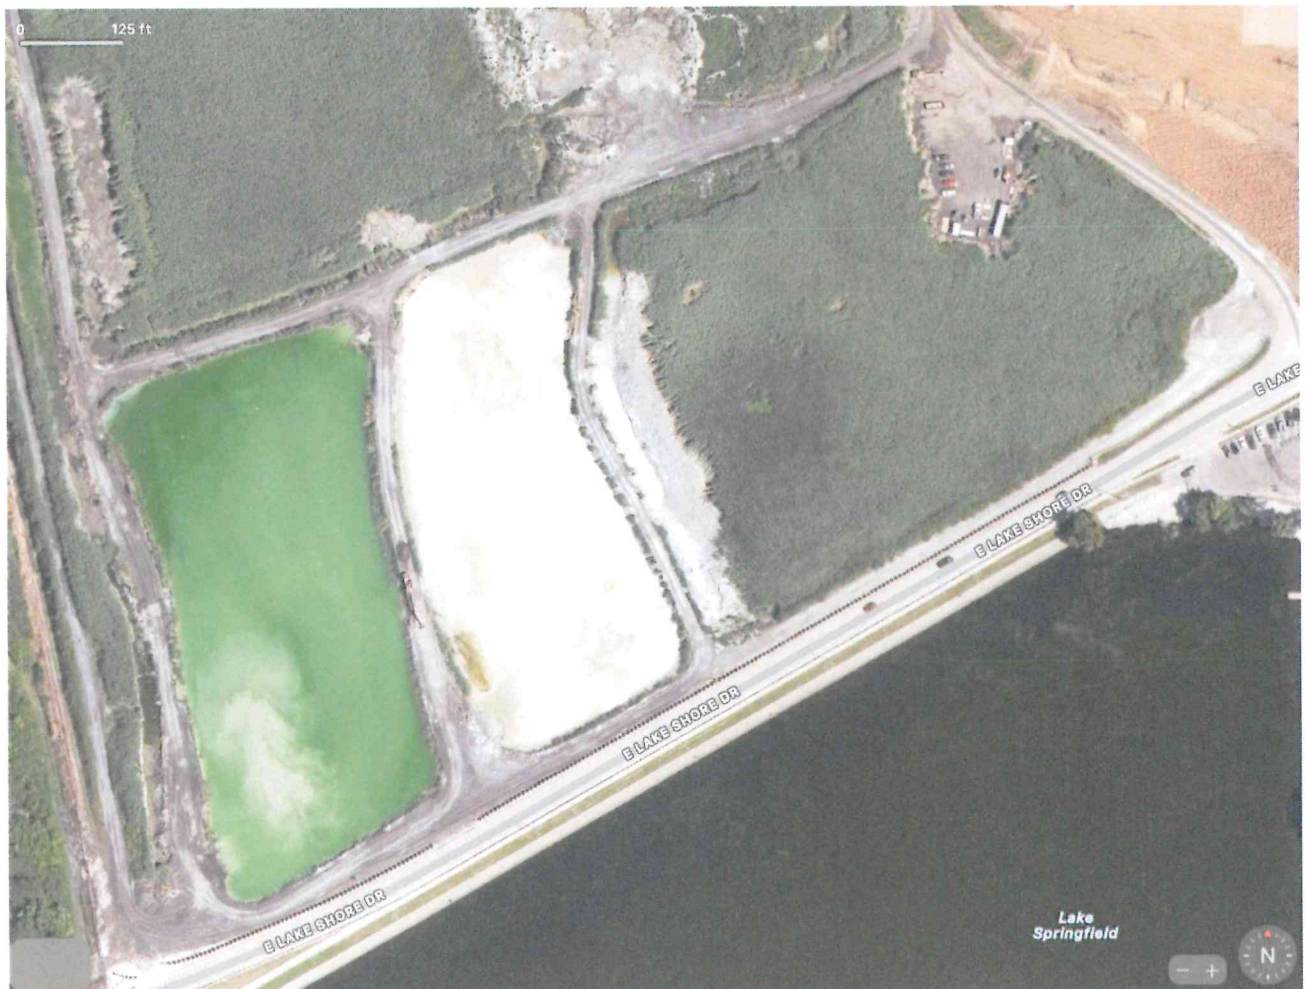
**Berms – Lime Softening Ponds**

☒ No observed problems
