City Water, Light and Power  
Coal Combustion Residuals Units  
40 CFR 257 and 35 IAC 845  
Weekly Inspection Form

Date: 9/16/26 Time: 9:00 Inspector(s) / Position: Schy Willmore

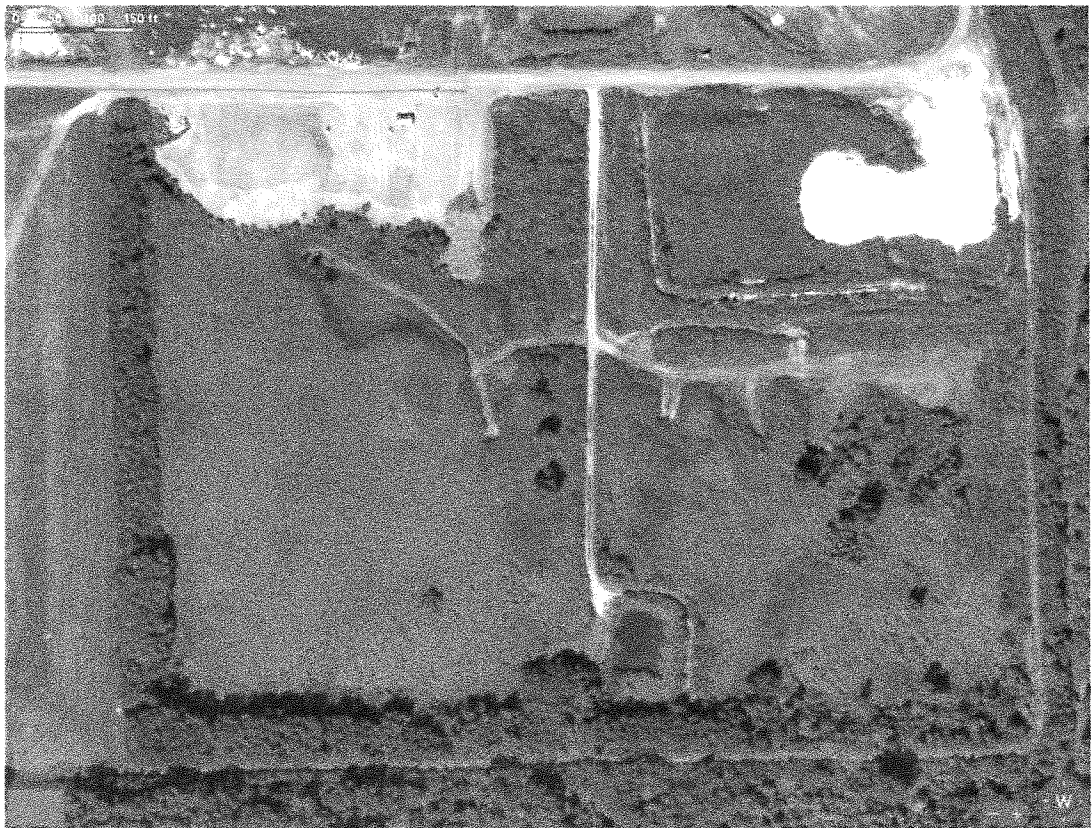
**Berms – Landfill Unit 2:**

- ☐ Sudden drop in impoundment level  
☐ Actual or potential structural weakness  
☐ Improper operation of overtopping control  
☐ Visible release  
☒ No observed problems

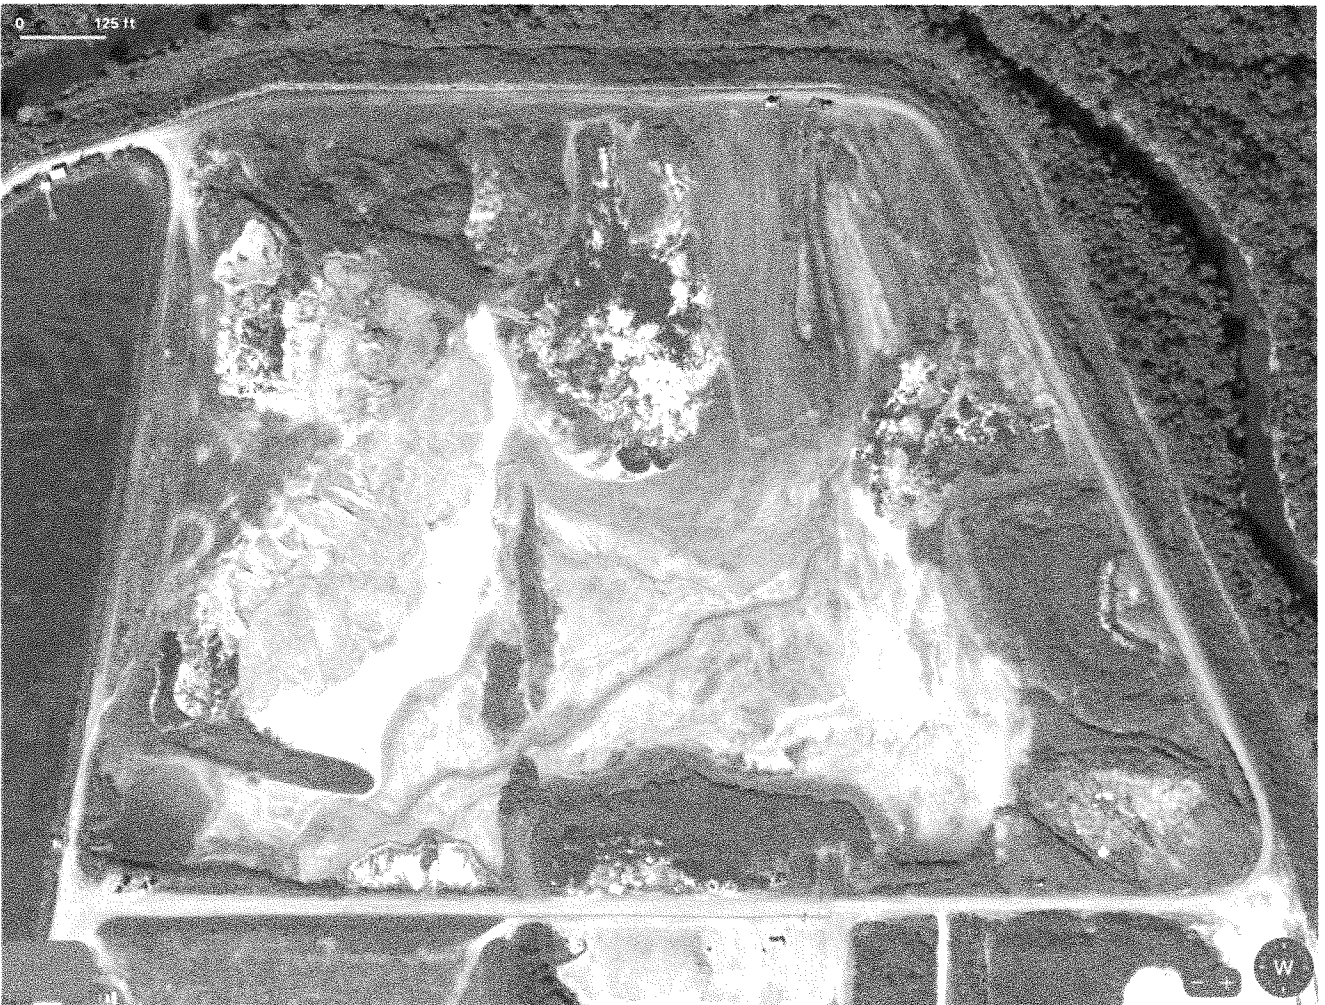
**Berms – Dallman Ash Pond**

- ☐ Sudden drop in impoundment level  
☐ Actual or potential structural weakness  
☐ Improper operation of overtopping control  
☐ Visible release  
☒ No observed problems

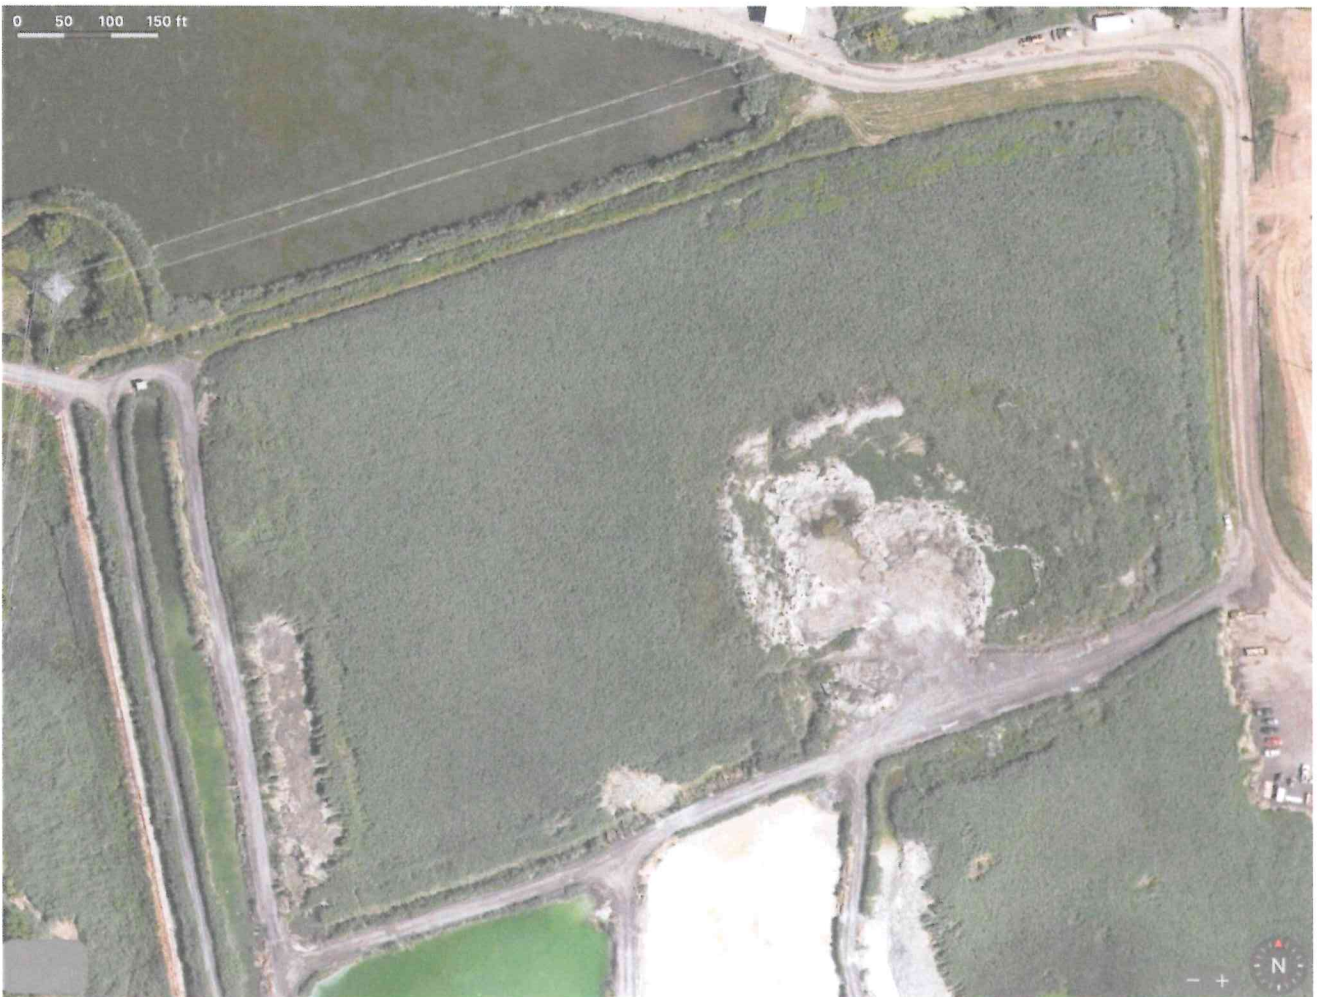
**Berms – Lakeside Ash Pond**

☒ No observed problems

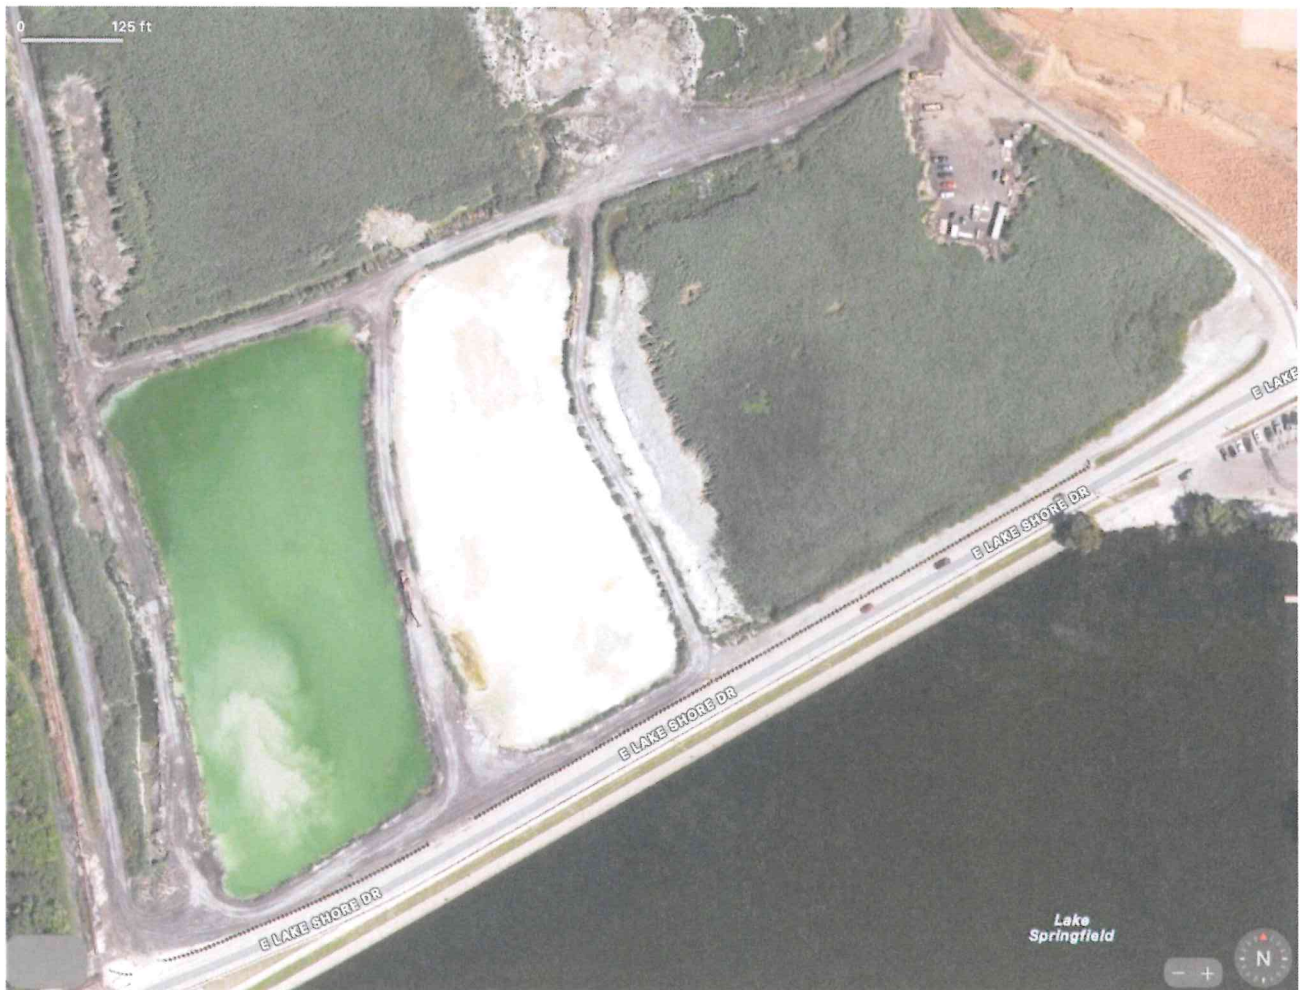
**Berms – Lime Softening Ponds**

☒ No observed problems
