Annual Inspection Report for Coal Combustion
Residuals Surface Impoundments

City Water, Light & Power
Ash Impoundments
Springfield, Sangamon County, Illinois

January 2025

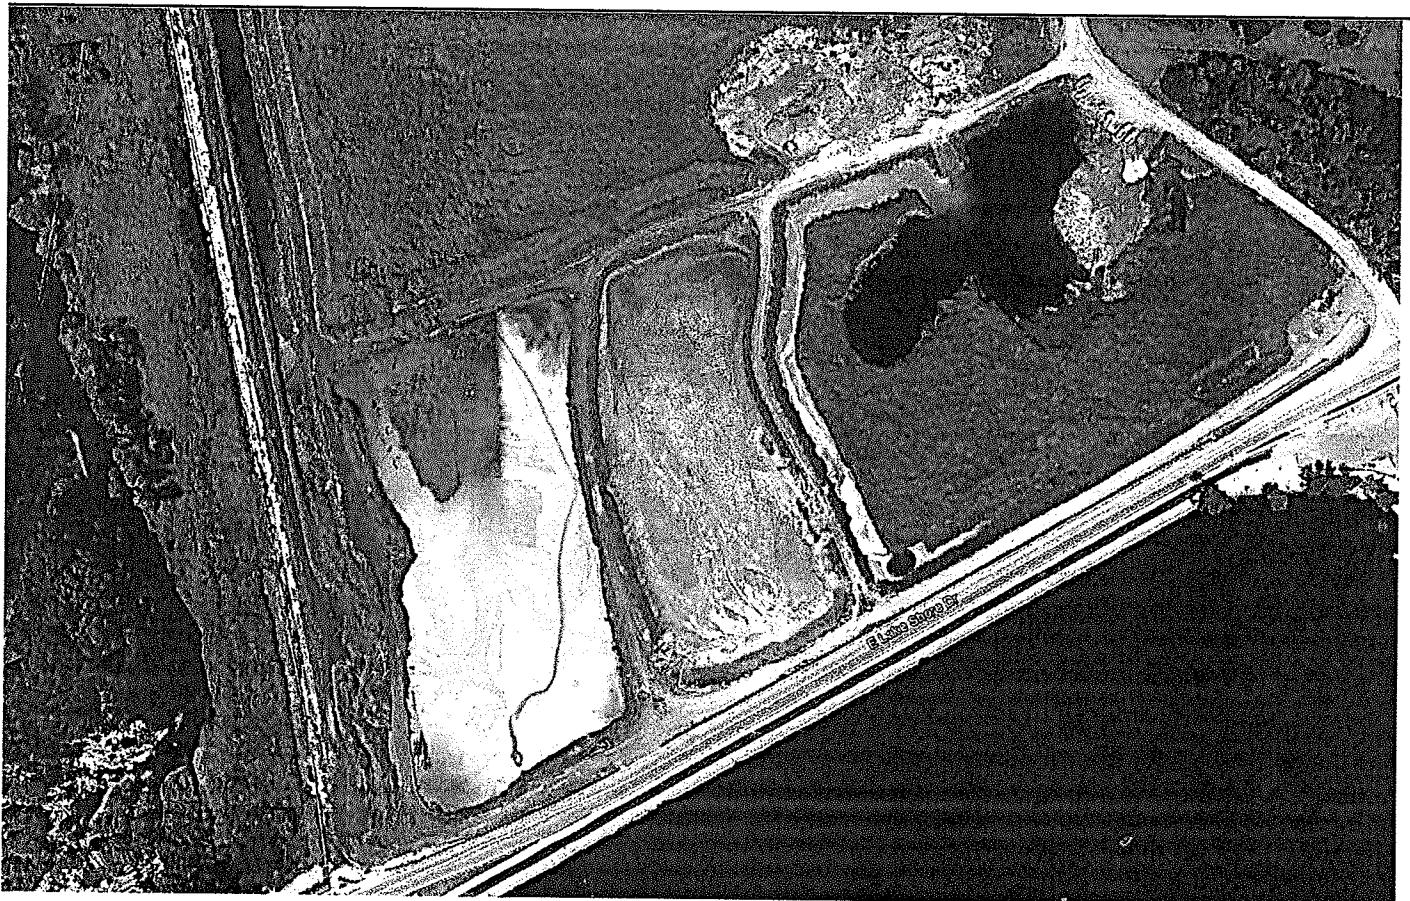
Description of Repair: Seepage occurs after spring rains. The seepage is contained in a ditch at the toe of the berm. The water then reports to the Clarification Pond. There were five or six rain events that caused seepage.

Description of Repair: Animal dens are completely filled with clay and compacted. There were approximately five instances/locations.
