Date: 4-16-25 Time: 7:45 AM Inspector(s) / Position: Jim KETCHUM				
Site Conditions:				
Sky: Sunny Ground Moisture: DRY Temperature: 41°F Precipitation: NONE				
Berms – Landfill Unit 2:				
Conditions Limiting Visibility:				
□ Snow Cover □ Other				
∀ Vegetation  □ None				
Observations:				
□ Erosion / Gullies □ Sudden drop in impoundment level				
□ Cracking / Sloughing □ Actual or potential structural weakness				
□ Seeps / Damp Areas □ Improper operation of overtopping control				
□ Signs of Creep □ Visible release				
□ Failed/eroded vegetation >100sq ft. No observed problems				
Describe findings. Identify locations on attached map. Attach additional pages if necessary.

### Berms - Dallman Ash Pond

### Berms - Lakeside Ash Pond

### Berms - Lime Softening Ponds

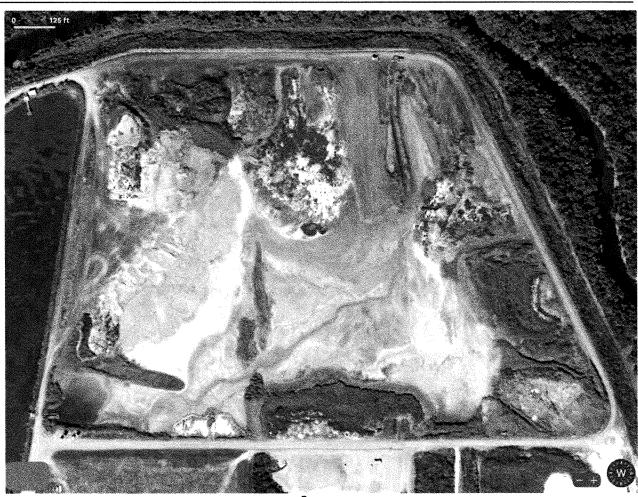
Condit	ions Limiting Visibility:			
	Snow Cover		Other	
×	Vegetation		None	
Obser	vations:			
	Erosion / Gullies		Sudden drop in impoundment level	
	Cracking / Sloughing		Actual or potential structural weakness	
	Seeps / Damp Areas		Improper operation of overtopping control	
	Signs of Creep		Visible release	
	Failed/eroded vegetation >100sq ft.	×	No observed problems	
Describe findings. Identify locations on attached map. Attach additional pages if necessary.				
***************************************

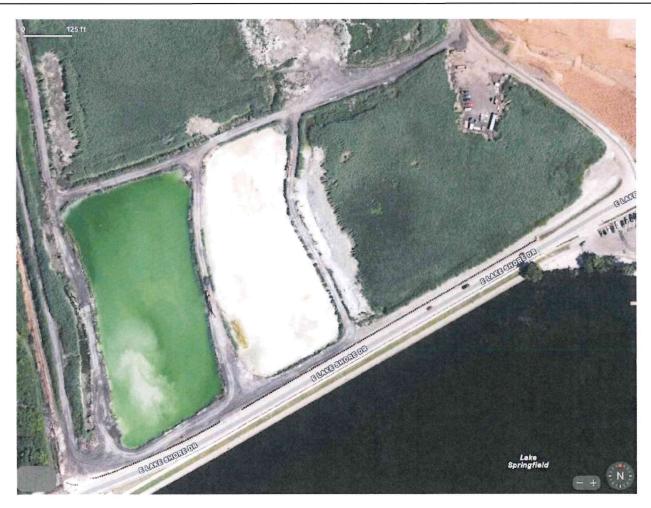
Condit	tions Limiting Visibility: Snow Cover Vegetation	□ <b>⋊</b>	Other None			
Obser	vations:  Erosion / Gullies  Cracking / Sloughing  Seeps / Damp Areas  Signs of Creep  Failed/eroded vegetation >100sq ft.		Sudden drop in impoundment level Actual or potential structural weakness Improper operation of overtopping control Visible release No observed problems			
Describe findings. Identify locations on attached map. Attach additional pages if necessary.
