Annual Inspection Report
for
Coal Combustion Residuals Landfill

City Water, Light & Power
FGDS Disposal Facility- Unit 2
Springfield, Sangamon County, Illinois

January 2025

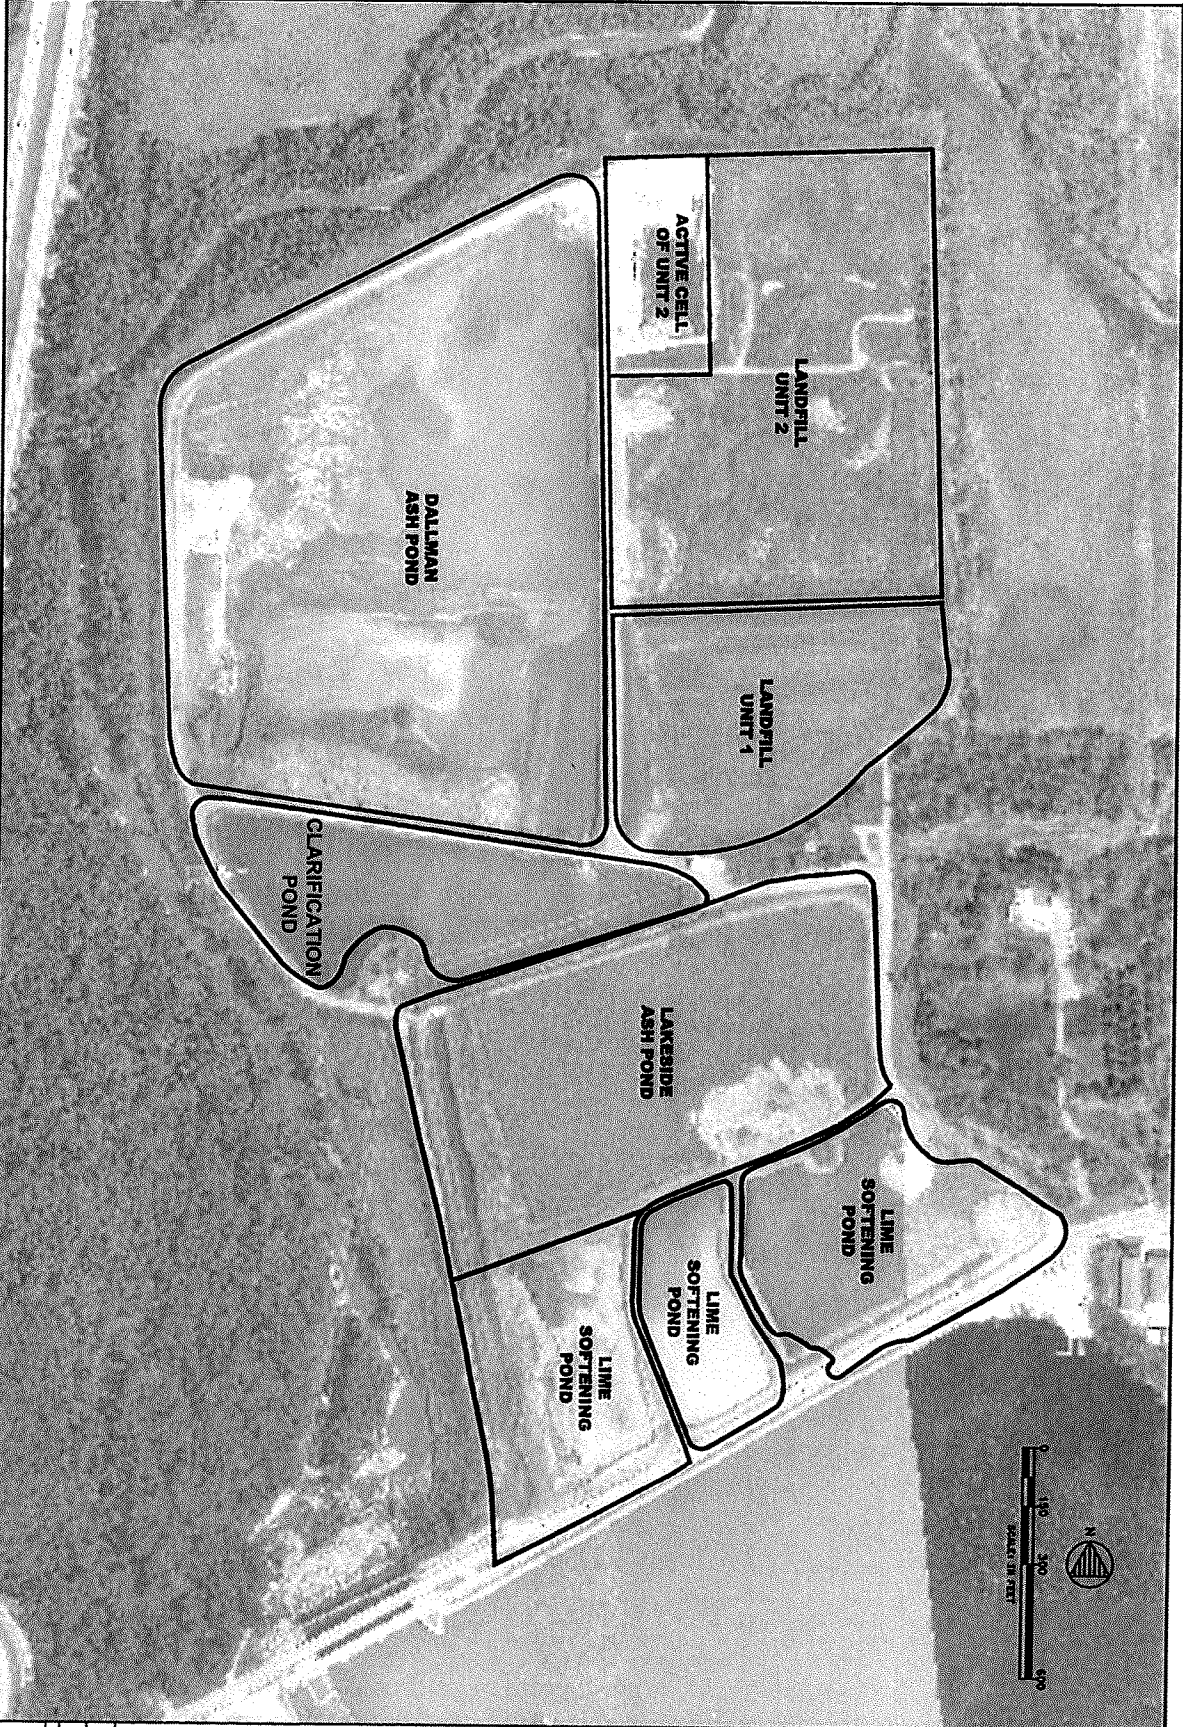
Site Map

CHLP COAL RESIDUAL COMBUSTION UNITS
 PLANS PREPARED FOR
CITY, WATER, LIGHT & POWER
 SPRINGFIELD, SANGAMON COUNTY, ILLINOIS

At the time of the inspection, one cell of Unit 2 has been constructed and is currently the only active portion of the CCR landfill. The active cell, which is approximately 3.5 acres, is rectangular and is located in the northwest portion of Unit 2. The constructed wall sections of Unit 2 bound the cell to the north and west. Constructed containment berms bound the cell to the east and south. A site map drawing containing an aerial photograph and approximate boundaries for all of the CWLP CCR Units, including Unit 2 and the active cell, can be found in Appendix A.
